A REPORT ON

Geological Field Visit of Several Villages in Yamkeshwar Block, Pauri Garhwal

UTTARAKHAND

UTTARAKAND LANDSLIDE MITIGATION AND MANAGEMENT CENTER

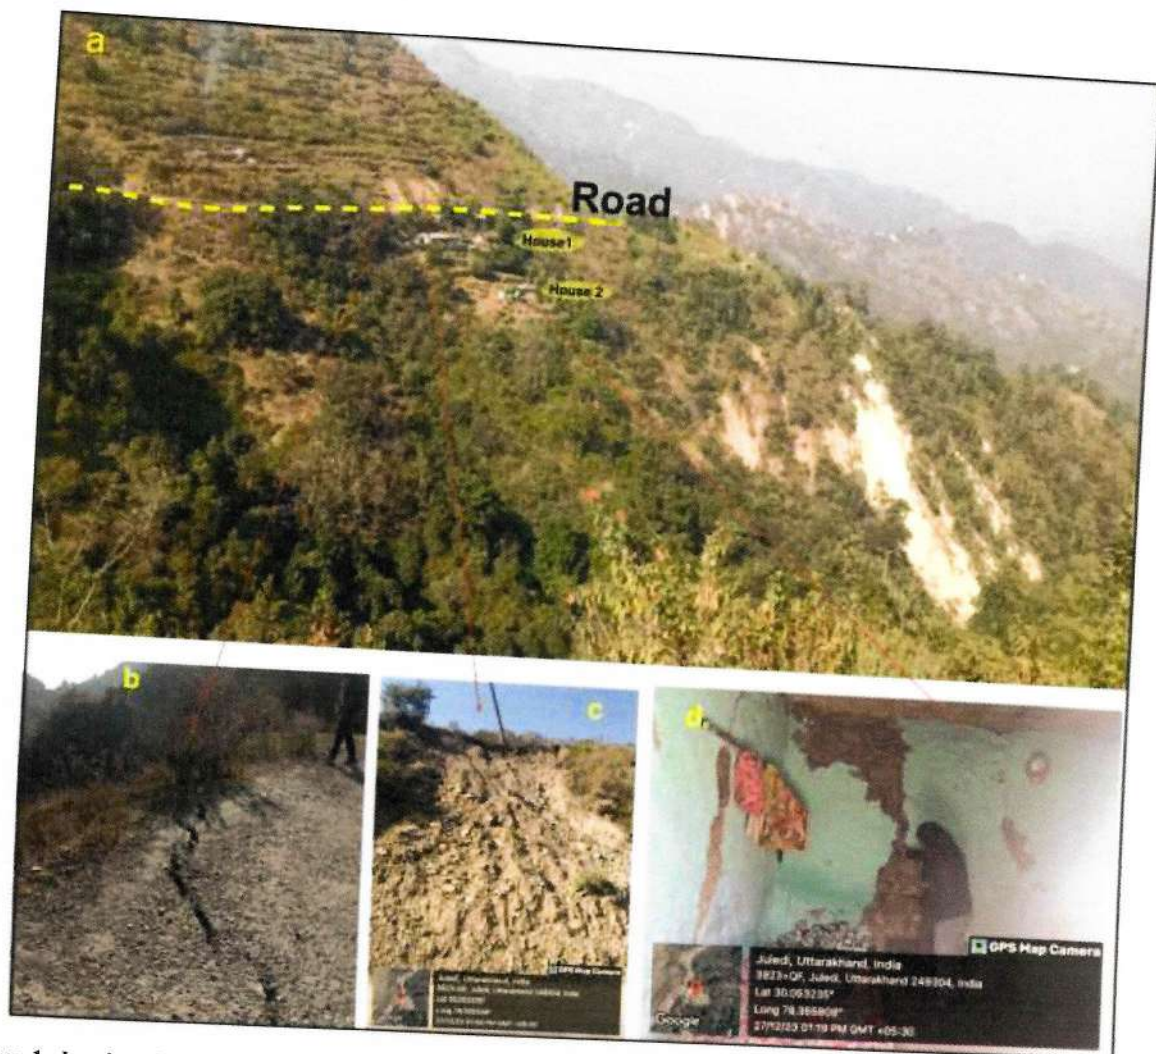
A) Observations: There are two houses including 4 families (according to Patwari) settled in the spot 1 and experienced cracks on floor and walls of their houses during August 2023. According to resident, these cracks were first time visible in this site during monsoon of 2023 whereas previously, there were no cracks on ground and houses observed before monsoon of 2023.

Presently the cracks on walls of house-1 are repaired whereas other house has not been repaired, and associated with poor construction and differential ground movement. From the distant view, it is clearly seen that landslide activity is also present at the base of hill where slope is very steep i.e. >70° (Fig1a) but presently about 20-30 m horizontally away from the settlement.

Figure 1 showing the position of landslide scarp in Spot 1 along with road cracks and poor construction of house-2 in which fallen plaster has seen

Due to the continuous and heavy rainfall, there were initiation of smaller scale landslide activity crown of which is above the road and settlement whereas toe of which is near agricultural lands near to house-1 (Figure 1) that causes instability/cracks in the area.

1. A **retaining wall** is needed on road side along with **side drainage** to channelize the flow of rainwater away from this scarp in order to arrest the movement. It is also advisable to make **contour drain** with impermeable base above crown so that water may not enter in the crown of landslide scarp and able to resist further movement
2. A **sign board** is needed at the site mentioning the date/year of landslide activity and warning to people to restrict the construction in this area as its landslide prone zone.
3. **Repair and filling of cracks** with impermeable material is recommended on road site.

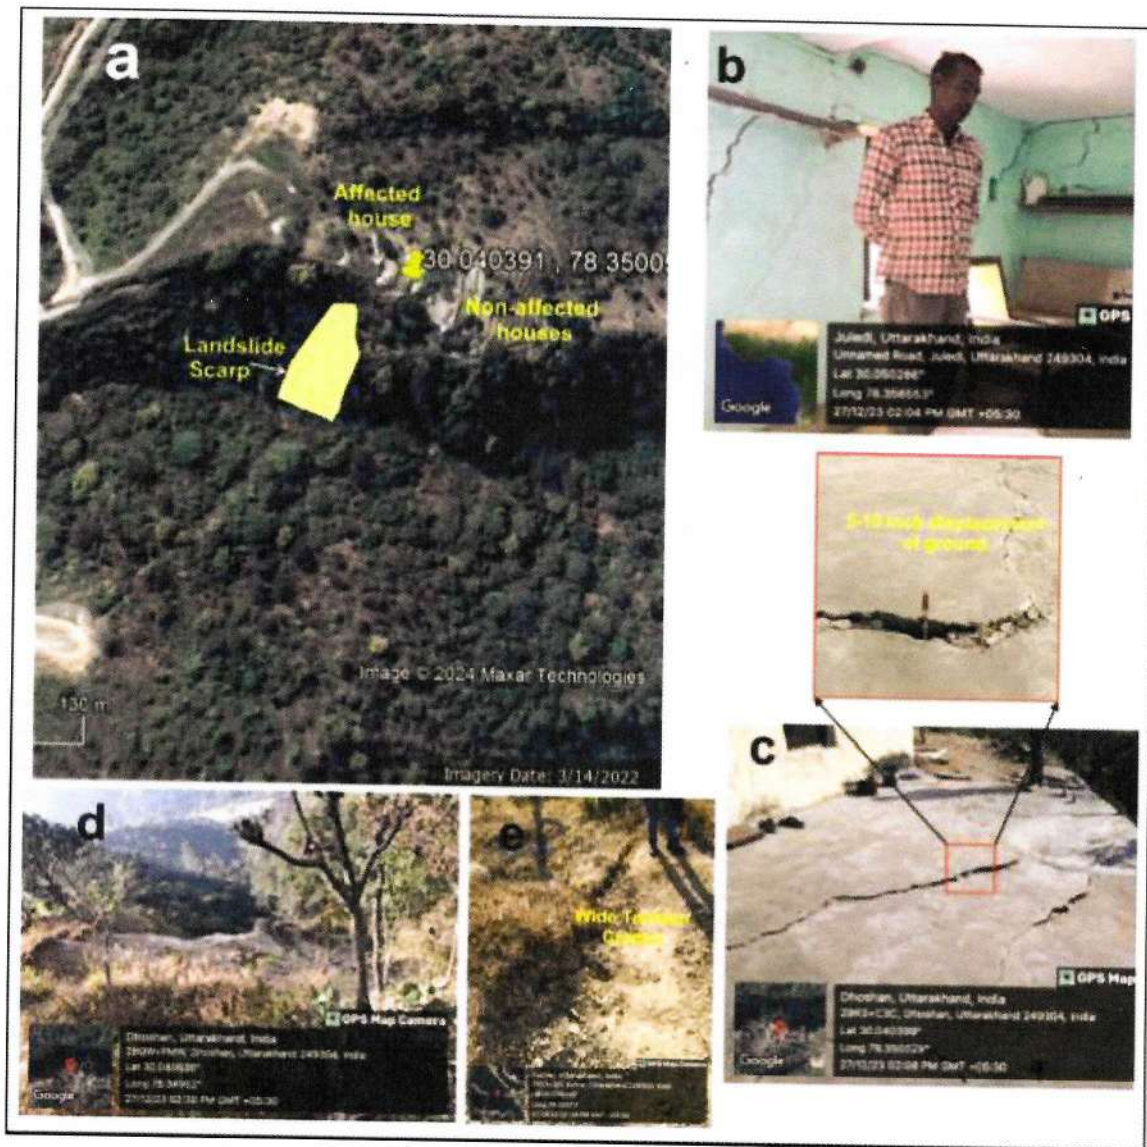
There are irregular pattern cracks observed at 5 houses located at Bijakhet tok but two houses are severely cracked. These houses are located at an elevation of 840 msl and above a large landslide that initiated in August 2023. The landslide is 40 m in length and 10 m wide. A previously constructed concrete footpath just above the head of landslide is also washed away. There are many wide tension cracks (upto 2ft deep) still present at crown of landslide in which 1-2 ft vertical displacement is noticed (fig 2). Above the landslide scarp, the affected area in which tensional cracks on ground visible is upto 8 m. In general, the houses that are far from landslide scarp are not having cracks whereas the houses located above the landslide crown having cracks. The severity of cracks in houses depends on their distance from the landslide scarp. Since houses are not located just above landslide margin or very close to crown (approx more than 10 m away) therefore there is no serious risk involved for the people but chances of more visible cracks and ground settlements during heavy rainfall after triggering of same landslide again.

There is possibility of increase in landslide scarp as there are many open and deep cracks present on crown portion. If water will percolate further inside the cracks in next monsoon, there may be chances of reactivation of the same and more visibility of cracks on houses. As the houses construction are of poor in nature with foundation lying on loose soil and only upto 1 ft in depth.

Figure 2 showing the landslide scarp as in yellow colour in satellite view along with damage in form of cracks on ground and house

B) Causes: Due to heavy rainfall of continuous five consecutive days initiated landslide and those house situated above the crown packed with substantial cracks on walls and ground

1. The area falls under **moderate to high risk**

2. Since, the landslide material fallen down into the forest areas with no road and settlement below, is inaccessible and very steep (80°) therefore, providing any **mitigation measure is not possible** however **Early warning system (EWS) system** may consider in order to avoid unpleasant activity in future

3. The house that is severely affected has not been repaired therefore risk involved near future may not be monitored. It is desirable to instruct **related department to monitor whether the repair of the cracks is done or not**, if relief fund released to them as per the govt. norms otherwise repairment is advisable. It is important to monitor these cracks whether increasing or not showing any deformation in next season in order to provide safety to people and further planning which cannot be possible if repair work not be done.

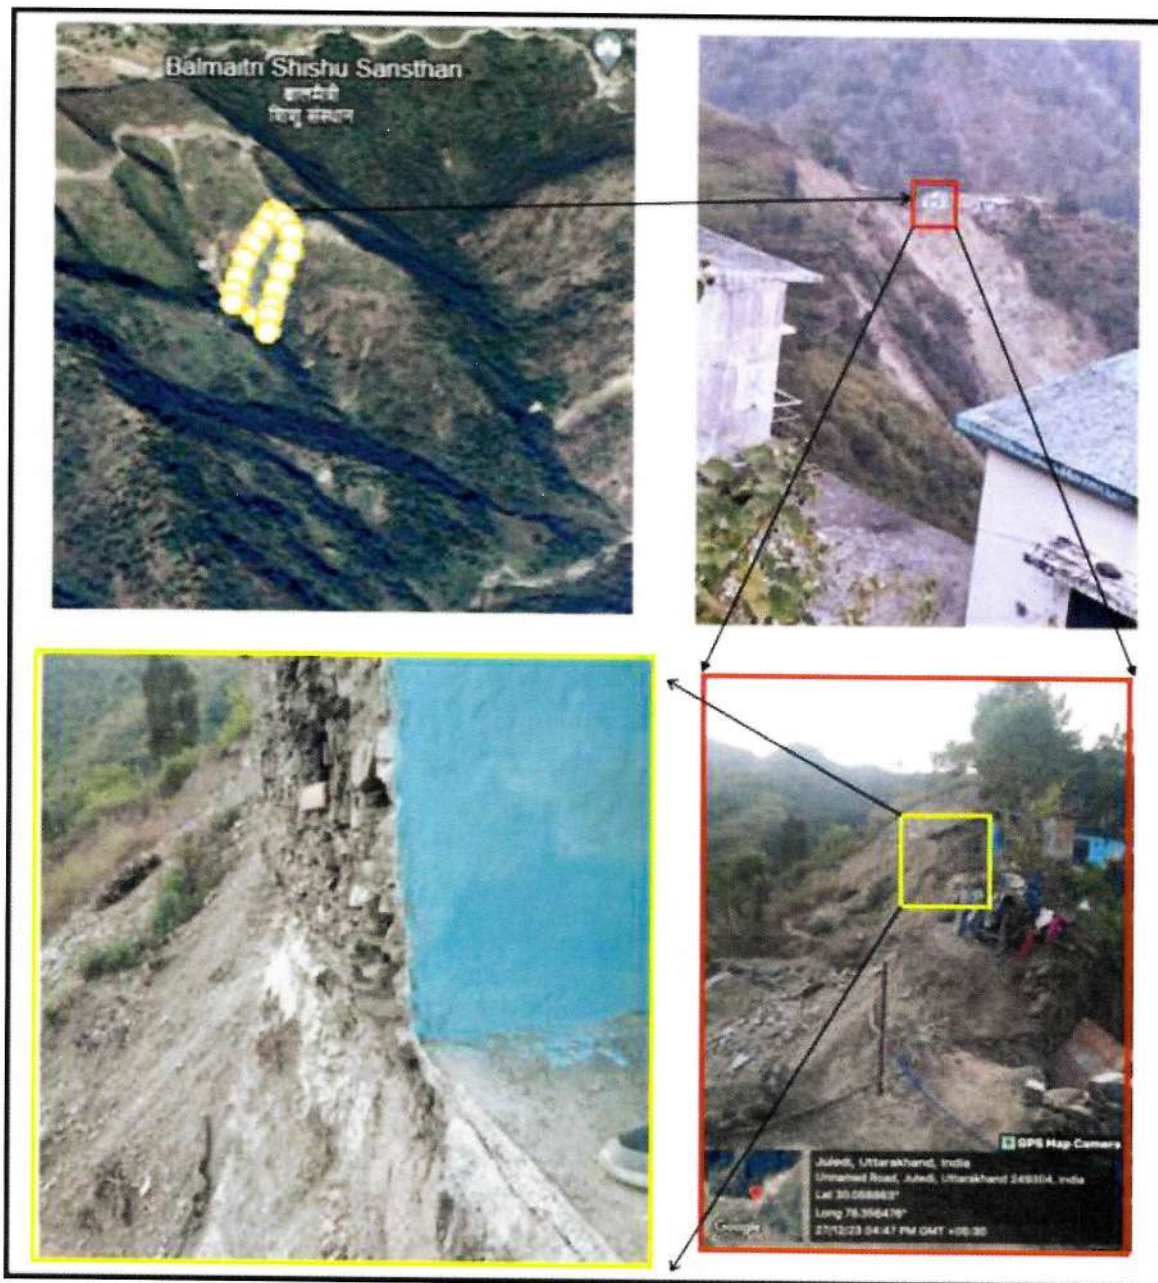
The Spot 3 is located at latitude 30.058963°N and longitude 78.356476°E at an elevation of about ± 820 m from msl and the slope faces towards SSE. At the base of the hill, a nala is present that further meets with a tributary of river Ganga i. e. Hewal nadi. The entire area is occupied by the slope ish material and the slopes, in general, are steep whereas flat (nearly horizontal) where only two houses are built. A landslide of 140 m length and 20 m width covered an area of 1658 m^2 occurred on 16th August 2023 in which a house is completely washed out. The other house is situated justaposition of landslide scarp at an elevation of 800 m (Fig3). An another house is situated little far of this landslide site and does not show any significant cracks on wall and ground and subsidence.

Geologically, the rock is mainly phyllite with bands of quartzite and is thinly bedded, highly fractured and sloping towards the valley side. Therefore there may be chances of activation of landslide again during heavy downpour.

B) Cause : As a prima facie, it appears that the sudden landslide is caused due to the toe erosion of steep slope due to heavy gush of water at confluence of two first order seasonal rivulet positioned at the base of hills (Fig3) at an elevation of 780 msl during 16th August 2023.

Figure 3 showing the satellite view and location of house from far to closer view that located just above the landslide scarp and falling under high risk

No construction in future may allow in this spot with the **resettlement** particularly the family located in the margin of landslide. After relocating, it is advisable to damage the roof of house so that it may not occupy again along with **signboard mentioning "landslide risk area and restricted for any construction"**. Although other house in the region seems stable as presently no cracks seen and located at the middle of flat portion in ridge but both side seasonal rivulets are present, therefore in extreme rainfall condition, it would be in risk again as chances of landslide activity may not be overruled in both the side. Therefore monitoring and awareness is needed for the family and reporting if any tension cracks appear.

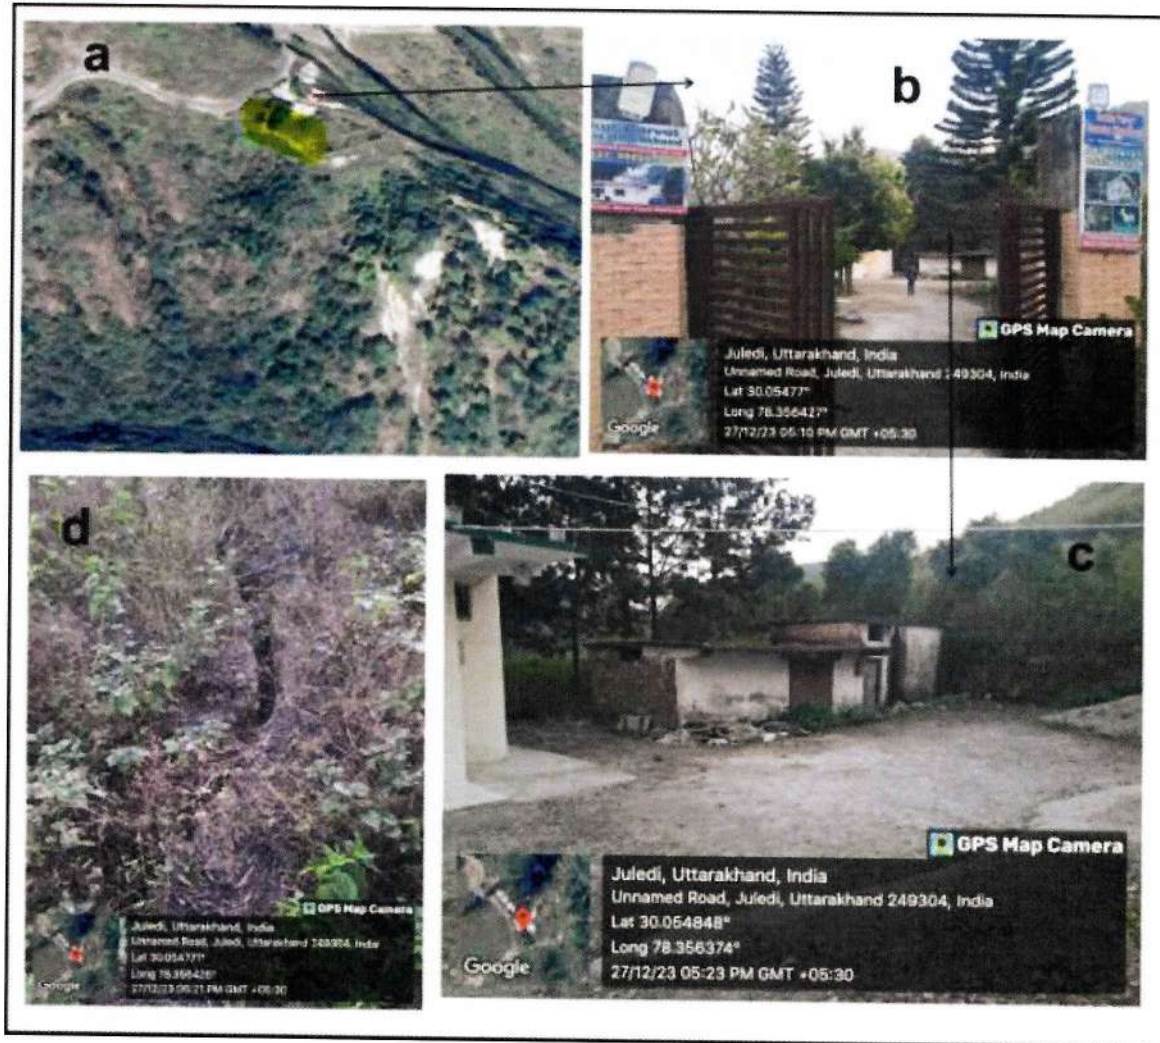
A) Observations : The Spot 4 is located at latitude 30.054857°N and longitude 78.356418°E adjacent to metalled road which is 500 m far from Jhilmil gufa pedestrian track and about 200 m far from Spot 3. A private property named Manikut parvat homestay is situated at this spot which is presently closed for visitors. The backyard of the homestay building are packed with open tension cracks of < 1 ft wide and 10-20 m in length. Highly fractured quartzite rock and chunks of rock quartzite in soil are exposed along the open tensional cracks giving the possibility of fault scarp at this site. From Google view, many older landslide scarps are also noticed in this hill slope indicating landslide activity in past also occurred. The entire area is covered with thick slope ish material giving the clue that its already weaker zone and numerous arcuate open, 1 m deep and ½ m wide ground cracks is visible in the area. There are no agricultural lands all around and no settlement except a guard looking after the property.

B) Cause: There is possibility of a fault passing in the area which fractured and crumbled the rock quartzite and hence weak zone prone to landslide, hence triggered by intense rainfall activity of August 2023.

Figure 4 Satellite view of Markut Parvat homestay that exhibits wide open cracks located at the backyard. Note that satellite view is of 2022 and many older landslide scarps are visible. The yellow highlighted portion exhibit the presence of open cracks of about 1 ft wide

1. It is recommended to **fill the cracks with impermeable material**. Since, there is no agriculture lands and families staying there and only a guard looking after the property therefore it is advisable of **resident of any person/guard/ family must avoid during monsoon** at this site. For that, a **signboard may be mounted**

2. There is possibility of landslide occurrence in the site as having many tension cracks which are open just at backyard of the main homestay building therefore **any sort of further construction and use of place during monsoon should be avoid.**

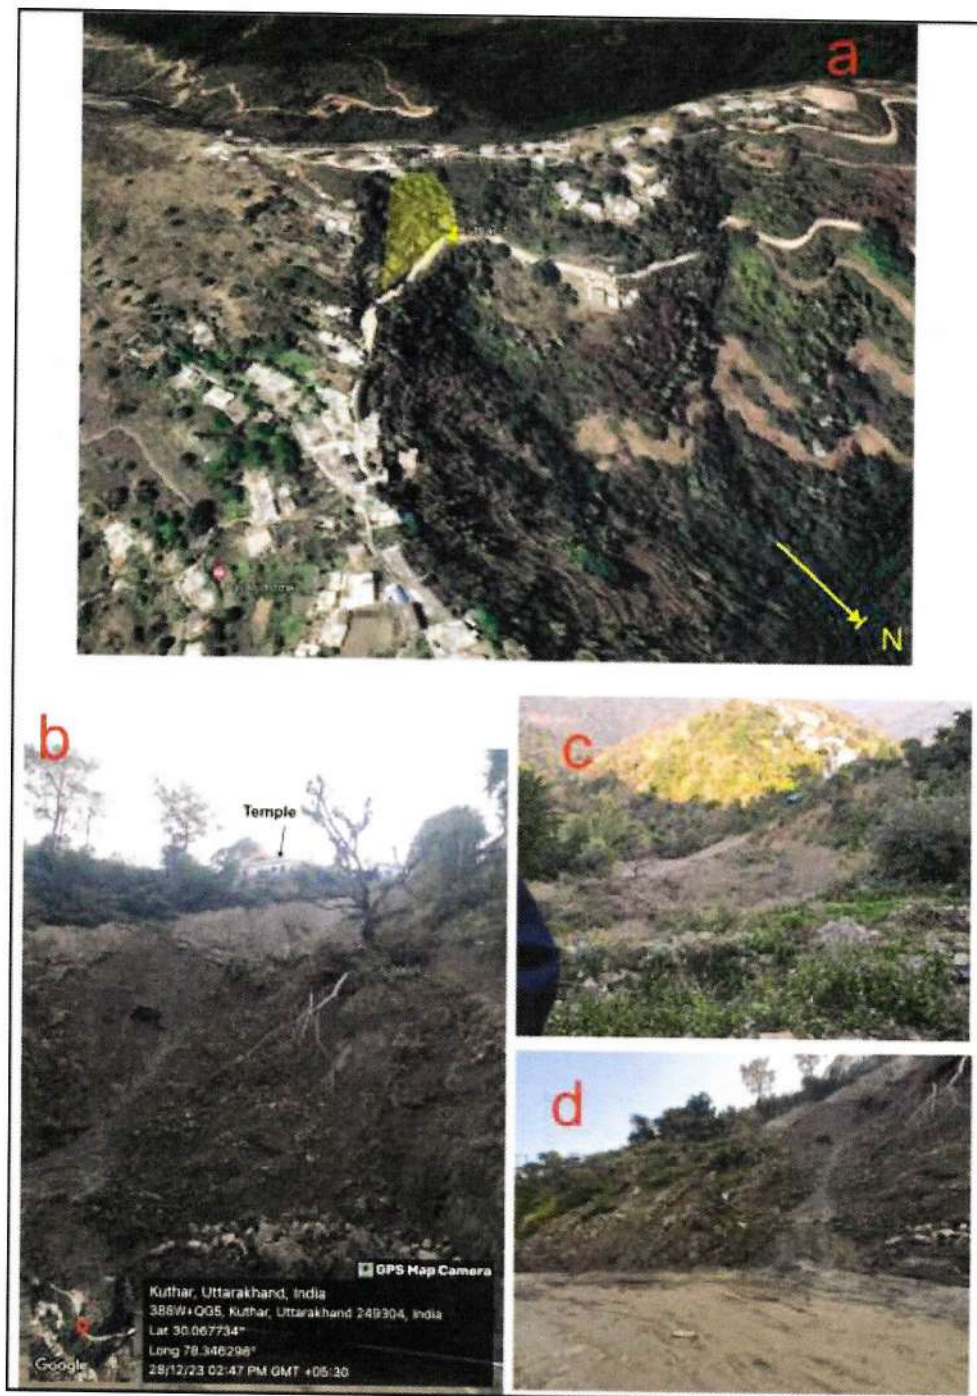
A) Observations : The Kuthar village is located in Pauri tehsil of Garhwal district in Uttarakhand, India and being awarded the Deendayal Adarsh Gram Award . It is situated 6 km away from Pauri, which is both district & sub-district headquarter of Kothar village. It is located at latitude N 30°04'3.3" and longitude E78°20'47.7" at elevation of about 981 m (on road side). The slope direction is towards N20°E. A landslide having 40 m height (approx) and 15 m width (approx) occurred along Neelkanth –Kothar road after the prolonged rainfall for continuous three days in August 2023 that damaged the road approaching to village, waterpipeline , agricultural lands and also threat to the houses and temple located near the crown of the hill. Four houses and a temple of Mata Bharvi Bhawani are situated just above the landslide crown poses serious threat to their stability. The drains of these houses and temple are towards the same slope. Adjacent to this landslide scarp, an another landslide scarp is also observed in which one house is located at close proximity and top of a smaller scarp with all house hold water draining towards the landslide site. As a temporary arrangement, the portion of upper disturbed slope are being covered with plastic sheets.

Geologically, no rock is exposed in the site and the entire slope is comprises of clayey silty material which is wet in nature. Geomorphologically, the slope direction is towards N20°E with landslide affected area steepness varies from 30° (middle portion) to 80° (top). Below the road, first order seasonal nala is present. The slope forming material is wet in nature and percolated water is also present on roadside as the area does not received sunrays and in shadow zone.

B) Cause : During the continuous and heavy rainfall for consequently three days during August 2023, the slope comprises of clay rich slope got oversaturated at certain and swallower depth since clay are poor in permeability and landslide triggered.

Figure 7 (A) Satellite view of Kuthar village. The yellow highlighted portion is of landslide occurred on 17 August 2023. (b) landslide view and location of temple just above the crown (c) view of landslide from the top of the crown (d) the landslide site sloping towards north hence not received sunrays for longer hours and slope material is still wet with water on road even during winter

1. The area falls under **high risk for settlement above the landslide**
2. As four families are settled just above and margin of landslide scarp, therefore **relocating the houses are recommended in order to reduce the weight** on the top of the landslide zone and for the safety of temple.
3. **Repair the damaged water pipeline** ensuring no ingress of water into slopes

4. A **step retaining wall** of (1-2 m) is recommended along the road side with side drainage and considering insitu condition of foundation material.
5. Since, the debris disposed in the valley side along the road after landslide activity, therefore it is recommended **to provide the support below the road with retaining wall with weep holes below road level.**
6. Since the slope is gentler in the middle **therefore bamboos, vetiver grasses** or any other plant species that may hold soil and strengthen the slope is recommended.

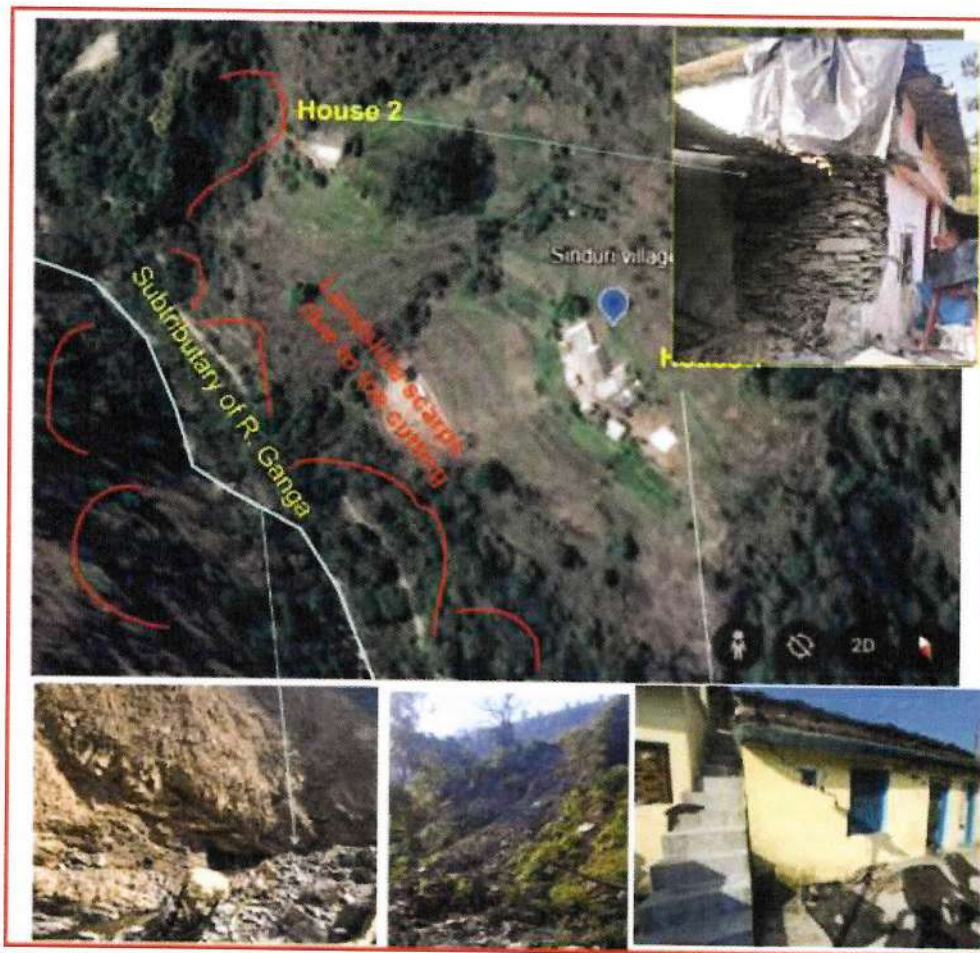
A) Observations: The Veerkatli tok of Sinduri village is located at latitude N 30.052435° and longitude E 78.398048 ° at an elevation of El ± 600. The slope direction is 60° towards ENE. There is no road connectivity in the area and approached through a foot track. The agriculture is being practiced on these slopes extending from the height of 640 m till the steep slope present. Only Two houses are situated at an elevation of 600 msl in a hill sloping towards east whereas a sub tributary of river Ganga is flowing at the base at an elevation of 540 m. Along both side of sub-tributary, landslide occurred (Fig 8). Towards the left side of river, the slope comprises of debris with boulders of quartzites of 1-1/2 m dia whereas towards right side, highly fractured, fragile rock quartzite and shale is exposed dipping towards south. The slope is sub-vertical near the base of the hill whereas ~20° where two houses are situated and again slope is highly steep (~70°) on the top of hill. These houses that located at the middle of the slope are packed with cracks on walls and ground whereas their location are far from the landslide site, therefore the cracks are due to poor construction and differential ground movement during heavy downpour. An another swallower landslide occurred along the spur adjacent to house-2 however the front face of this landslide, its extend and associated degree of risk cannot be estimated due to topography of terrain and hence the width and height may not estimated.

B) Cause: The cracks are due to poor construction and little differential ground movement during heavy downpour.

Figure 8 Field conditions and condition of houses in Veerkaatli tok of Sinduri village (Red arcuate portions denote landslide scarps developed in the monsoon of 2023)

1. The area falls under **low risk**
2. The house-1 may **implement necessary repairs** whereas house 2 may be shifted towards its left from present position as falls near the edge of hill/spur to the rivulet where landslide occurred in August 2024
3. Smaller bridge (may be wooden) is recommended as during extreme condition , there is no escaped route for villagers and the area is only approachable by crossing the river

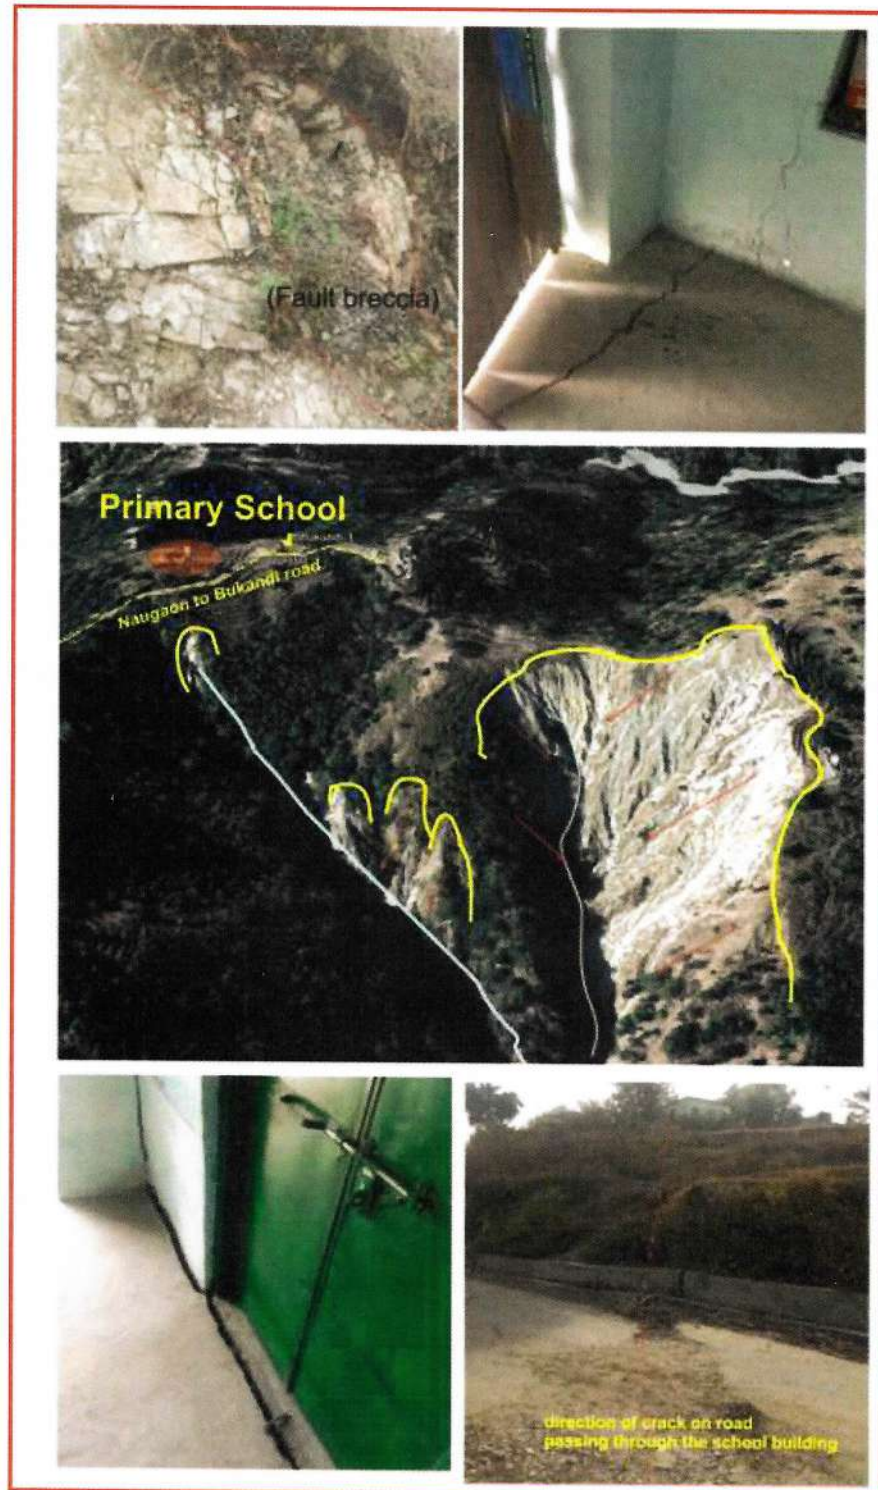
The first spot is located at latitude and longitude of N $30^{\circ} 02'23.17''$ and E $78^{\circ}22'7.52''$. At this site, 5 cm wide crack aligned in the direction of $150^{\circ} - 330^{\circ}$ is observed on road site that further runs across the primary school building located at the top. Below the road, agriculture fields and vegetation growth is present due to which the direction of the cracks cannot be traced beyond. There are no cracks seen on open ground in front of school building but cracks are present on floor and wall of school building

Figure 9 exhibiting the condition at spot 1 where landslide scarp can be seen below the school building. A crack observed in the school building as well as on road is just extension of landslide scarp.

1. The area falls under **moderate risk**
2. Recommendation to **repair and reinforce the damaged school structures.**
3. **Instructions to construction company** to follow guidelines on **disposing muck dumping.**
4. **Awareness programs** are needed for villagers as they should know the safer and unsafer place and response during the unpleasant activity with coordination of local authorities.

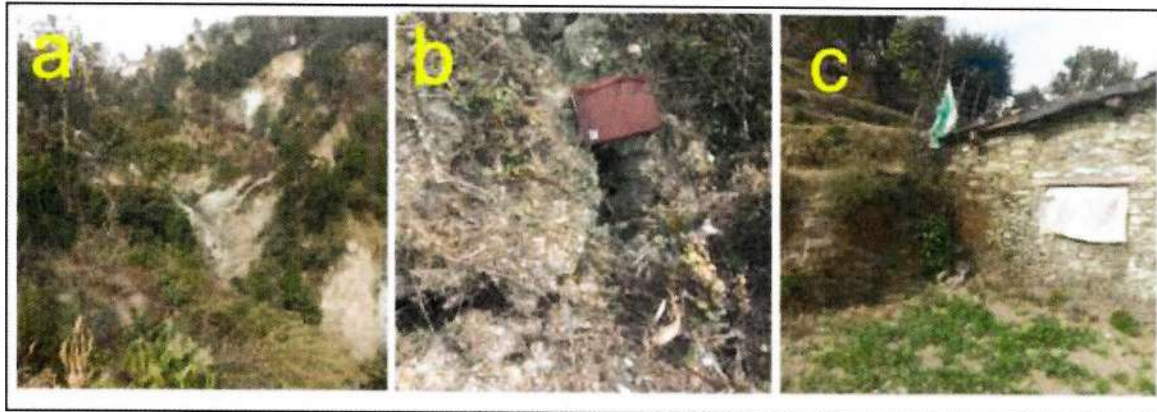
Figure 10 Photographs of Spot 2 of Bukhandi village

The sub-village of Bukandi known as Katali (Spot 2 at N $29^{\circ}58'15.27''$ & E $78^{\circ}20'50.71''$ at an elevation of 800 m from msl), where few houses settled near to highly weathered and crushed rock i.e. phyllite observed giving clue of presence of fault along the entire valley thus initiated landslide activity. The orientation of fault is parallel to Nala i.e. $160^{\circ}-330^{\circ}$. All the houses are kachcha and build with stones with slanting roof. There are no damaged occurred in Katali as houses are located at considerable distance from faulted. however just close to slope edge, cracks are seen on ground. The landslide activities are common in both side of valley due to exposed of fault and weathered rock. It is observed that few house is either located at near to

valley side or in just contact with hill slope although lot of space are available which resulted allow the water to percolate and ooze in from the backside of houses as houses are of kuccha in nature and constructed of stone blocks.

B) Cause: Due to poor and highly weathered rock, landslides scarps appeared majorly on nala sides. Many places got unstable particularly where there may be possibilities of fault as shown by few geological and geomorphological evidences.

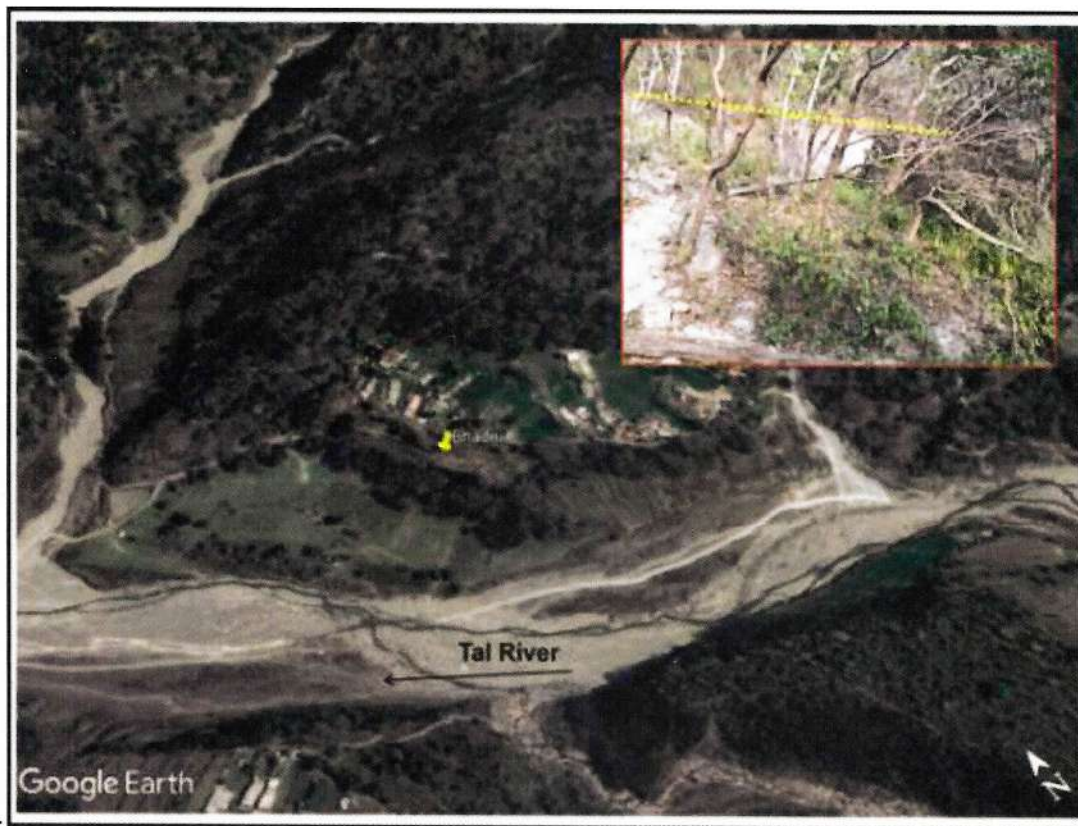
A swallower ~3-4 m high landslide scarp with few uprooted trees seen in the area marked by yellow dashed line in figure 11 in the slope facing 220° (SW). The detached portion accumulated at slope break and not reached to settlement. No cracks have seen in any of the houses and agriculture field are flat and at considerable elevation from the river base. An outcrop of weathered phyllite is noticed giving clue that there is thin cover of overburden.

Figure 11 showing the location of Badhni village which is almost flat area having 8-10 m elevational difference from River Tal

B) Cause: The heavy rainfall in August 2023 resulted, outish of small patch of land portion in Bandani village where overburden is thin and which has not impacted on residential area.

1. The area falls under **low risk zone**
2. A wide portion may dig out **to accumulate** debris at back side of settlement ensuring the safety of houses with proper water drainout pipes and also **removal of disturbed uprooted and fallen trees** which settled just above residential houses. However, it is noticed that 1ft wide ditches are already digout to install waterline. It must be ensure that such work must complete before monsoon otherwise such dig portions may accumulated water helping to trigger the swallower landslide activity.
3. It is advisable that **construction of road and bridge** are necessary to approach the area with scientific and technical support of expertise and special attention to the fact that river bean and tributaries showing signature of active environment in form of landslides, toe cutting and sediments deposition.

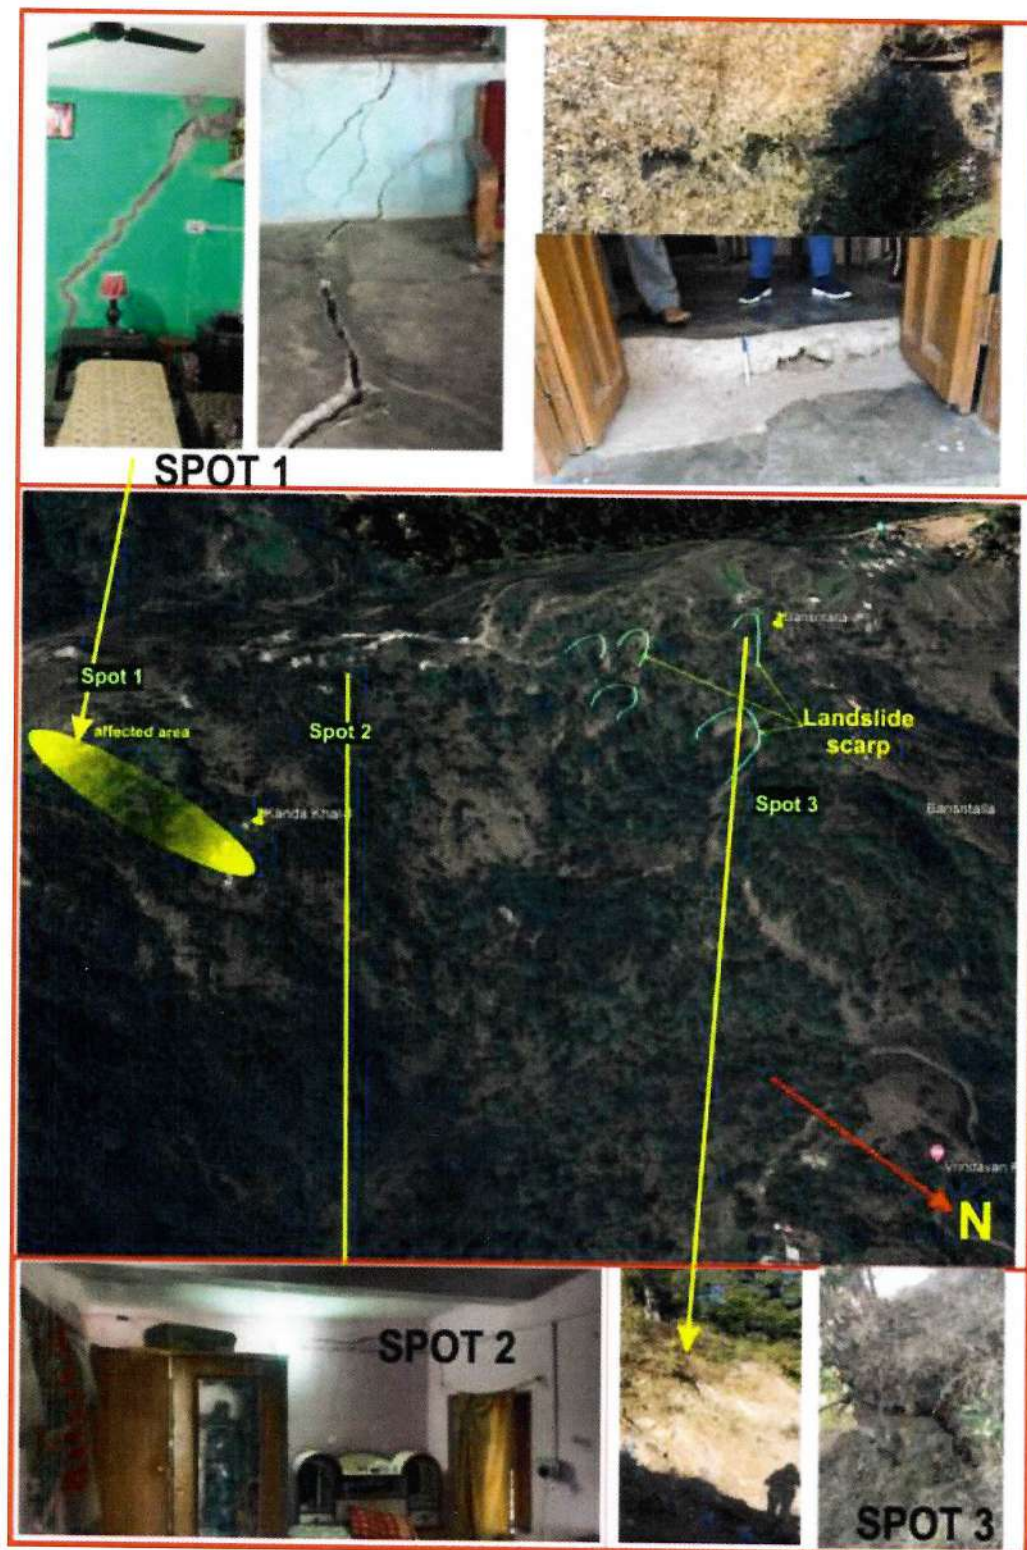
The first spot known as Aamkatar tok in Kandakhal village located at latitude N 29° 58' 26.4" and longitude E 78°20'00.3" with scattered houses lying at the top and middle of an arc shaped ridge. The houses at spot 1 showed significant wide cracks on walls and ground indicating severe structural damage (Fig 12). This is evident in approximate 6 ft long and 3-5 cm wide cracks on floor of houses. The slope direction is towards North with major 2 ft deep tension crack orientated in direction of NE-SW appeared on agriculture field. A house is situated at latitude and longitude of 29°59'21.38" N and 78°19'2.61" E where at the back site, a scarp developed in the direction of 120°-300°. N-S oriented nala appear of extreme left of the site.

The residents are still inhabiting in the damaged houses despite the unsafe conditions. Geologically, the spot 1 having thick soil cover of dark brown clayey soil with no rock outcrop.

The Spot 2 is located along the metalled village road where many houses are in cluster. There is no risk identified except the initial evidences of subsidence in form of tight wall cracks in few houses and settled portion of road (Fig 12).

At Spot 3, many smaller swallower landslides appeared in this site with 4-5 numbers of wide 1 m deep tension cracks appear on top of ridge. Due to occurrence of multiple landslides, a foottrack is highly damaged towards the slope direction i.e. N75° (towards East) but not affected any houses.

B) Cause: The village and houses are located on clay rich soil with many places having steep slopes and arcuate shaped. Since, the clay bearing soil has low permeability therefore swallow landslides may common during heavy rainfall.

Figure 12 represents the condition of houses affected during August 2023 in three spots in Kandakhal

1. The Spot 1 **falls under moderate to high risk**. Thus, resettlement and rehabilitation is recommended at Spot 1.
2. The Spot 2 have **low risk** therefore **monitoring of this area** is required.
3. The Spot 3 have **low to moderate risk**, since only 1 house located at top of the hill at Spot 3 below which landslide occurred but slightly far from landslide scarp therefore the house is not under high risk but probability of landslide may occur in this zone due to widen tension cracks. Therefore, it is suggested that if there are abnormal movement and cracks appeared then inform local authorities for further action. Presently, **no action required at this site**.

In addition EWS may install in the area to monitor the deformational changes

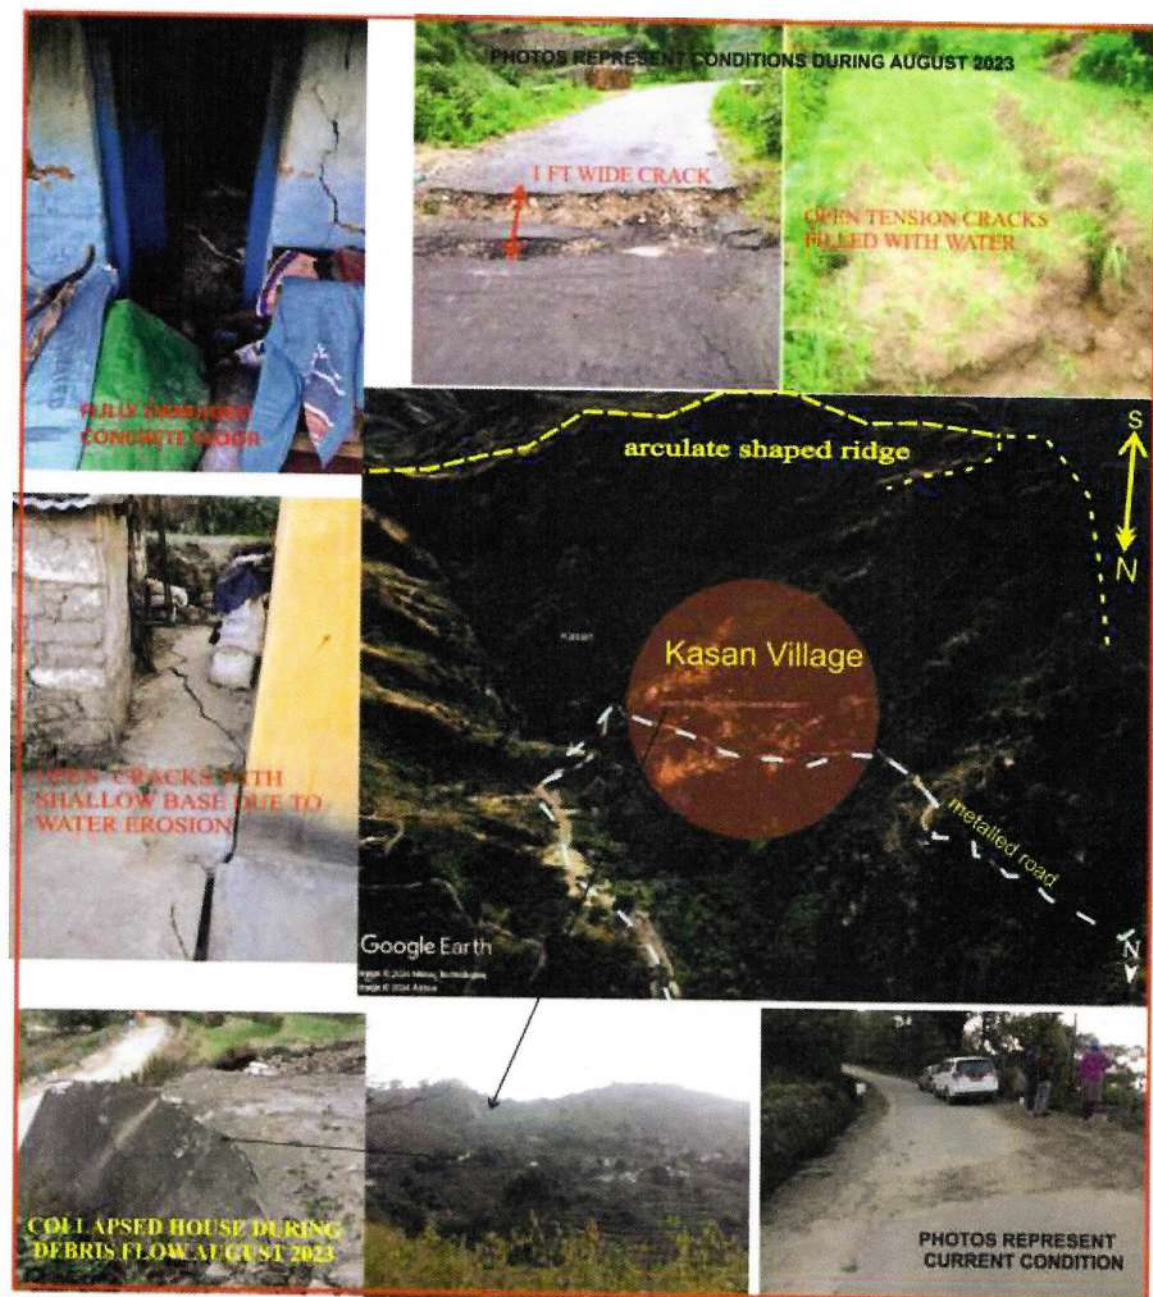
B) Cause: Geologically and geomorphologically, the area formed a small catchment with thick overburden comprises of clay rich soil. Since clayey soil have low permeability and due to agricultural practices, the infiltration rate of water is slow and run out is more and at certain depth the soil starts flowing after mixing with water.

Figure 13 exhibiting the satellite view of village Kassin and damaged occurred during monsoon of 2023. Presently, the cracks on roads are temporarily repaired

C) Recommendations: The area formed small catchment, presence of clayey soil with no presence of strong rock up to greater depth, wet environment as sloping towards north which adversely impacted on instability of an area and not suitable for population, therefore may consider for **rehabilitation**.

Appropriate and quick action on implementation of the mitigation plans in form of closely network subsurface and surface drainage plan and debris flow ditches are required that reduces the water in filtering considering the properties of slope forming material.

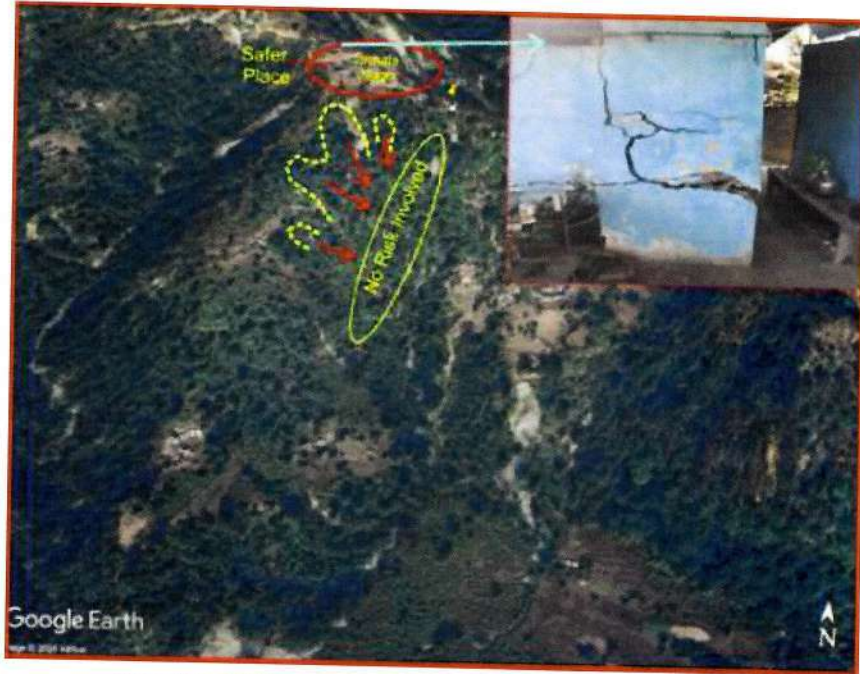
A) Observations: The Tachla village is located at latitude N 29°53'42.64" and longitude E 78°24' 48.71' and settled in various clusters at different elevations. A newly aligned kaccha road named Amola Chaurani motorable road is constructed till altitude of 1028 m from msl. This approach road is constructed having very sharp turn and need to widen at turns before metallized it. A main cluster of houses are lying on top of hill where no instability caused except one house which is very old and having cracks. As a prima facie, it appears that the cracks are due to poor and old construction and not

Figure 14 exhibiting the sites of landslide activities in Tachla village

related with any ground subsidence since no cracks seen on ground. A new house is also now constructed besides this old house. Also, the trunks of 3-4 cutted trees are also noticed near house.

limestone and shiny and slippery micaceous rick clay –silt matrix. Since there is no settlement below this track, therefore no risk involved (Fig 14).

B) Cause: The multiple swallow landslide occurred due to heavy flow of rain water and surface erosion in steeper slopes ($>50^\circ$) facing NE.

C) Recommendation: There is **no risk identify** along the foot track and top of hill where sparsely populated area is located. Therefore, **no measures are recommended.**

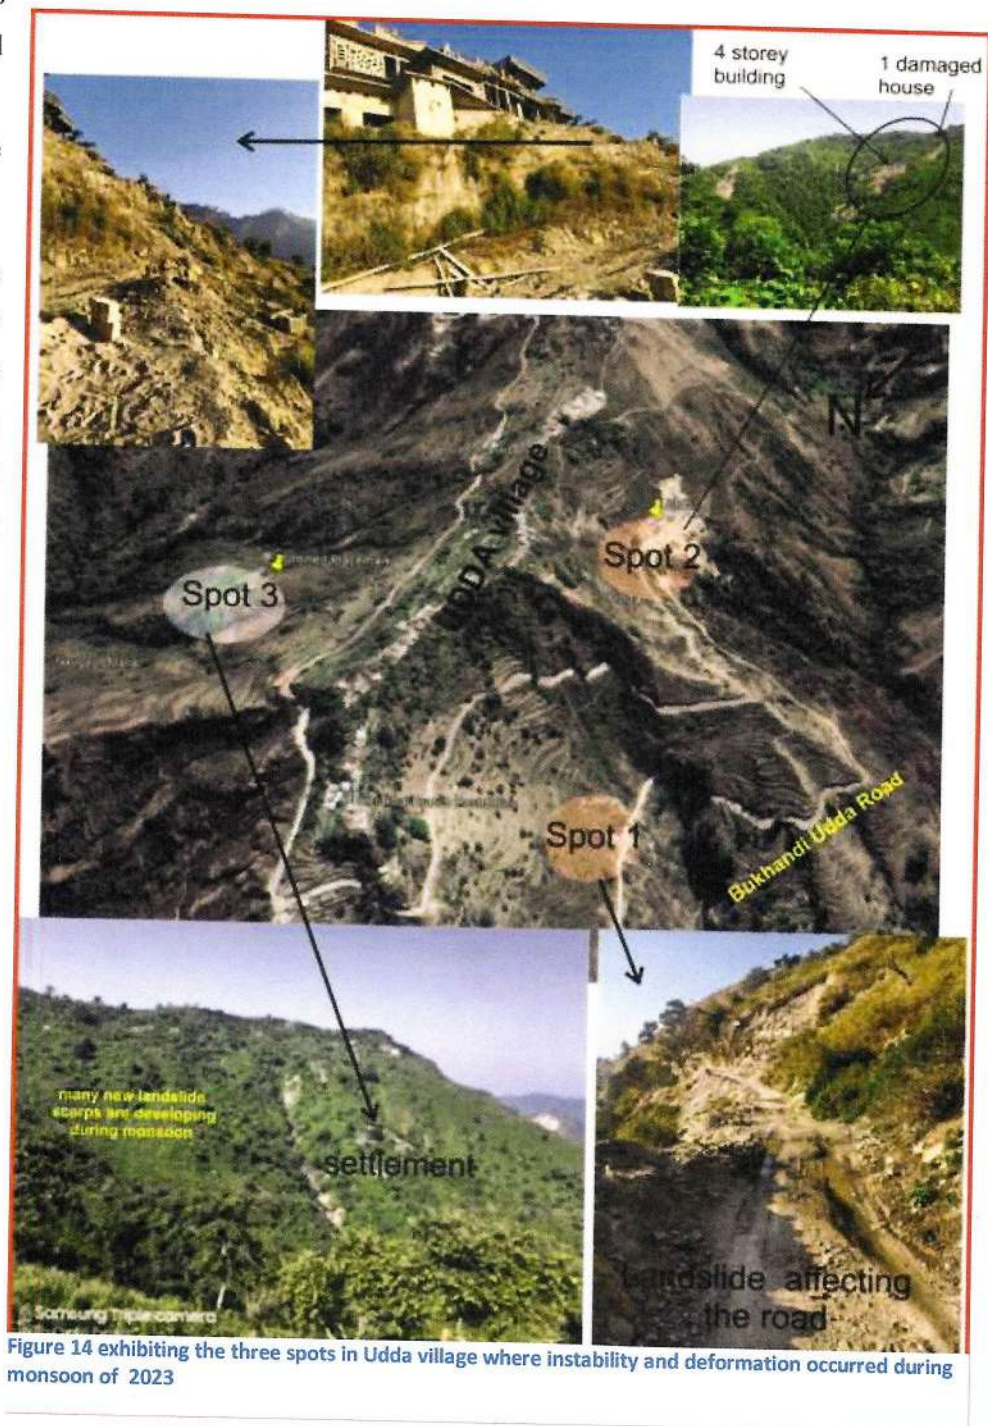
The first spot is located at latitude of $N 29^\circ 59' 45''$ and $E 78^\circ 22' 10.6''$ along Chaurani- Amola road where due to landslide activity the portion of road got damaged. The intense and prolonged precipitation on August 2023 initiated landslide at this site in which a road section of 100 meters is damaged. The debris comprises of 1-2 ft chunks of phyllite and quartzites. Geologically, the slope is covered with thin overburden with rocks dipping towards North. The percolation of water is also observed at this site (Fig 14)

The second Spot lies in the middle of east sloping hill at latitude $N 29.993884^\circ$ and longitude $E 78.369316^\circ$ having an elevation of 1100 m from msl. The under construction heavy 4storey building is established which is damaged due to the landslide activity occurred during August 2023 at this site (Fig 14). Other than this heavy building, one more house is damaged lies just above this building due to the landslide activity. Near the heavy building the weathered rock phyllite is exposed. There are presence of houses and school at top of same hill at an elevation of 1200 m from msl and imposed risk to their stability due to the hill cutting and construction of heavy structure. Further moving ahead along a foottrack towards uphill, a crack is mapped oriented at $310^\circ - 130^\circ$ parallel to hill ridge above the heavy building exhibiting the slope is in stress. At the crown of landslide scarp, 1 m displacement is clearly seen near the damaged house. At the top, no cracks seen on ground and outcrop of strong rocks i.e. metabasics and quartzite are present. The rocks are dipping towards North with dip amount of 10° .

B) Cause: Due to heavy rainfall during August 2023, landslides occurred Spot 1 and Spot 2 of Udda village whereas new swallower landslide scarps developed at spot 3 without affecting the settlement but may be critical in future.

Figure 14 exhibiting the three spots in Udda village where instability and deformation occurred during monsoon of 2023

1. At Spot 1, Retaining wall with weep holes are required with adequate drainage arrangements along the road side and also below the road level as part of road width is already affected due to landslide.
2. Geologically, Spot2 appeared not safe as due to highly weathered rock i.e. phyllite exposed and

3. Spot 3 require monitoring and **installation of EWS** is recommended.
