A REPORT ON

Geological Field Visit of Several Villages in Yamkeshwar Block, Pauri Garhwal

UTTARAKHAND

UTTARAKAND LANDSLIDE MITIGATION AND MANAGEMENT CENTER

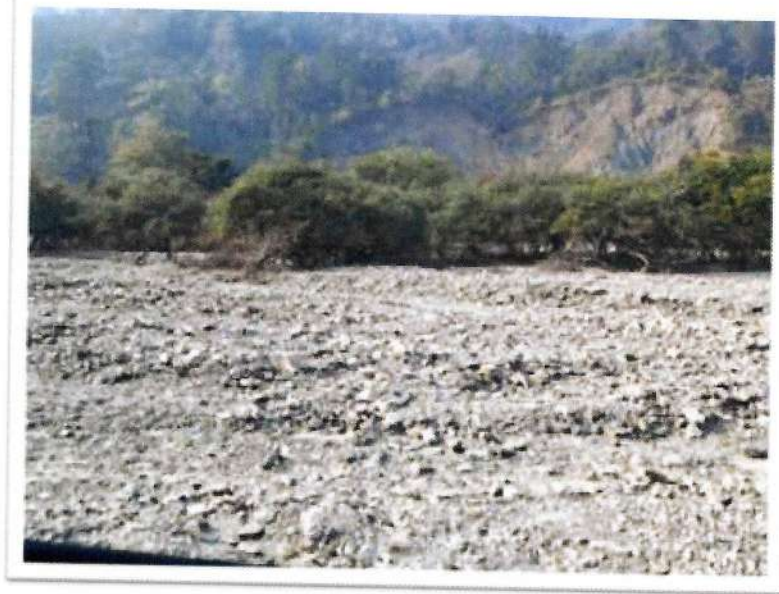
In addition to the location wise observations and suggestion given above, it has been observed that major of the villages are situated right and left side of the tributaries and subtributaries of River Ganga. At many places, there is no road connectivity in the area respecxially villages close to river Bean and its tributaries. A famous vidhyvasini temple is also located in the area. During the monsoon, the entire river is heavily flooded that causes the landslide activity in the area and erosion and deposition of high suspended particles. A debris carried out by river is large in amount therefore the base of the river is continuous filling up by river born material.

Figure 15 buried trees under RBM

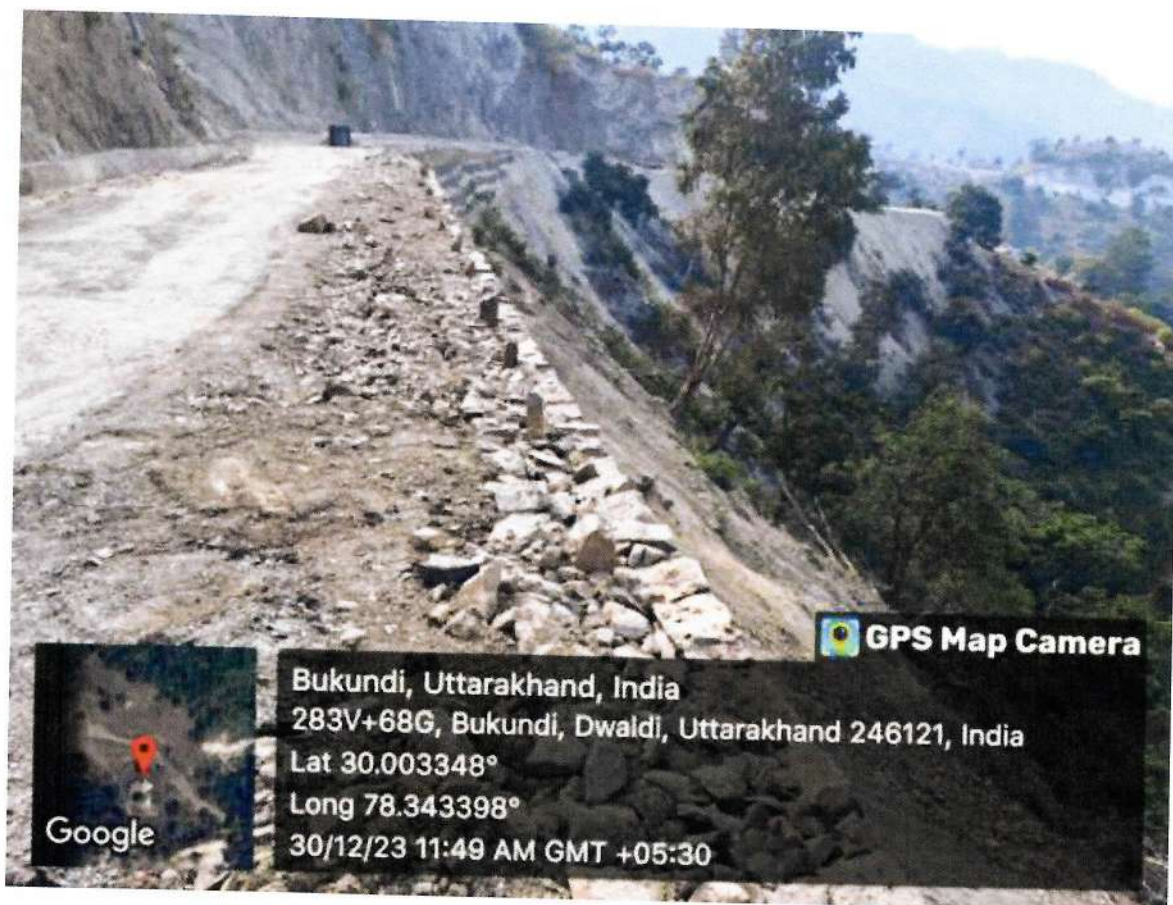
Figure 16 muck dumping along valley side

Also, a road constructed from Naugaon to bhukhandi dumped the muck in the valleyside, during rainfall, these loose debris flowed towards further downslope and adversely affected the agriculture lands lying on the base of valley and damaged occurred. Such construction activities should be properly monitored otherwise secondary cause of damaging environment and also affecting livelihood.

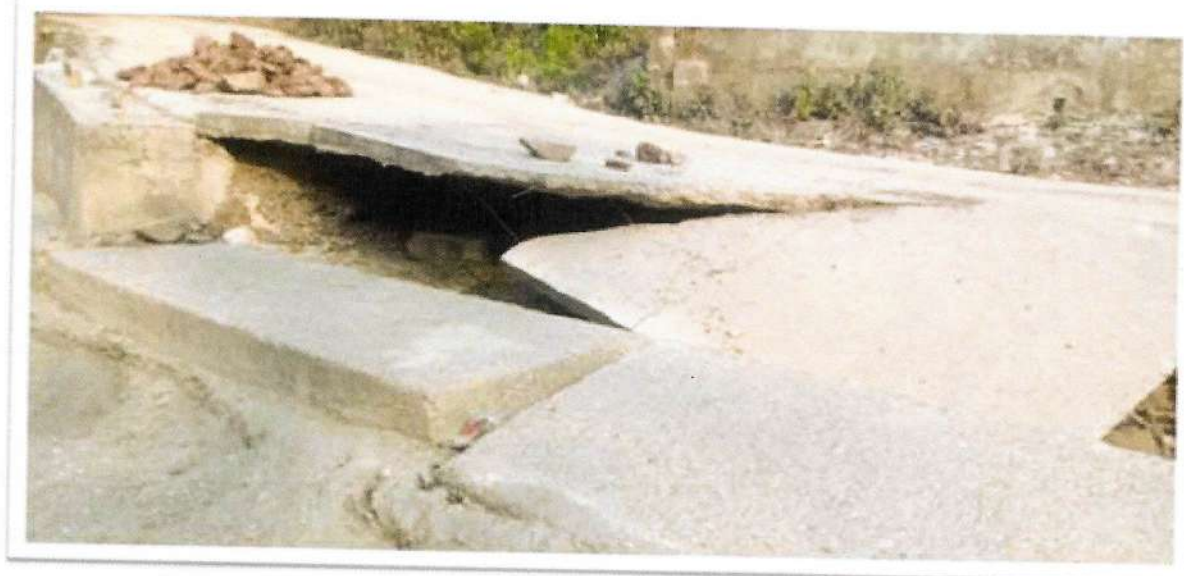
Figure 17 exhibiting the erosion and wrong constructional practices
