A preliminary report on field visit to Ghatdhaar and Khotila landslides, Dharchula, Pithoragarh

Uttarakhand Landslide Mitigation and Management
Centre (ULMMC)

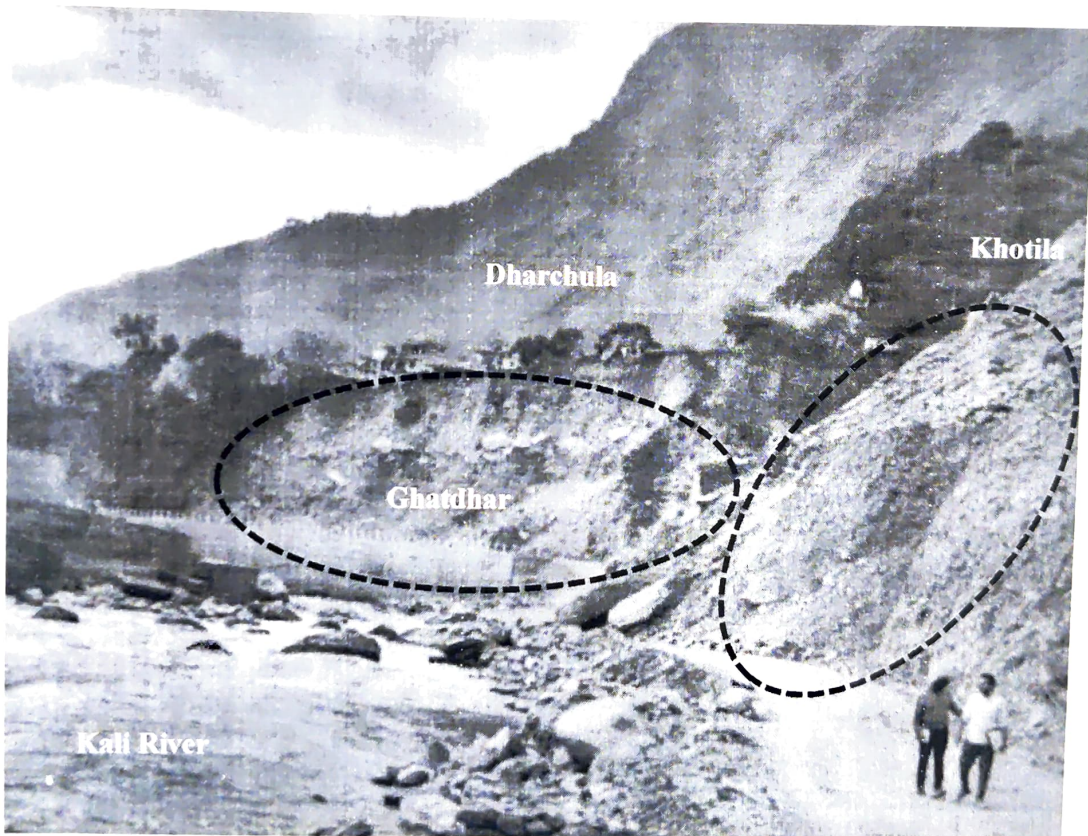
Landslides are very common phenomena in this geologically and tectonically active Himalayan terrain during rain and earthquakes due to its complex geomorphology and geological setup. A severe landslide occurred on October 4, 2016, near Khotila village in Dharchula. The landslide was possibly triggered by saturated slopes after receiving 88% more rainfall than the previous year, the landslide endangered villages downstream by partially blocking the Kali River (Solanki et al., 2019). The two main slope failure occurred in 2016 i.e. Ghatdhar and Khotila (*Figure 1*), both the slope are in close proximity to each other. The preliminary investigation of these slope was undertaken which have been discussed in this report.

Figure 1: Slope failure along the Kali River near Dharchula, Pithoragh.

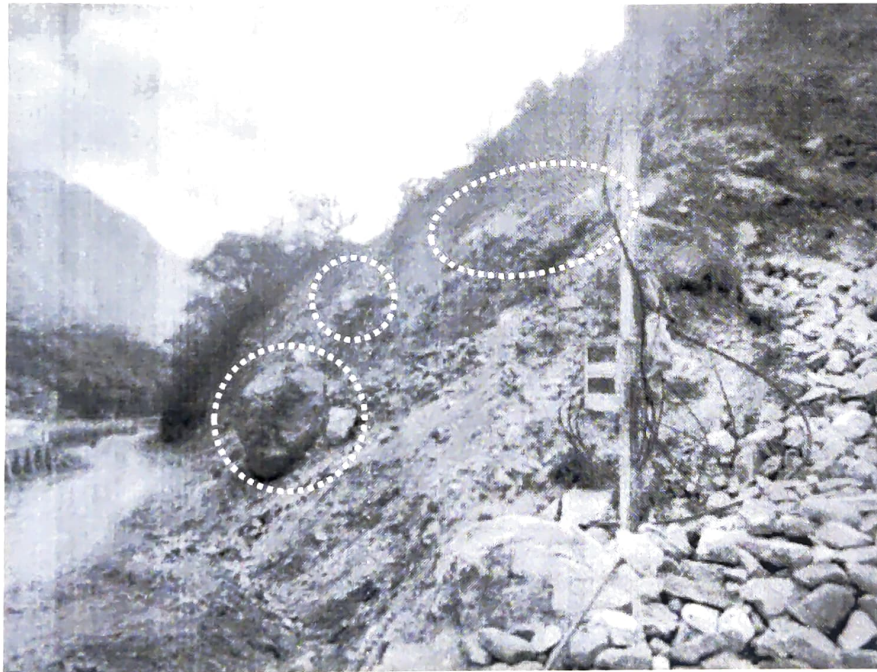
- The slope is predominantly composed of loose material (cohesionless). The slope is steeply dipping with an average height ranging from 30 to 40 meters, and with an average stretch of about 100 to 130 m.
- The large size of boulders are embedded (*Figure 4*) within the slope which exacerbates instability during monsoon.
- The dense habitation, including administrative offices, is present in close proximity to the crown of the landslide.
- The slope lies in very close proximity to Dharchula Faults.
- Given the close proximity of the major settlement (Dharchula town), which encompasses crucial infrastructures like the Tehsil office and residential areas, it is imperative to address the significance of mitigating the slope.

Figure 4: Ghatdhar landslide showing large size boulders at the toe & middle side of the slide zone.

- Ghatdhar landslide underscores the necessity for thorough site investigations to evaluate and implement appropriate mitigation measures effectively.
- Reinforcement Concrete Cement (RCC) wall of adequate height may be one of the suitable mitigation measures at the site which may be design according to site conditions with appropriate geotechnical slope stability analysis.

- RCC Wall may be anchored with required yield strength and depth based on the failure circle.

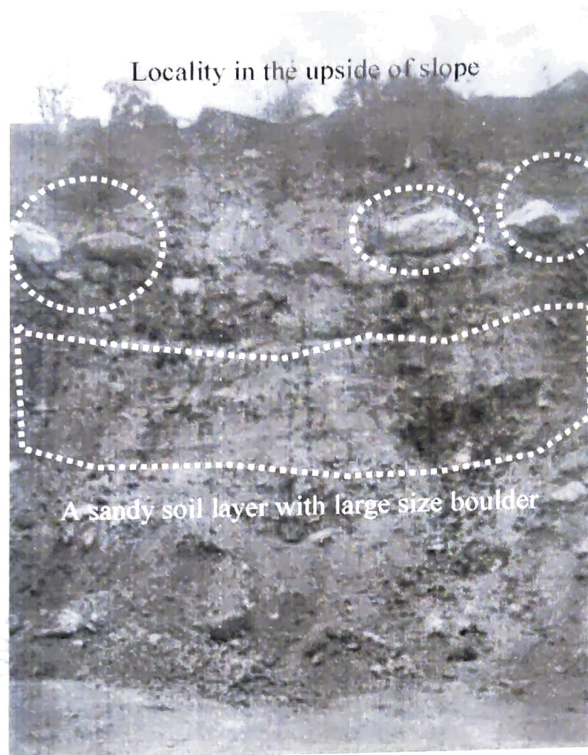
Figure 4: Ghatdhar landslide showing large size boulders and a sandy soil layer in of middle of the slide zone.

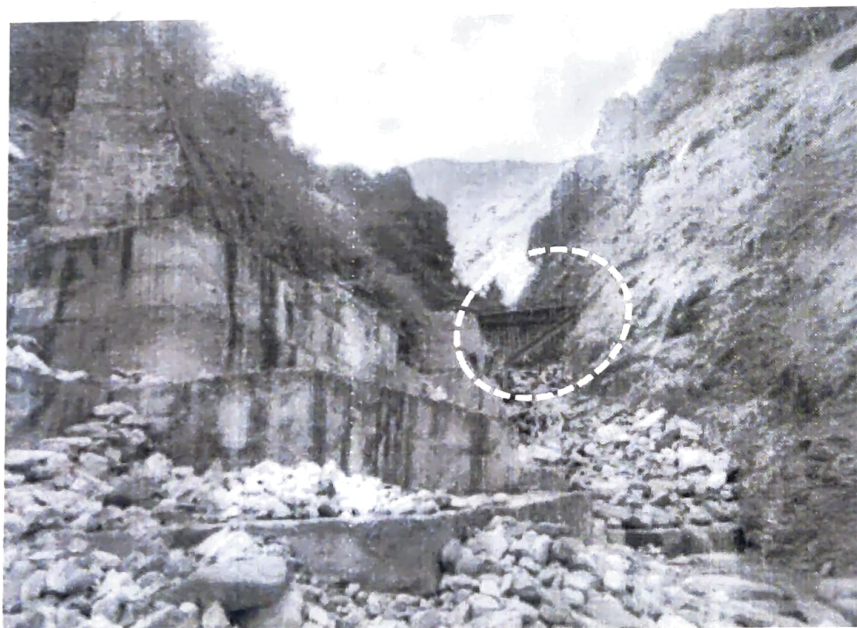
Figure 5: Figure shows the destruction of the bridge caused by the intense discharge during the monsoon.

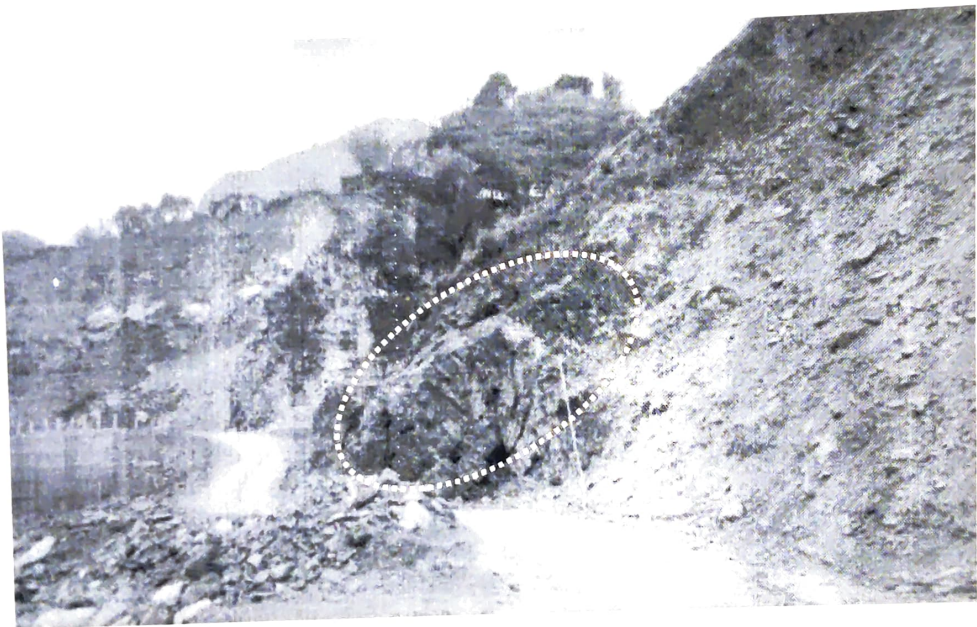
- The slope is predominantly composed of Slate/ Phyllite dipping northerly. The slope is steeply dipping (N160) with an average height ranging up to 110 m, and with an average stretch of about 150 m.
- Large rock boulders are scattered across the slope, posing a risk of exacerbating instability, particularly during the monsoon season.
- The landslide on the footpath or trail leading to Khotila village poses significant challenges, especially during the monsoon.

Figure 6: Figure shows the Khotila landslide with the presence of rocky strata at the toe.

- The use of retaining wall with pile based foundation or counterfort retaining wall may be effective in control of toe erosion at the stretch of the Khotila slide.
- The height of the wall very crucial in order to attain long term stability of the slope due to high discharge in the Mahakali River during rainfall.
- Furthermore use of Rock Bolt/ Self drilling grouted anchor based on slope stability analysis and possible slip- circle. The slip circle need to understand using FEM modelling in order to attain the long term stability.
- The use of wire-mesh and high tensile rolled cable may be also effective to control rock slide and rock fall at the slide.

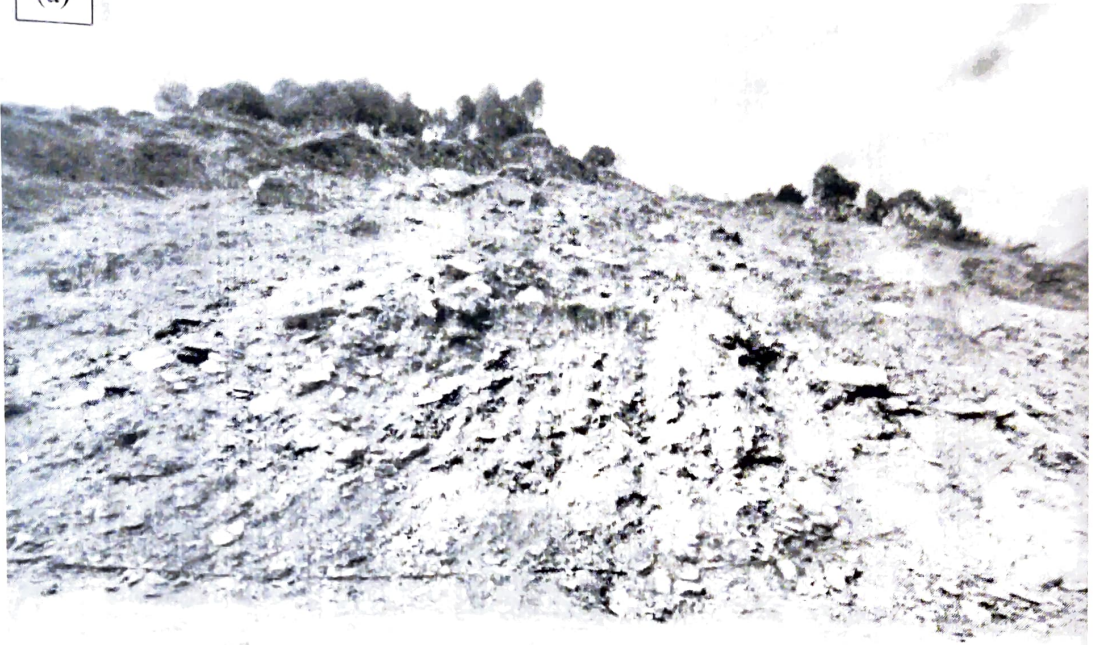
Figure 7: Khotila slope failure (a) landslide view from toe (b) rock strata at zone of detachment of the slope failure

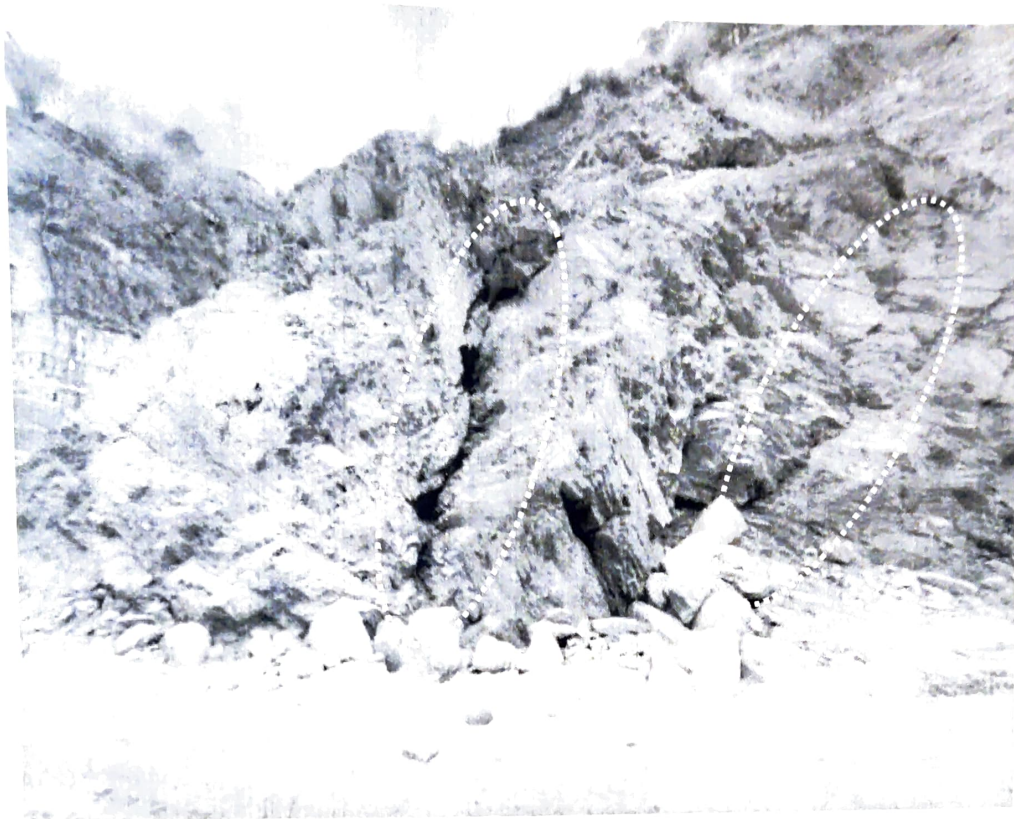
Figure 8: Widely fractured rocks at the toe of the landslide.
