Uttarakhand Landslide Mitigation and Management Center (ULMMC)

जनपद पिथौरागढ़ के सीमान्त क्षेत्र धारचूला के ग्राम पंचायत जिप्ती के तोक गर्बा के आपदा प्रभावित 68 परिवारों के पुनर्वास एवं विस्थापन एवं मुआवजा की मांग तथा समस्याओं के निस्तारण किये जाने हेतु जियोटैक्निकल सर्वे से संबंधित स्थलीय निरीक्षण आख्या।

Preliminary visit to Garbha Dhar, Jipti, Dharchula, Pithoragarh, Uttarakhand

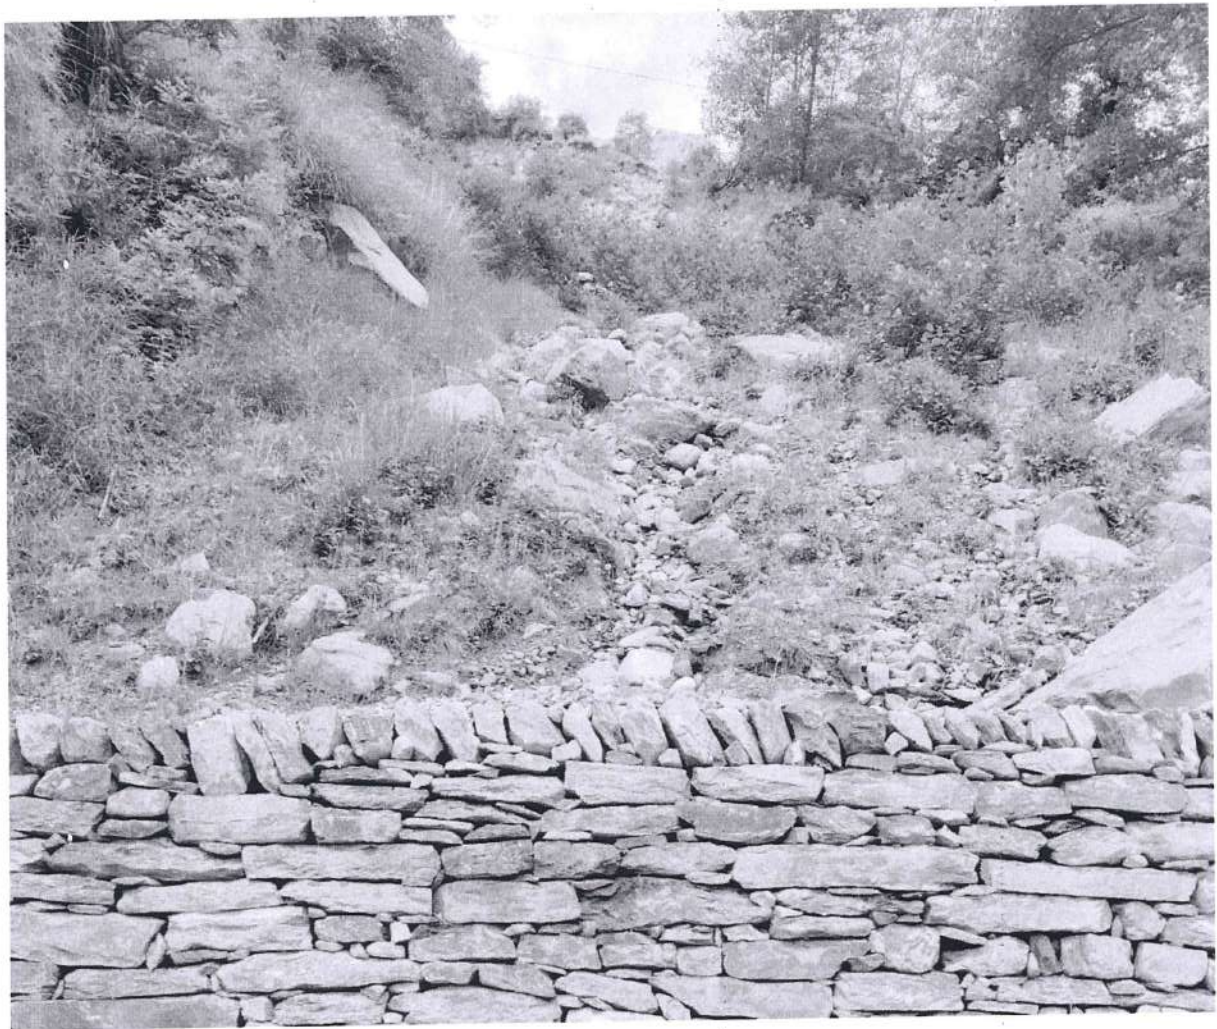
Figure 3: Field photograph showing a slope failure in the Garbha Dhar area, near Jipti village, Dharchula tehsil, Pithoragarh district. The failed slope consists of heterogeneous material, including slope wash deposits, colluvium, and large boulders. The exposed lithology primarily comprises augen gneiss, micaceous gneiss, and garnetiferous schist, reflecting the geological complexity and slope instability characteristic of the region.

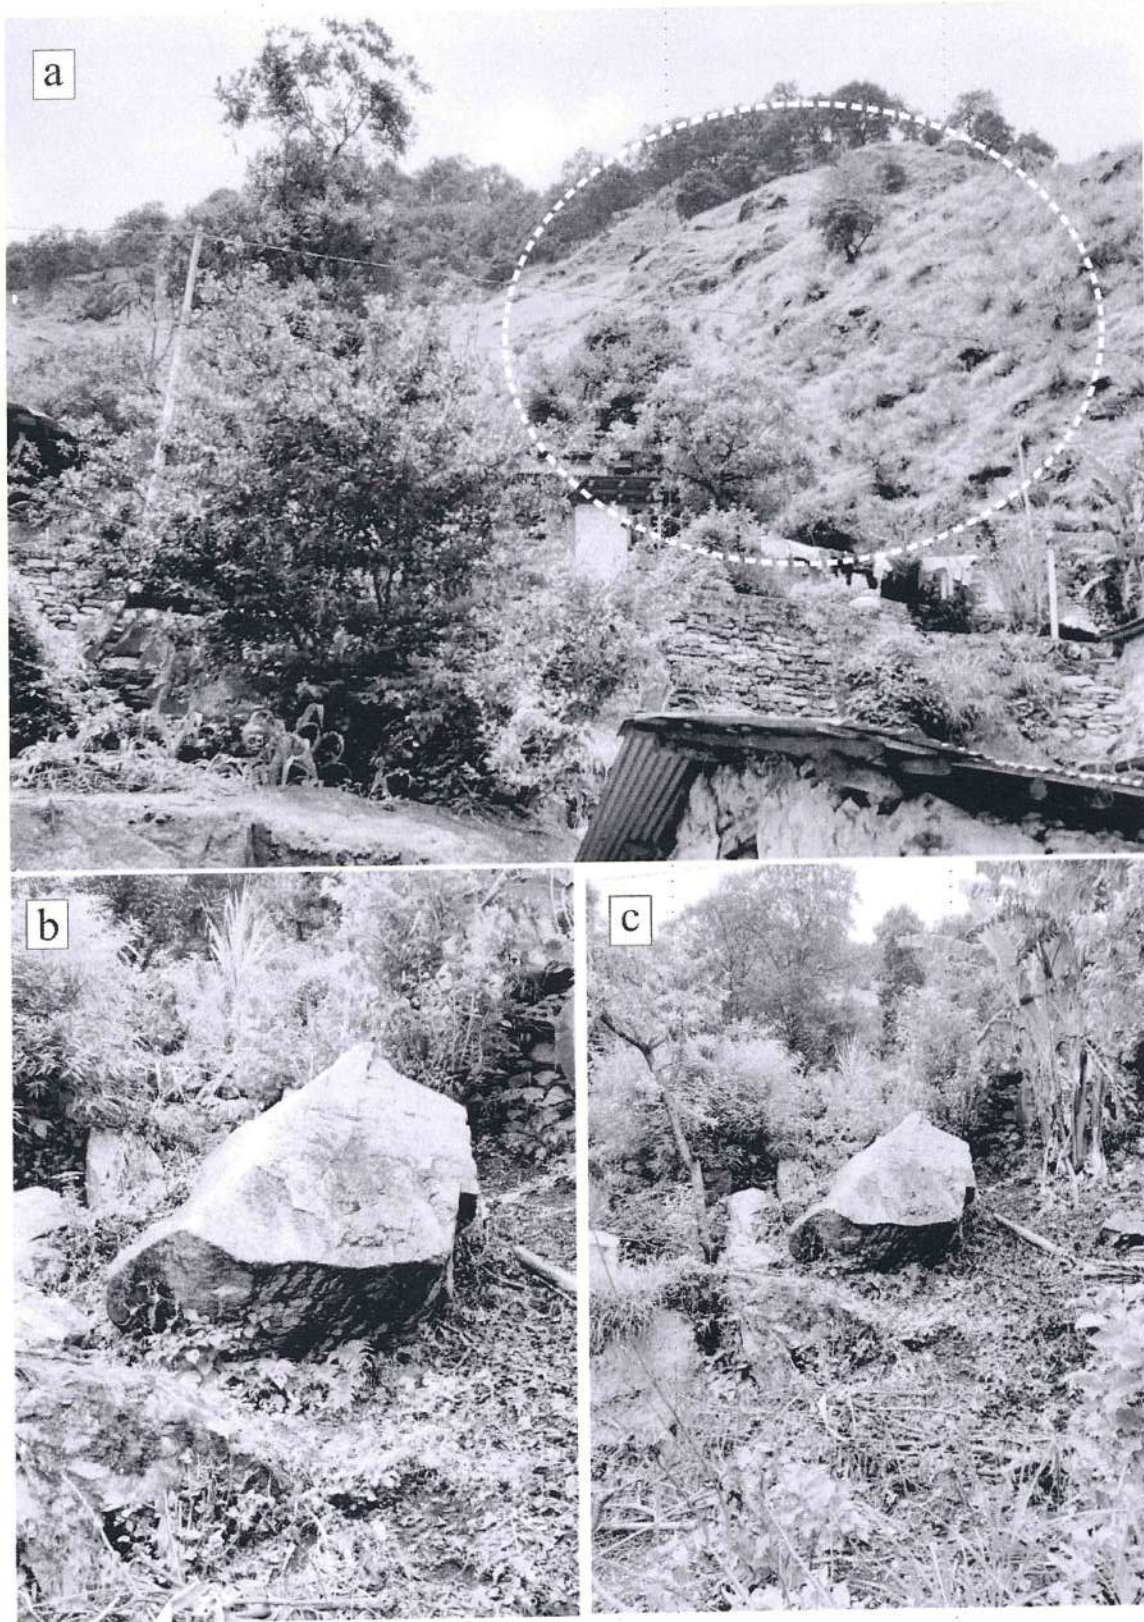
1. The settlement of Garbha Dhar is under significant threat due to ongoing and potential slope instability, particularly in the form of rock falls originating from the uphill slopes, mainly on the Gharmali side of the village. These rock falls pose a direct hazard to the habitations situated below.

3. Residents report that rock falls are a common occurrence during the monsoon season, putting lives and property at risk. They have also observed wide and deep cracks developing in the rocks near the hilltop. However, due to the steep terrain and dense vegetation, the crown area could not be accessed or visually examined during the field visit, and thus the cracks could not be directly verified.

4. The slope angles in the area are very steep, ranging between 60° to 75°, and in some places, even steeper, especially where frequent rock falls are reported. The general slope orientation is towards the south and southeast, which aligns with the natural drainage and gravitational movement patterns contributing to instability.

Figure 4: Field photograph showing the zone of active slope with evidence of rock fall and the presence of large detached rock blocks in the Garbha Dhar area. The steep slope and exposed rock surfaces indicate ongoing mass wasting processes.

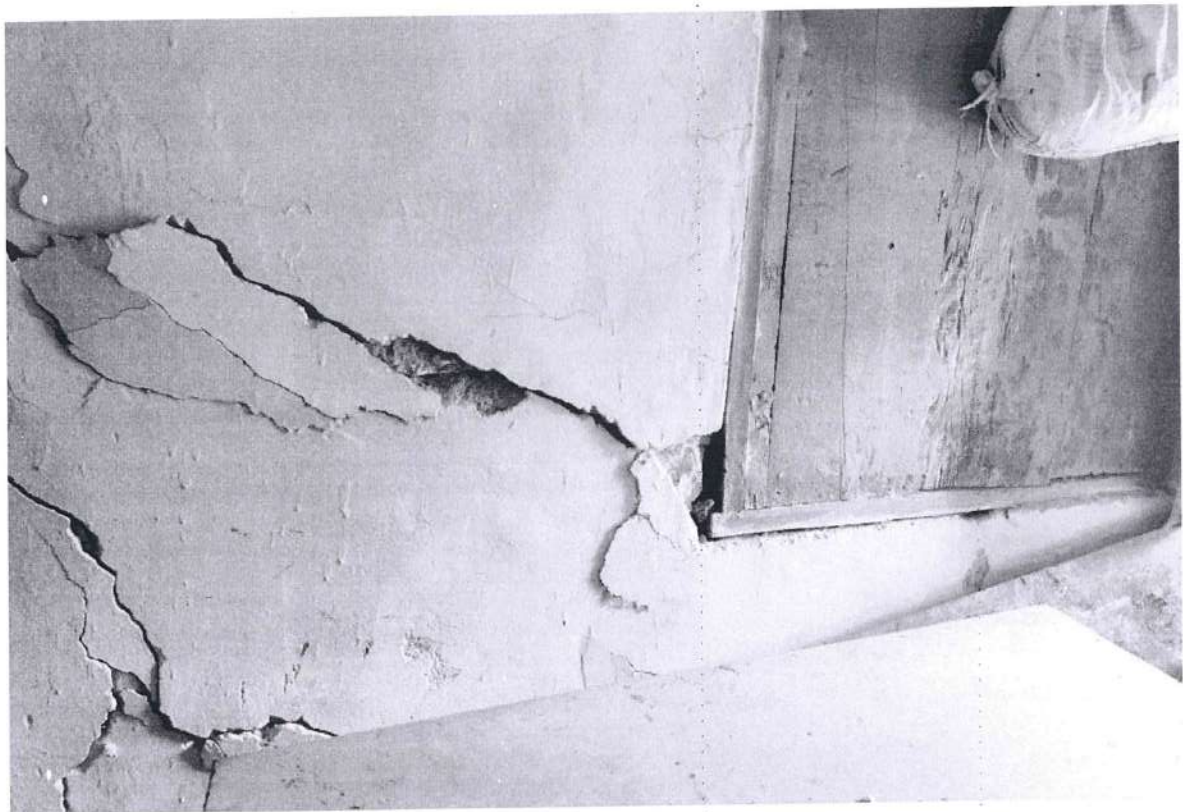
5. Several houses in Garbha Dhar have developed multiple structural cracks, indicating stress and movement within the ground. These cracks are symptomatic of ongoing slope deformation and ground instability.

7. Tilting of houses, accompanied by multiple cracks, has been observed across the settlement, further confirming differential ground movement and the compromised bearing capacity of the underlying debris material.

Figure 5: Cracks observed in building structures during field inspection, suggesting potential differential settlement or ground movement.

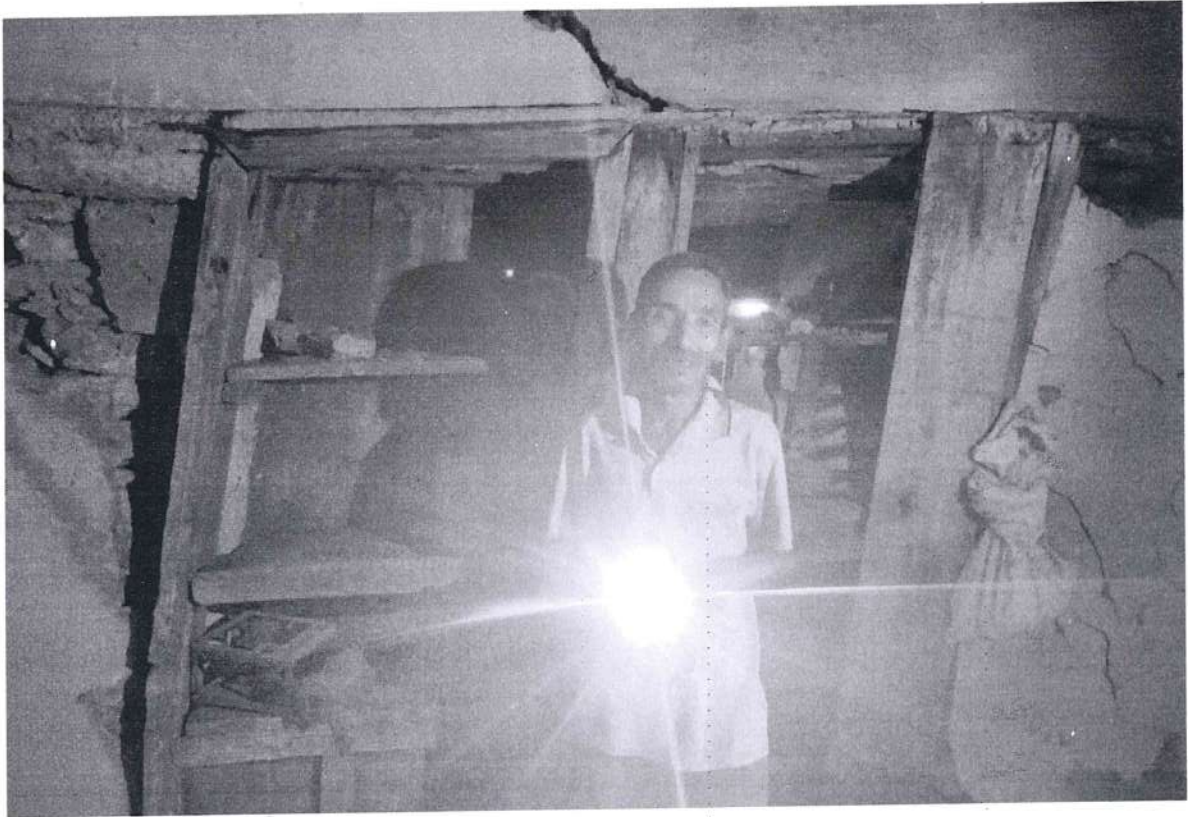
6. The entire village appears to be situated on slope wash or debris material, which lacks stability and exhibits multiple signs of slow creep movement, debris slides, and localized rock fall activity. These geomorphic indicators suggest that the foundation material is weak and prone to movement, especially during monsoonal rainfall.

Figure 6: Cracks observed in buildings at Garbha, highlighting signs of damage possibly due to creep.
