Field Reconnaissance Survey of Aamshaur Landslide Uttarakhand Landslide Mitigation Management Center August 2024

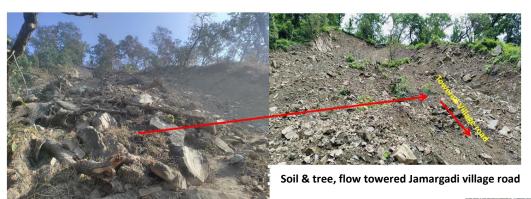
Debris on Jamrgadi village Road

- 1- Removal of unstable boulders, drift wood the flow area.
- 2- Cover the Scrap area by tarpaulin sheet, so that, during rain increase in scarp area can be prevented.
- 3- Installation of rock fall barrier in upstream side of village.
- 4- Installation of rain gauge with siren for warning.
- 5- Brest-wall and cross drainage for other village road.

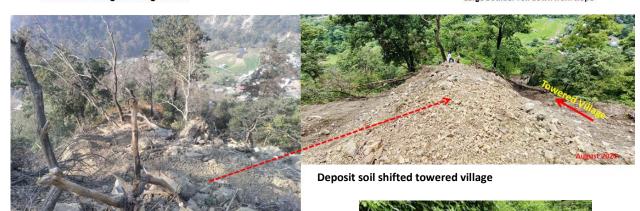
Natural spring on middle of slop failure

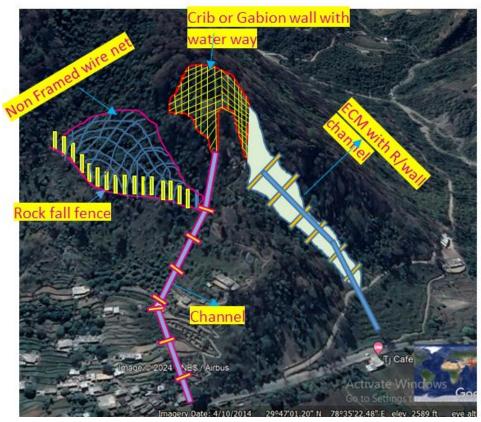
Figure – A Broad suggestive mitigation plan

A broad tentative mitigation measure is shown in the figure as "suggestive mitigation plan" in report. However detailed investigation is required for a complete design of mitigation measure. (Figure A)

- 1- Gentile cutting of unstable area and cover by erosion control / vegetative matt with anchor pin and anchor bar.
- 2- Crib work or Gabion / Wet Masonry at failure part.
- 3- Earth retaining structure (wet masonry / Gabion/ framed)
- 4- Small wooden or steel fence work in collapsed area.
- 5- Water channel work in slope area and channelize with the rainwater with from uphill side Stream.
- 6- Plain cement concrete channel with drop work.
- 7- Non framed wire net.
- 8- Plantation work.
