# A Preliminary Site Visit Report for Government Professional College, Banas-Paithani, Pauri- Garhwal

**Uttarakhand Landslide Mitigation and  
Management Center (ULMMC)**

On May 15, 2025, a technical team from the Uttarakhand Landslide Mitigation and Management Centre (ULMMC) conducted a site assessment at the Government Professional College, Banas-Paithani, Pauri-Garhwal. The objective was to evaluate the geological and structural suitability of the site for proposed constructions, including the multipurpose hall, boys' hostel, principal's residence, and guest house.

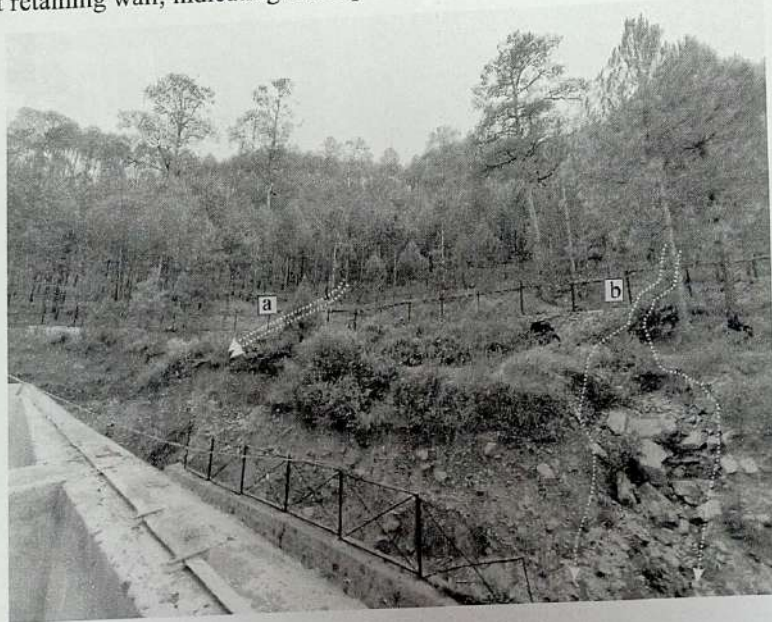
- ❖ During the site visit, two seasonal local drainage channels (*Figure 1*) were observed at the rear side of the girls' hostel (*Figure 2*). The absence of proper drainage channelization and management has already contributed to damage (*Figure 2*) in the adjacent retaining wall, indicating inadequate diversion and control of surface runoff.

**Figure 1:** Field photograph showing natural drainage

- ❖ Design and implement a comprehensive drainage system, including both surface and subsurface components, to prevent hydrostatic pressure build-up behind retaining structures.

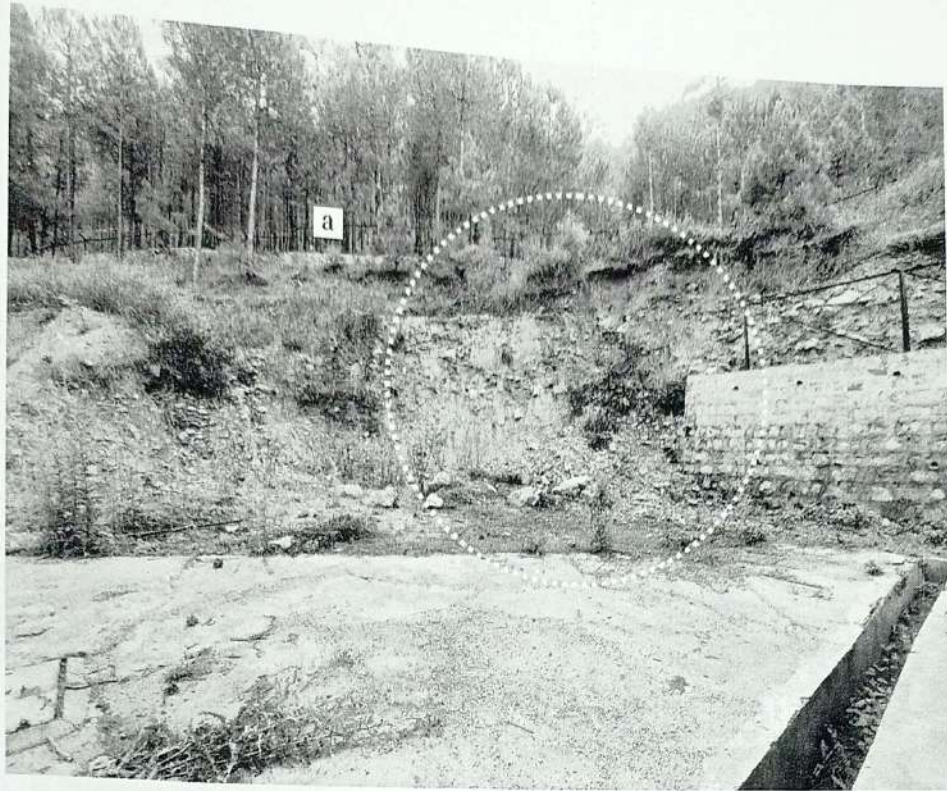
**Figure 2:** Field photograph showing the altered drainage path following the construction of the college infrastructure.

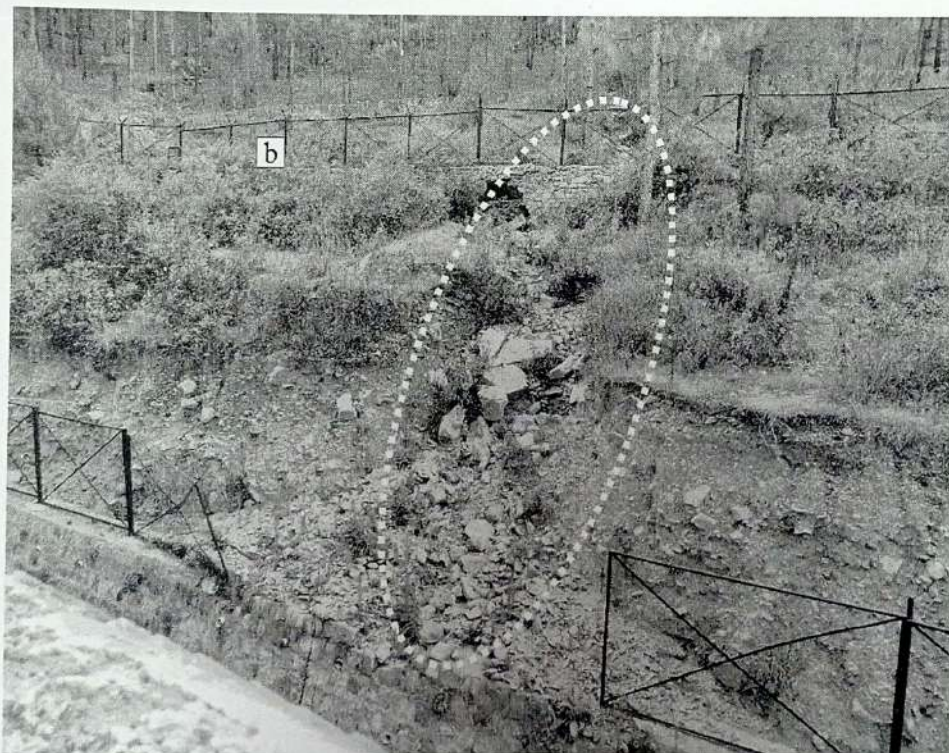
**Figure 3:** Field photograph showing damage to a retaining wall caused by seasonal drainage and inadequate water management.

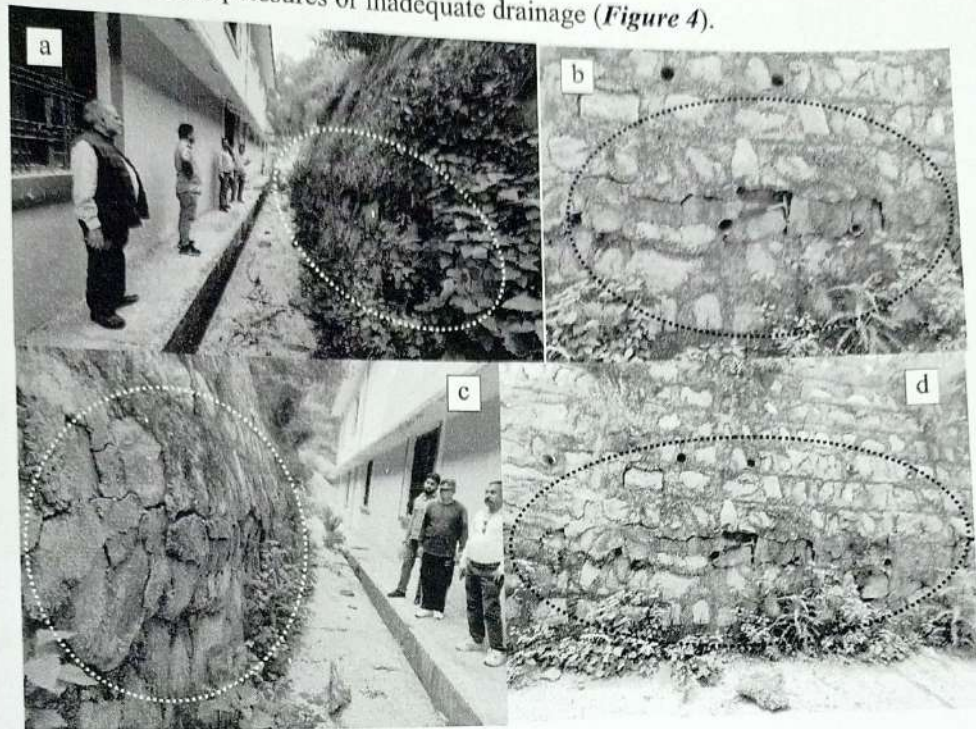
- ❖ A 6–7 meter high retaining wall behind the computer lab and downhill of the girls' and boys' hostels shows signs of outward bulging, indicating potential structural distress due to lateral earth pressures or inadequate drainage (*Figure 4*).

*Figure 4: Field photograph showing the damaged wall.*

- ❖ Provision of counterforts or buttresses is made to counteract the bulging of the random Rubble (RR) wall by offering external structural support and enhancing its stability.

- ❖ Undertake a structural audit of all existing retaining walls, assessing current stability, material degradation, and retrofitting needs based on their load-bearing performance and observed distress.

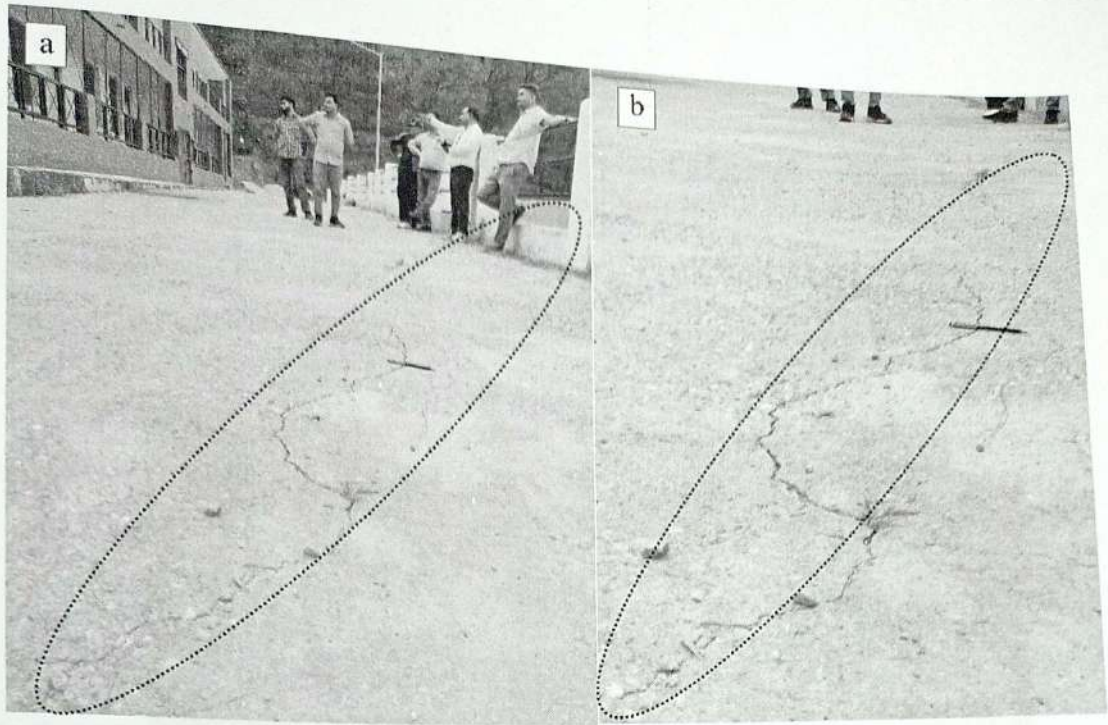
- ❖ Ground cracks, possibly related to the wall deformation, are observed between the girls' and boys' hostels (*Figure 5*). These include 3–4 parallel cracks with an aperture of 20–30 mm and an approximate length of 7–8 m.
- ❖ While these cracks may be structural or due to normal concrete settlement, their alignment and proximity to the bulging wall suggest a potential relationship that warrants further investigation.
- ❖ It is strongly recommended that regular monitoring of the cracks and wall deformation be conducted by the college authorities. If the cracks show signs of widening or deepening, it may lead to a retaining wall failure, posing a significant risk to students and staff.

**Figure 5:** Field photograph showing cracks developed between girls and boys hostel.

- ❖ The use of filter fabric or geotextile material behind the RCC wall helps in reducing pore water pressure by facilitating drainage.
- ❖ Monitor structural cracks and wall deformations regularly, especially before and after the monsoon season. Install crack meters or conduct periodic surveys to measure deformation progress.

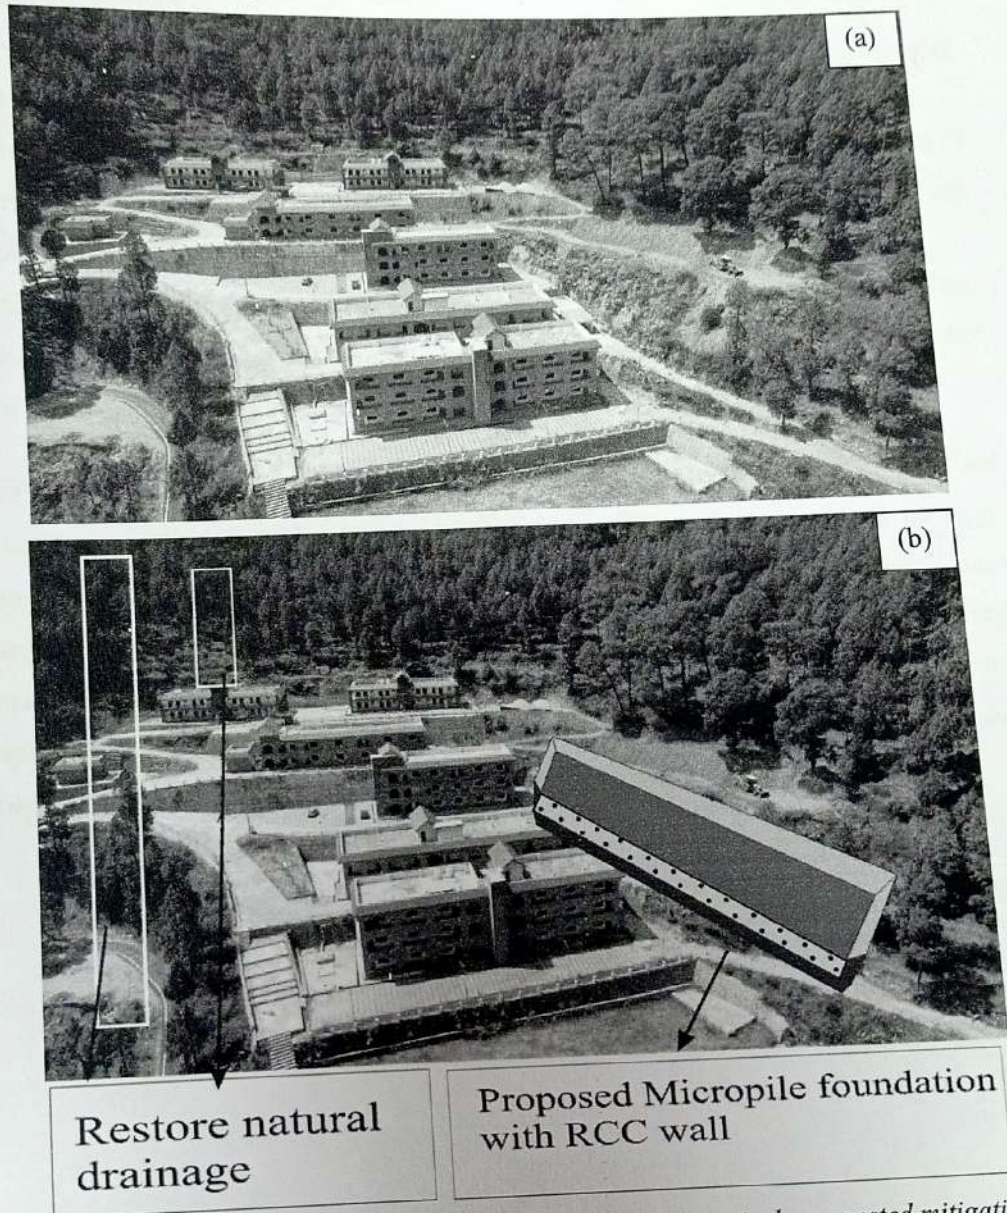
**Figure 6:** Drone photograph showing (a) without and (b) with tentatively suggested mitigation measures at Paithani. (Courtesy: College Principal and Mandi Parishad representative).

- ❖ Avoid Random Rubble Masonry (RRM) walls for new constructions, particularly in critical valley-side locations, due to their limited capacity to withstand structural loads and high wall heights.
- ❖ Implement Reinforced Cement Concrete (RCC) retaining walls combined with micro piles or ground anchors (**Figure 6**) to ensure robust structural performance under lateral loads and seismic activity.
