# Geological Field Investigation of ground subsidence in Khamroli Village, Kalsi Block

**December 2023**

# Geological Field Investigation of ground subsidence in Khamroli Village, Kalsi Block, Dehradun, Uttarakhand

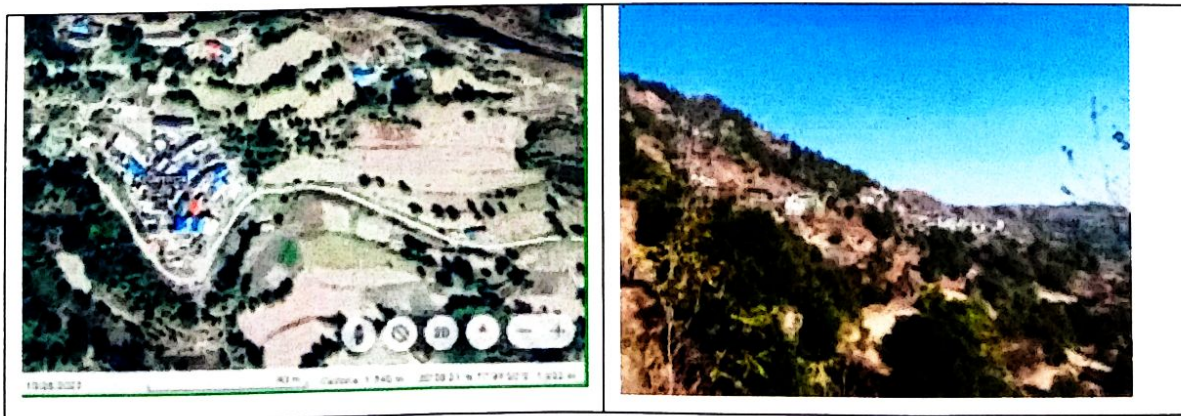
Figure 1 Satellite and pictorial view of Khamroli village (Note:slope gradient is gentle (~ 35°))

The Khamroli village is located at latitude  $30^{\circ}38'21''$  N and longitude  $77^{\circ}49'50''$  E just above the village road passing from Sahiya towards NW (Fig 1). The entire area is occupied by the overburden ranges from  $\sim 1$ -2 m at steeper gradient slope to 5-10 m at gentler slopes. The slope faces towards south and completely dry with no springs, no rivulet and no waterfall

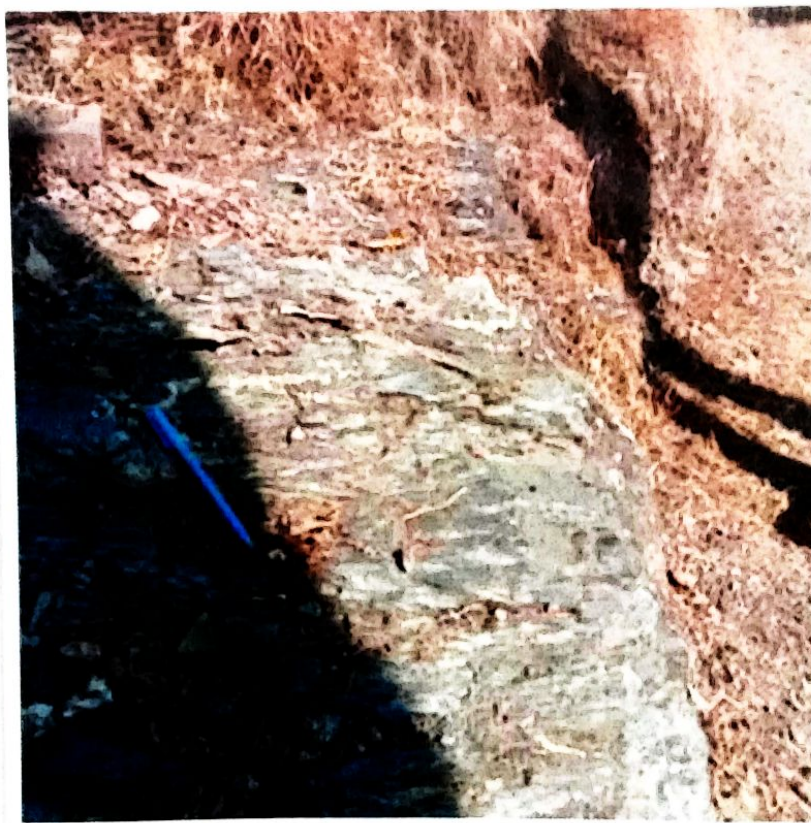
Geologically, the rock exposed in the area is thinly bedded shale belongs to Lesser Himalaya. It is of grey in colour and occupies below light brown, coarse grained and less clayey soil cover (overburden). The shale beds are sub horizontally aligned and slightly weathered with no major open joint pattern appeared near to site visited. In general, the overall slope gradient is  $35^{\circ}$  towards SE.

Figure 2 exhibiting well bedded shale without major joint set

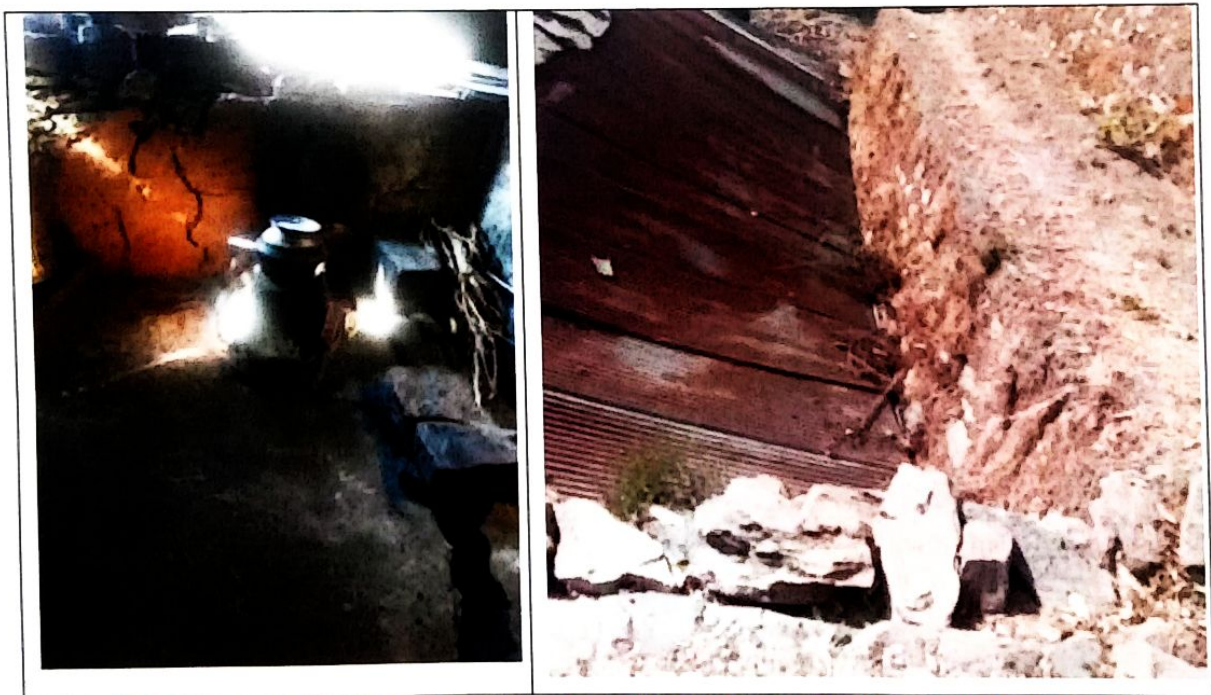
2. The maximum width cracks is of  $< 4-6$  cm on concrete ground and 5 m length as observed only in 2 adjacent houses whereas rest of the houses either have no cracks or observed hairline or 1-2 mm on walls. It has been observed that just above the mentioned ground crack in one house, the roof is covered by slanting tin shed that too fix with the back side wall so the rainwater from upslope as well as tilted shed collected near the base (where cracks have been observed)(Fig 3). Since, there is no proper drainage so collected water slowly percolate inside and may be the reason of cracks initiated and widen. Also both the houses are located near the manmade drainage (sloping towards road) without impermeable base concrete layer, which is steeper and may have heavy flow during rains. In addition, house owner confirmed that the minor cracks in houses initiated in 2022 and widen in 2023. Also in 2023, nearby area received heavy rainfall due to cloud burst activity at Tikochi, therefore ground crack and widening may link with the heavy rainfall activity of 2023, which is common in himalayan terrain which itself is dynamic in nature

Figure 3 : (left) widen crack on ground of a house just above village metalled road located at N 30.640540° lat and E77.830775 longitude , (right) just above the crack, a tinshed is placed that ingress the rainwater inside the closed room without having proper drain out system

4. The widen wall cracks observed only in 2 houses should be repaired and if further movement/ abnormal widening occur, it is suggested to report to the concern department for further investigations.

5. The cracks on floor of houses should be filled up with bentonite mud slurry or any impermeable material to prevent enlargement of the cracks by water action. Tin shed must be removed or proper arrangement be made to drainout the rainwater in one of the house where ground crack appeared (fig 3)

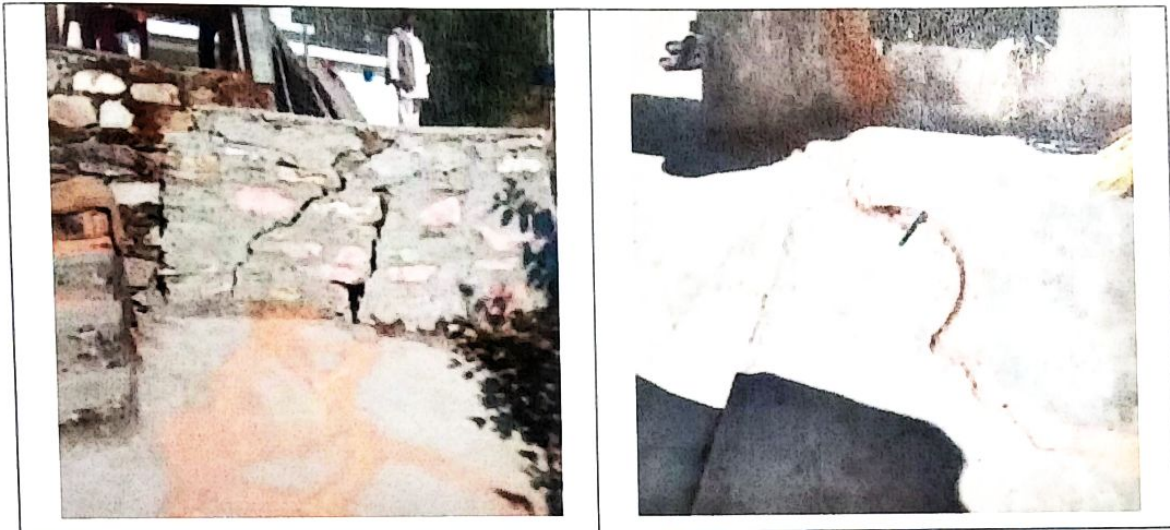
4. A house is located (N30.640903°, E77.831849°) at an elevation of 1675m, having cracks in retaining walls which may indicate differential movement of ground, whereas on floor unusual oriented cracks have been observed which is already filled by clayey material by the

house owner (Fig 4). Since the cracks are not on the natural ground and only in constructed concrete structure therefore it is hard to find out the depth of these unusual oriented cracks and could not be related with ground subsidence.

Figure 4 exhibiting unusual crack pattern on concrete base which is filled by mud and broken newly constructed retaining wall

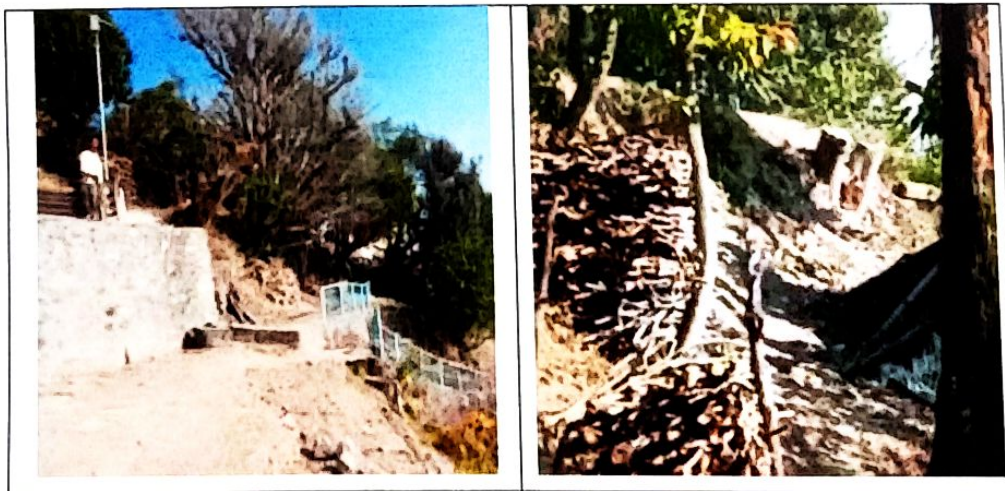
5. Entire area is covered with tilted trees indicating the creeping of slopes therefore minute cracks on houses may common and link with very slow movement.

Figure 5: Tilted trees and trunk of cutted trees showing creeping slope movement

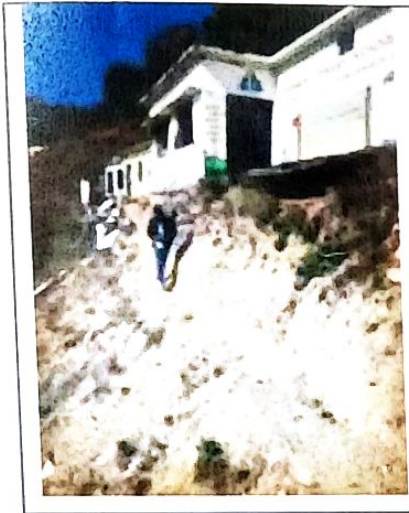
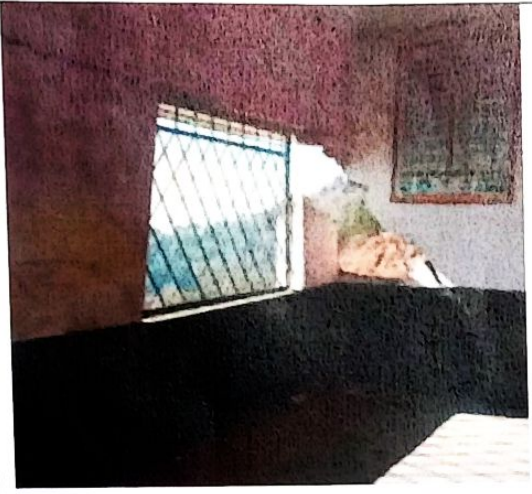
7. A small scale landslide was also observed just below a primary school facilitate the school building in critical stage (Fig 6). The site is little far away from the cluster settlement area of Khamroli village. As a prima facie, it appears that area has vegetation till 2019

Figure 6 exhibits shallow landslide activity near Primary school (left) and broken wall of school building (right)

of school building near the periphery of steeper slope ( $>45^\circ$ ) initiated the subsidence activity in 2022 in form of building cracks and finally landslide occurred in monsoon of 2023 and damaged the school building as well as completely fallen of school boundary wall (Fig 6).

1. In our opinion , the village does not poses any critical condition of ground subsidence and may falls under low to moderate differential ground movement. However, the shifting of school building is recommended.

2. The site below the school building should be covered with certain type of vegetation which can hold the soil.
3. All the man-made drains must be concreted to ensure no percolation of water.

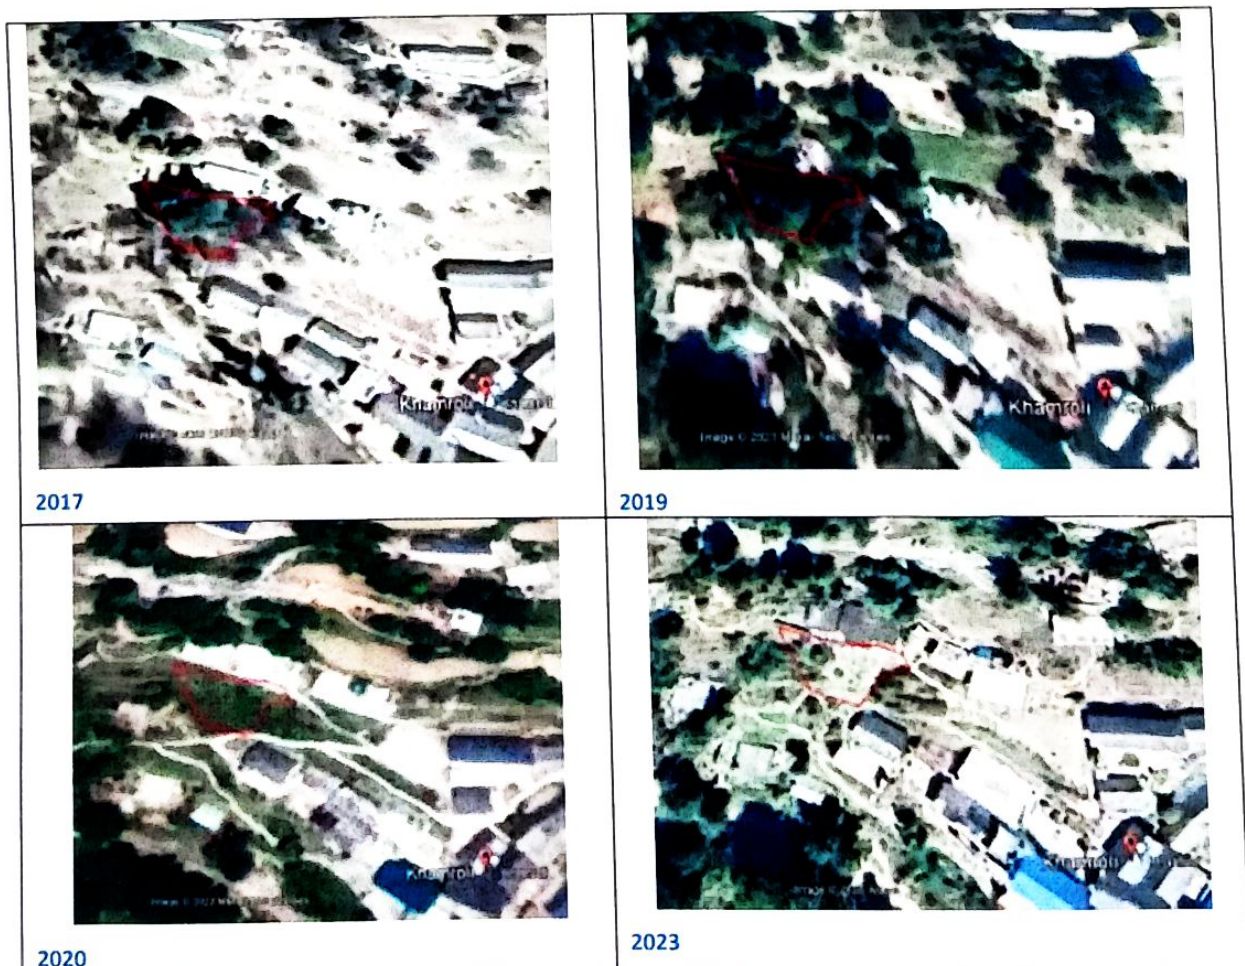
(as confirmed by temporal images obtained from Google earth) and removal of vegetation (Fig 7) along with further extension

Figure 7 : Temporal satellite view of slope just below Primary school building during 2017, 2019 , 2020 and 2023 respectively (Note: In year 2020, there is no vegetation cover below the school whereas in 2017 and 2019, thick vegetation cover observed on the slope and in 2023, landslide scar appeared)

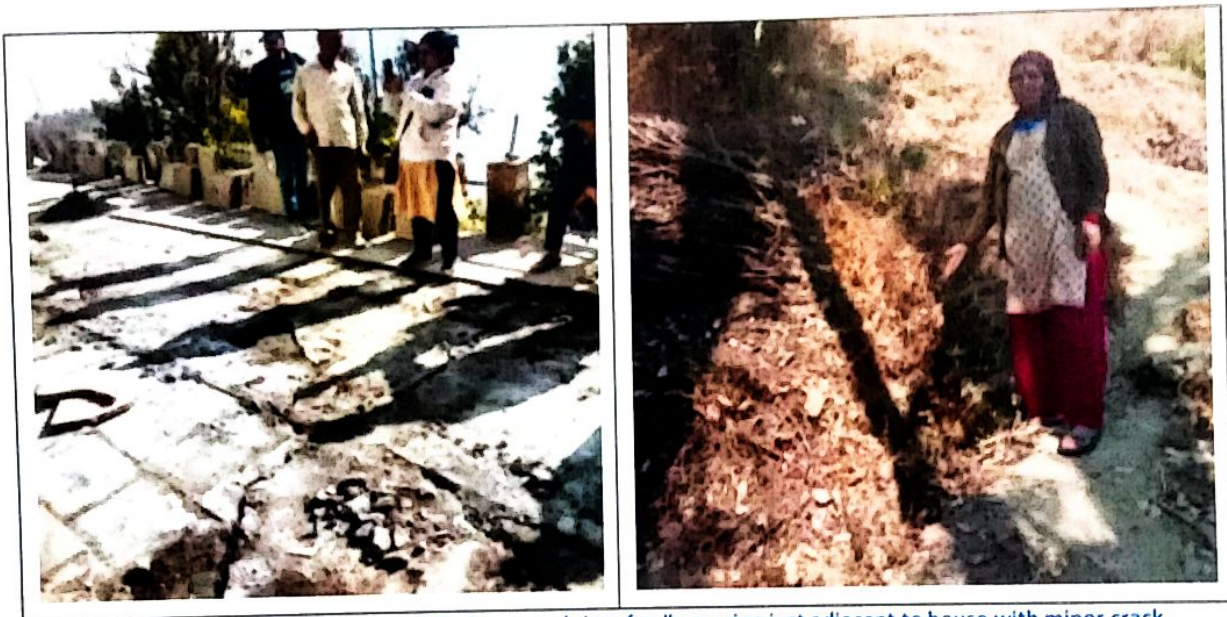
8. The cracked ground tiles were also observed in one of the house that too far-off located from the main village and may link with the slow ground movement or may be removal of any vegetation. A crack was also observed at right side wall of one of the house that too located far off from main settlement and may link with the development of gully erosion and ingress of water adjacent to house (Fig 8). Other than these, no other ground cracks and displacement were observed during field work.

Figure 8 exhibiting broken tiles in one of the house and site of gully erosion just adjacent to house with minor crack (note that such cracks do not appear inside the house and only restricted in small portion of outside of house)

6. Removal of vegetation cover should be strictly abandoned
7. Promoting the plantation especially at sites of gully erosion in order to stabilize the disturbances is important. If gullies will continue to move by headward erosion or by slumping of sidewalls, it will facilitate further soil erosion and ingress of water into ground.
8. The building codes and guidelines must be consider if further construction and development of buildings take place
