# **Geological Mapping along left bank of the River Alaknanda between Marwadi Bridge and Vishnuprayag**

**Uttarakhand Landslide Mitigation and Management Centre  
(ULMMC)**

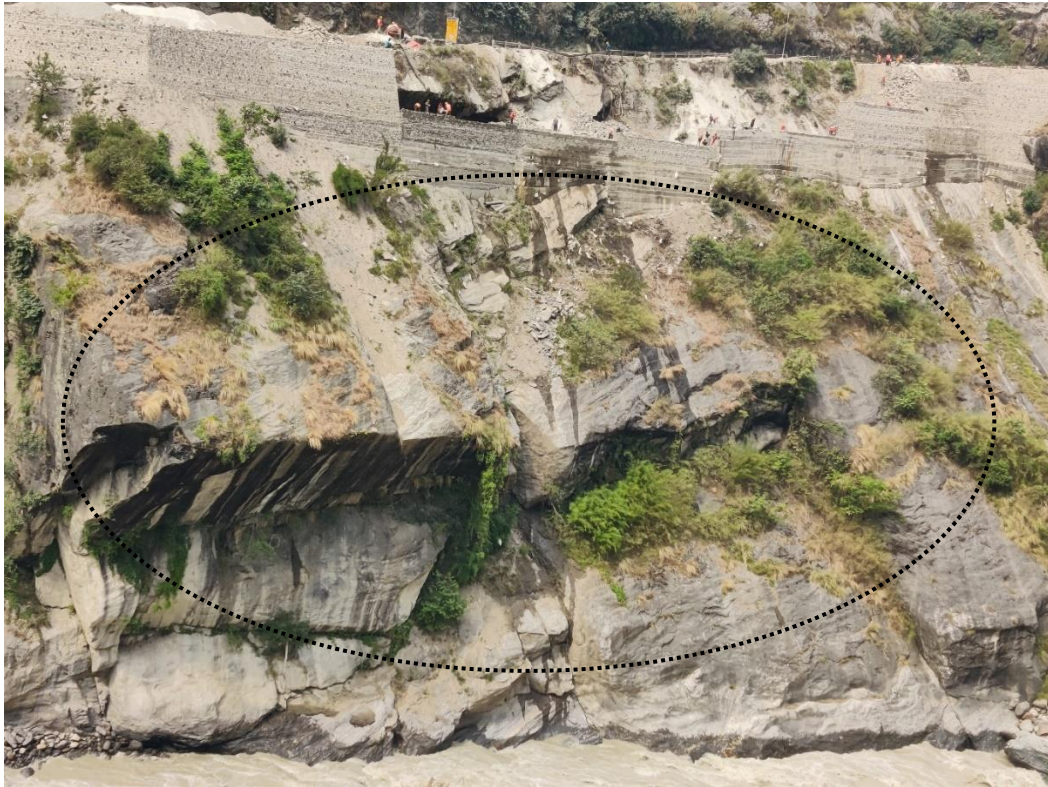
The biotite-gneiss in the Joshimath area is slightly weathered (**Figure 5**) and exhibits minor jointing and fracturing. Consequently, the biotite-gneiss in this area is classified as having fair to good rock mass quality (**Figure 6**). The dip of foliation ranges between  $17^{\circ}$  and  $61^{\circ}$  with a dip direction between  $N032^{\circ}$  and  $N358^{\circ}$ . Joint set J2 dips between  $72^{\circ}$  and  $89^{\circ}$  with a dip direction

**Figure 5:** Field Photograph is showing biotite - gneiss evident along Alaknanda River, Near Marwadi Bridge Joshimath.

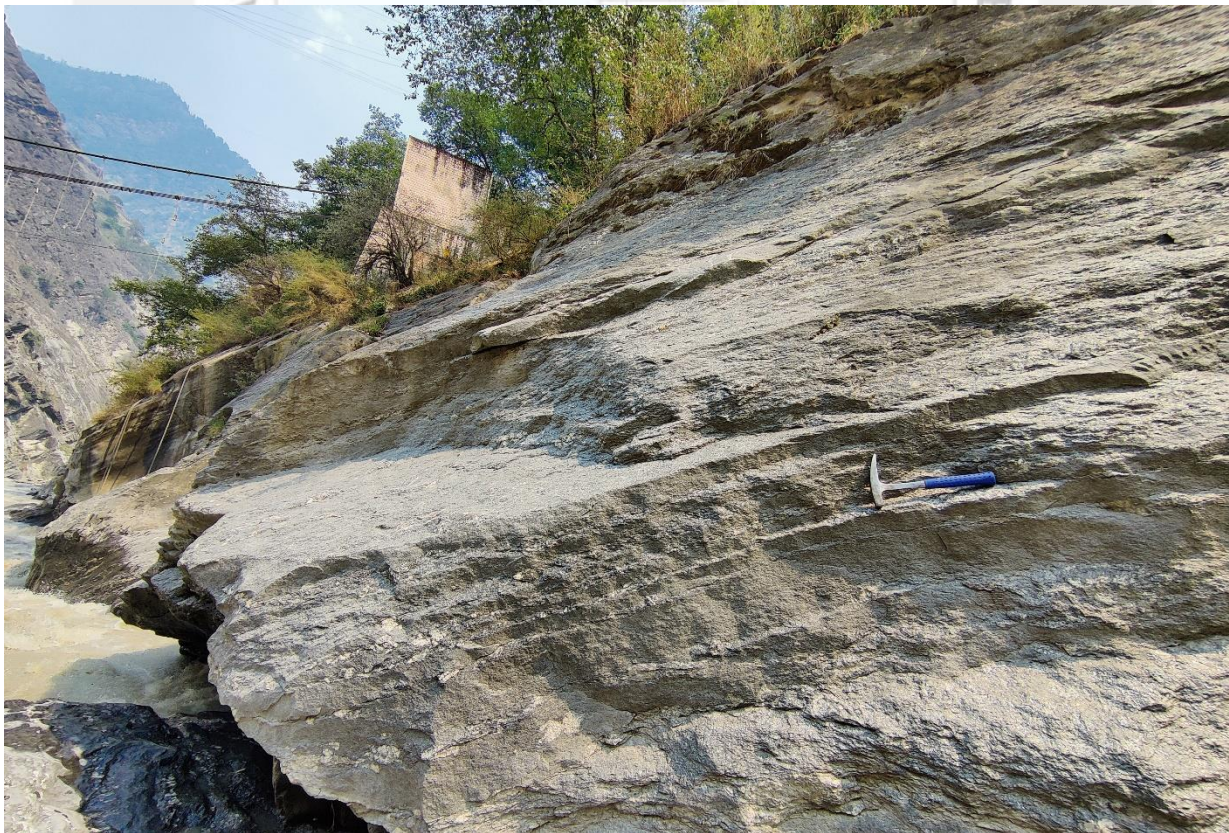
**Figure 6:** Field photograph is showing foliation plane (along geological hammer) of biotite - gneiss outcrop on left bank of the river Alaknanda, at Vishnuprayag.

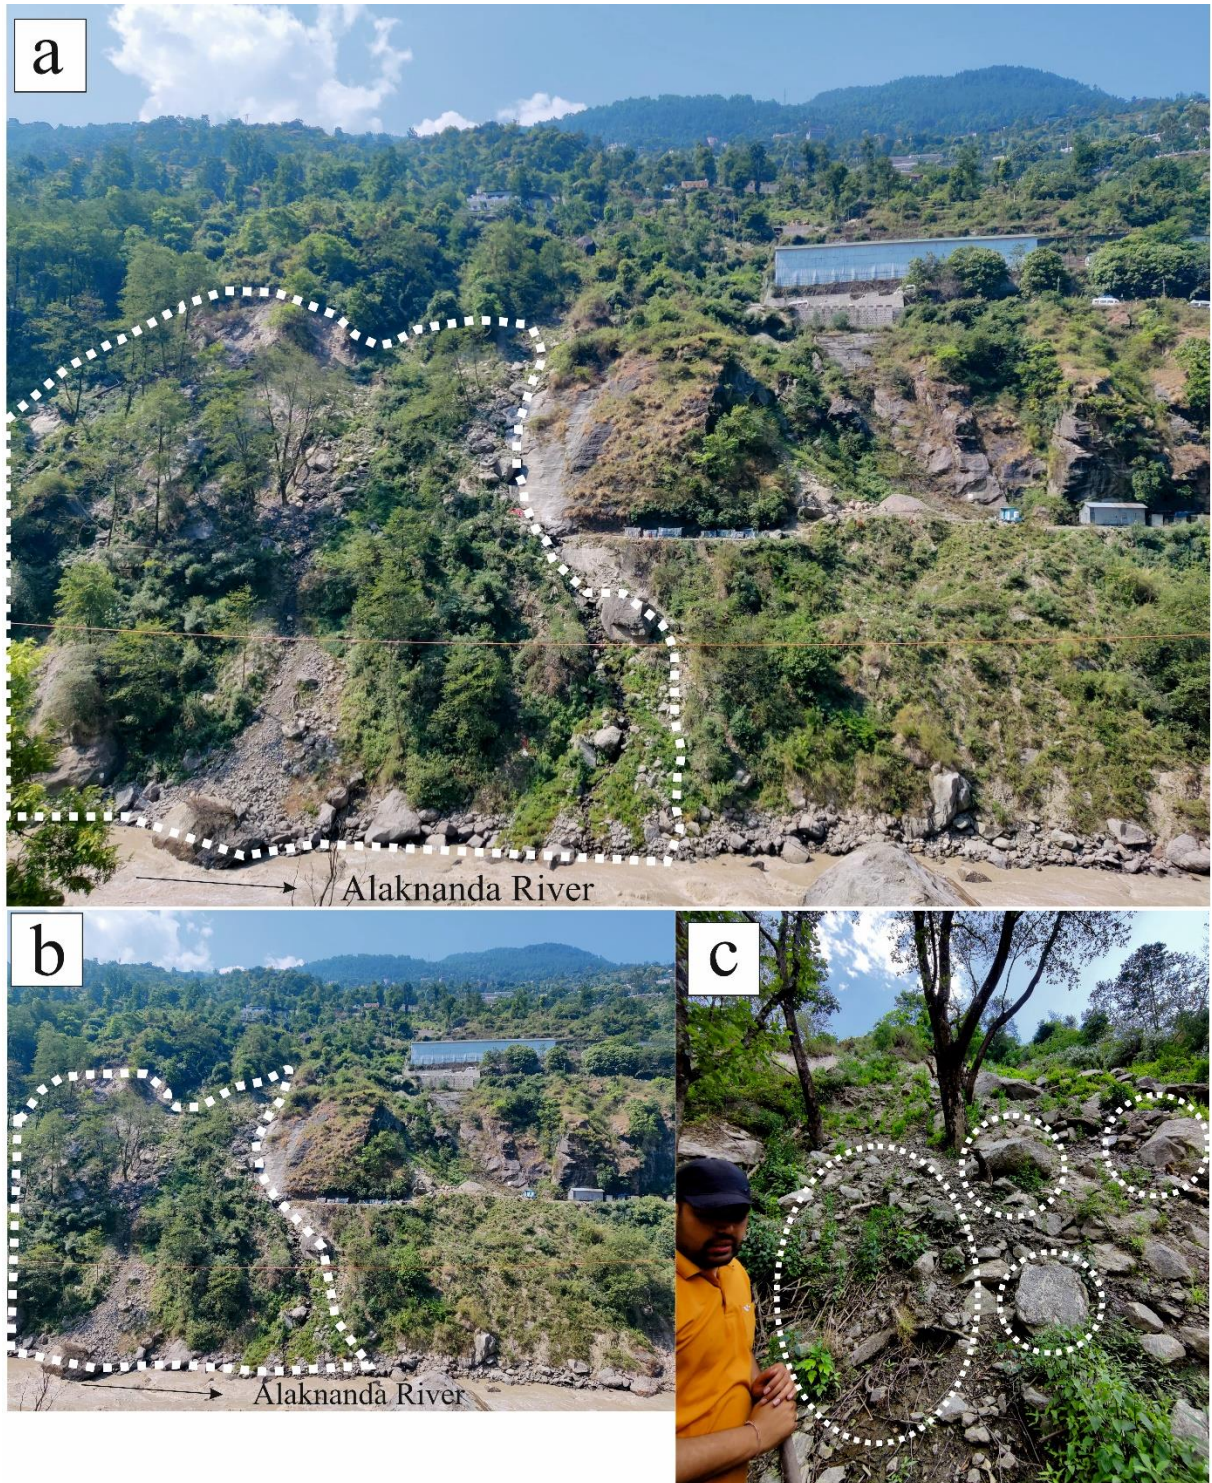
The landslide observed near Marwadi Bridge on the left bank of the River Alaknanda is situated between chainage 402 and 520 meters. The slope is experiencing failure in the 340° N direction through a rotational mode of failure. The slope material predominantly consists of old landslide deposits or moraine, which are primarily composed of large boulders of biotite-gneiss intermixed with soil (**Figure 9**).

The affected area covers approximately 8988 square meters (**Table 1**), with a maximum length of 125 meters. The primary factors contributing to the instability of this slope include toe erosion and the impact of drainage that traverse the middle and boundary of the slide zone.

**Figure 9:** Field photograph showing (a) and (b) landslide zone 1, and (c) boulders and debris material of the affected zone.

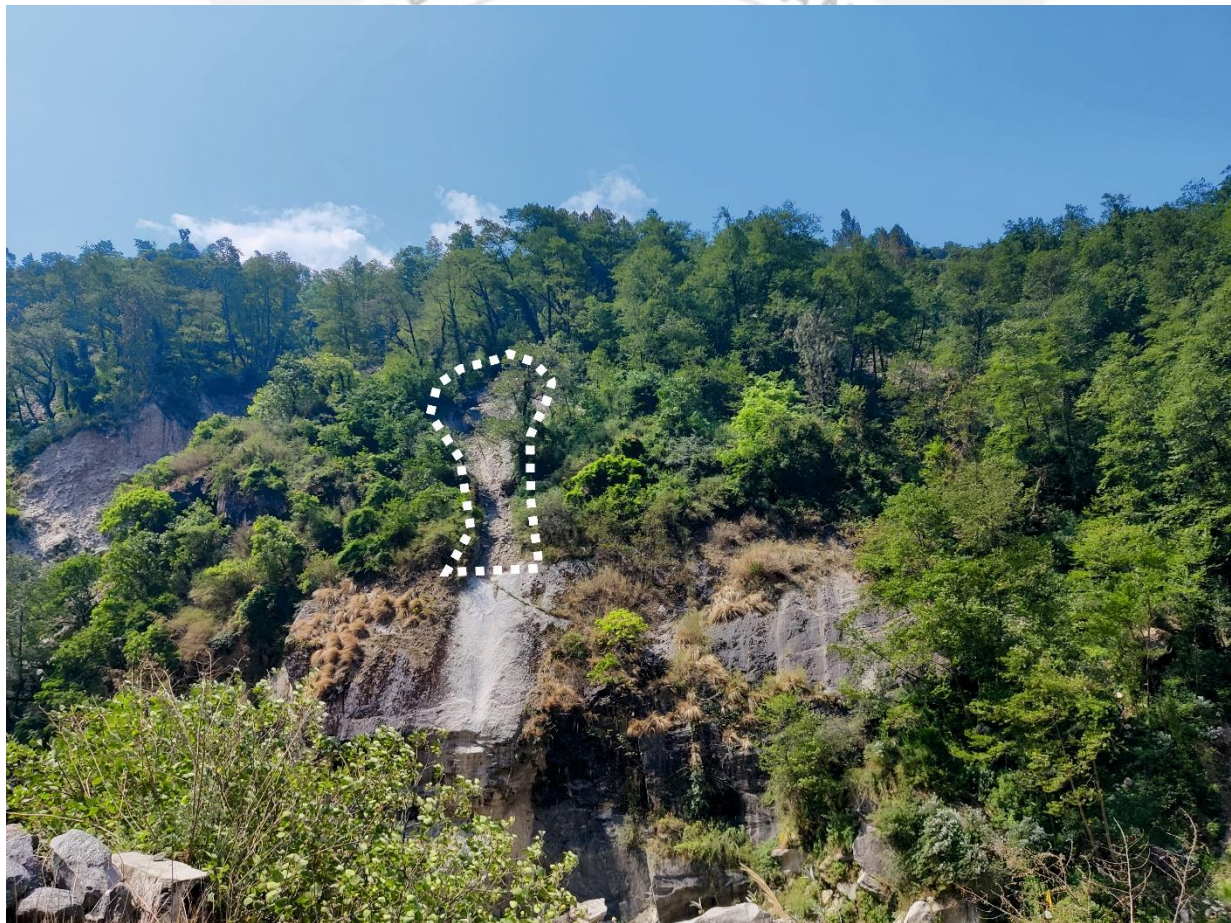
A debris landslide in the old landslide deposits may be triggered during the monsoon, evidenced by signs of running water. However, during the site visit, no flowing or dripping water was observed (**Figure 10**). The slide encompasses an area of 370 square meters (**Table 1**), with a maximum length of 54 meters and a width of 24 meters.

Biotite gneiss is visible at the toe of the slide, providing protection against river-induced toe erosion. The landslide material primarily consists of old landslide or moraine deposits, mainly composed of biotite-gneiss boulders, debris, and soil. The slide zone is predominantly surrounded by a lush green forest, adding to the overall stability and ecological context of the area (**Figure 10**).

**Figure 10:** Filed photograph showing landslide zone 3, left bank of River Alaknanda, Joshimath.

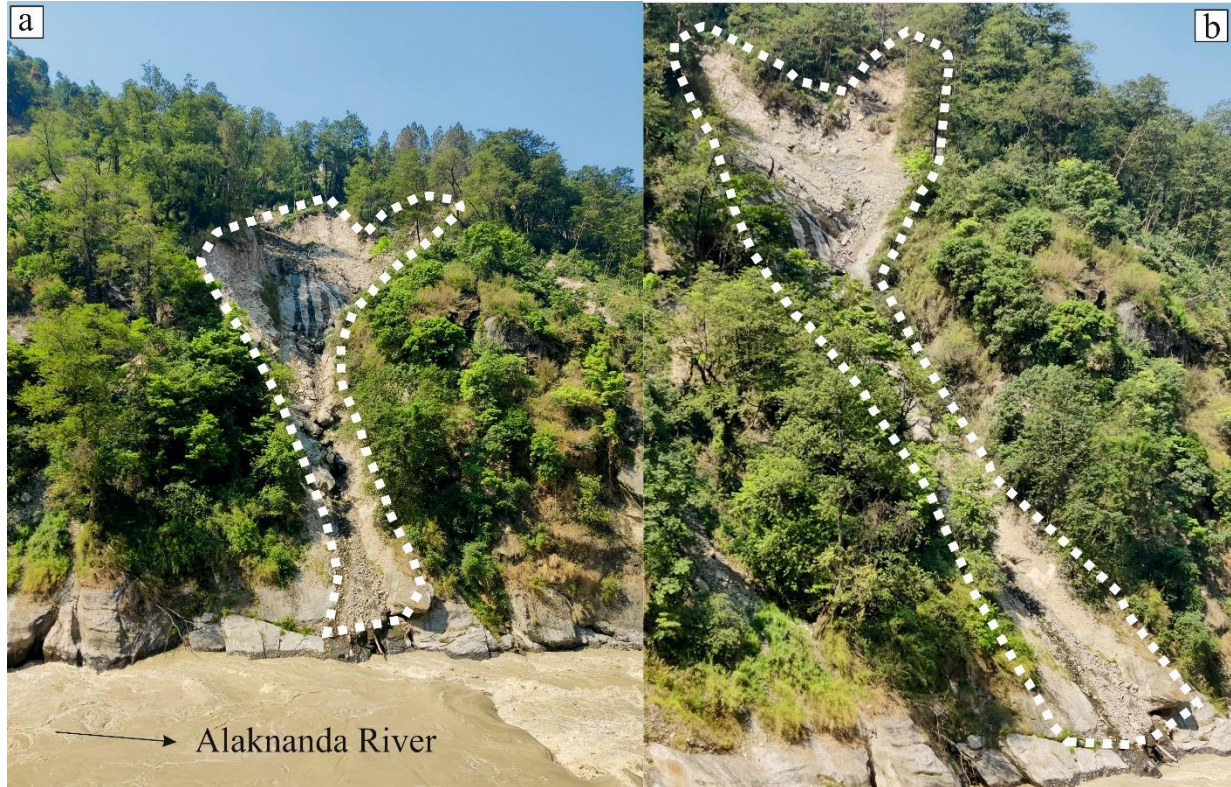
Another debris landslide occurred along the left bank of the River Alaknanda between Marwadi Bridge and Vishnuprayag (**Figure 11**). The landslide zone is composed of biotite gneiss, and debris of old landslide/moraine. These deposits primarily consist of boulders, debris, and soil.

The slide zone covers an area of 3811 square meters (**Table 1**), with a length of 101 meters and a width of 65 meters.

The slope also contains biotite-gneiss rock below the crown and at the toe (**Figure 11**). The main factors affecting the slope stability include the steepness of the slope and the drainage system passing through the middle of the slope.

**Figure 11:** Field photograph showing landslide zone 4 along left bank of river Alaknanda between Marwadi Bridge and Vishnuprayag, Joshimath.

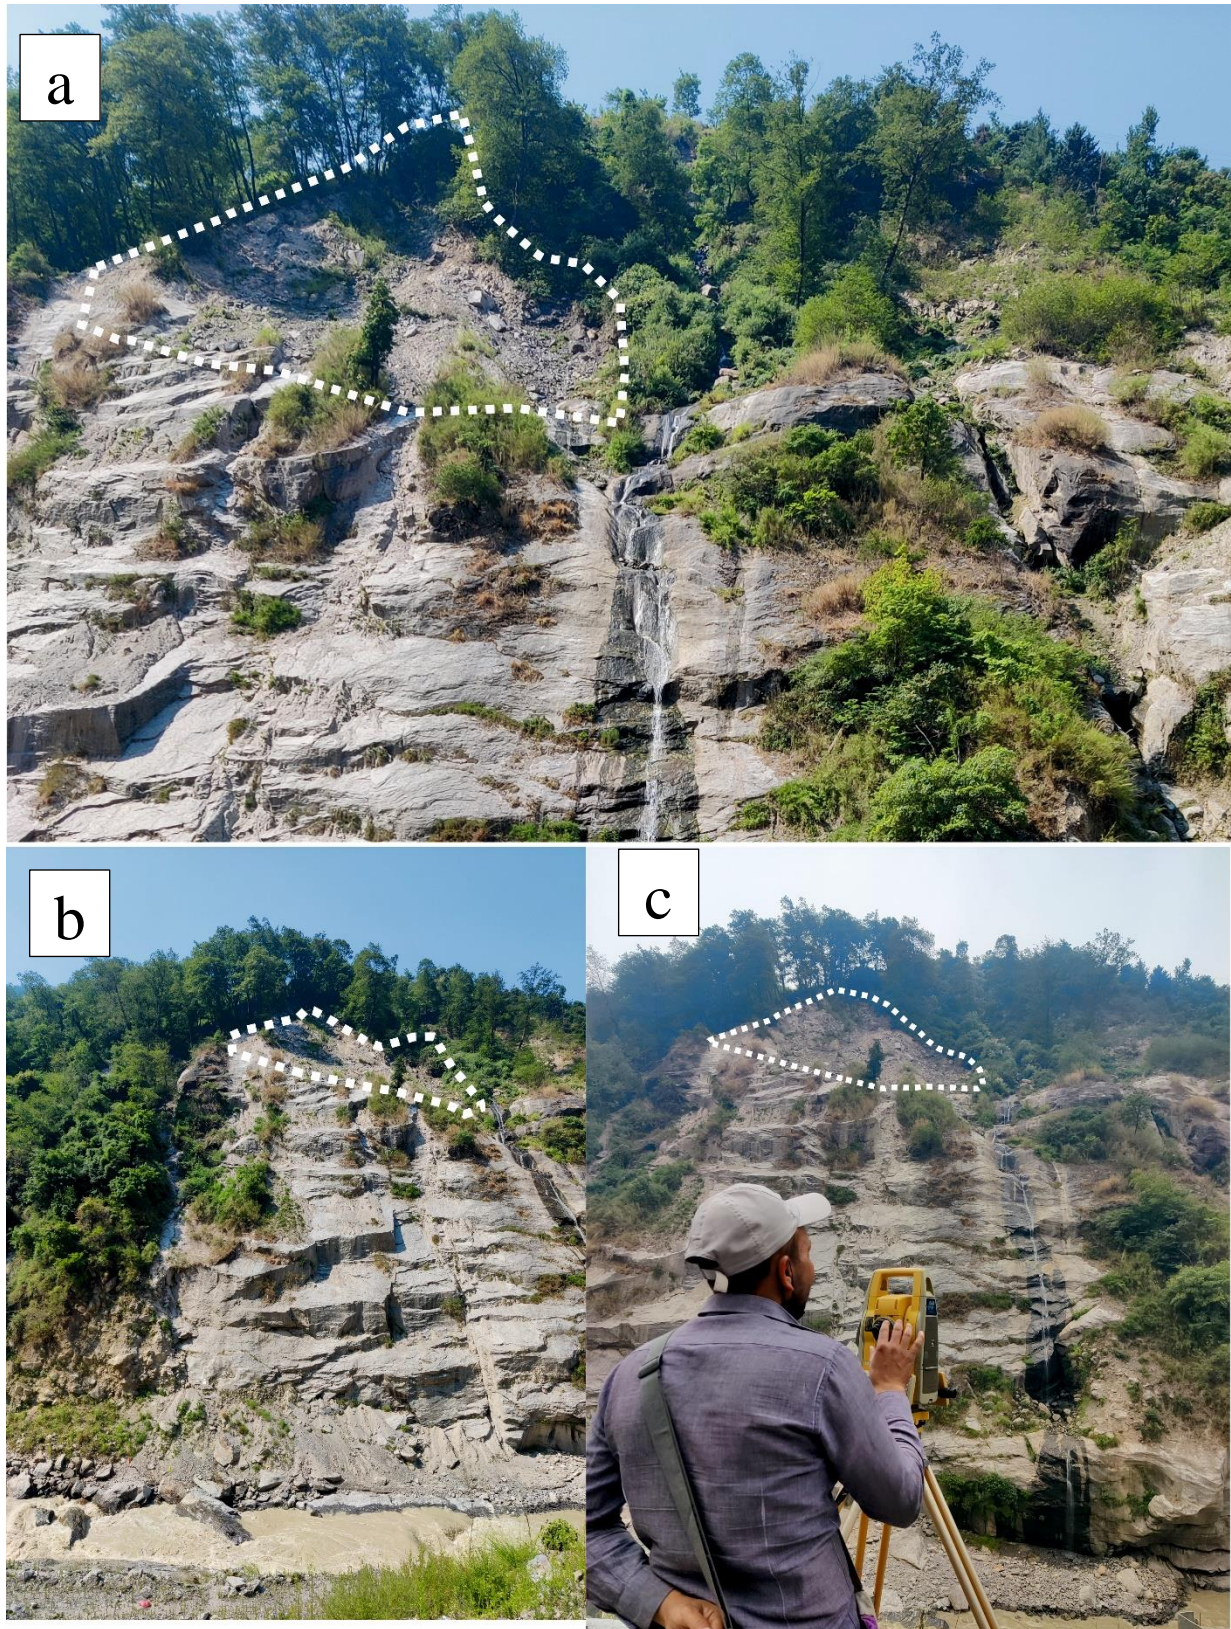
A debris slide covering an area of 1731 square meters (**Table 1**), with a maximum length of 62 meters and a width of 61 meters, is observed along the left bank of the River Alaknanda between Marwadi Bridge and Vishnuprayag (**Figure 12**). The landslide zone is primarily protected by a biotite-gneiss outcrop at the toe (Figure 12). Although the rock outcrop shows potential for planar and wedge failure, no signs of rock failure are currently observed on the slope. The stability of the slope is thus maintained, but continuous monitoring is recommended to detect any changes that may indicate future instability. Also the landslide zone (**Figure 12**) is suggested to mitigate in order to prevent further slope failure.

*Figure 12: Field photograph showing landslide zone 5 along left bank of River Alaknanda, Joshimath.*

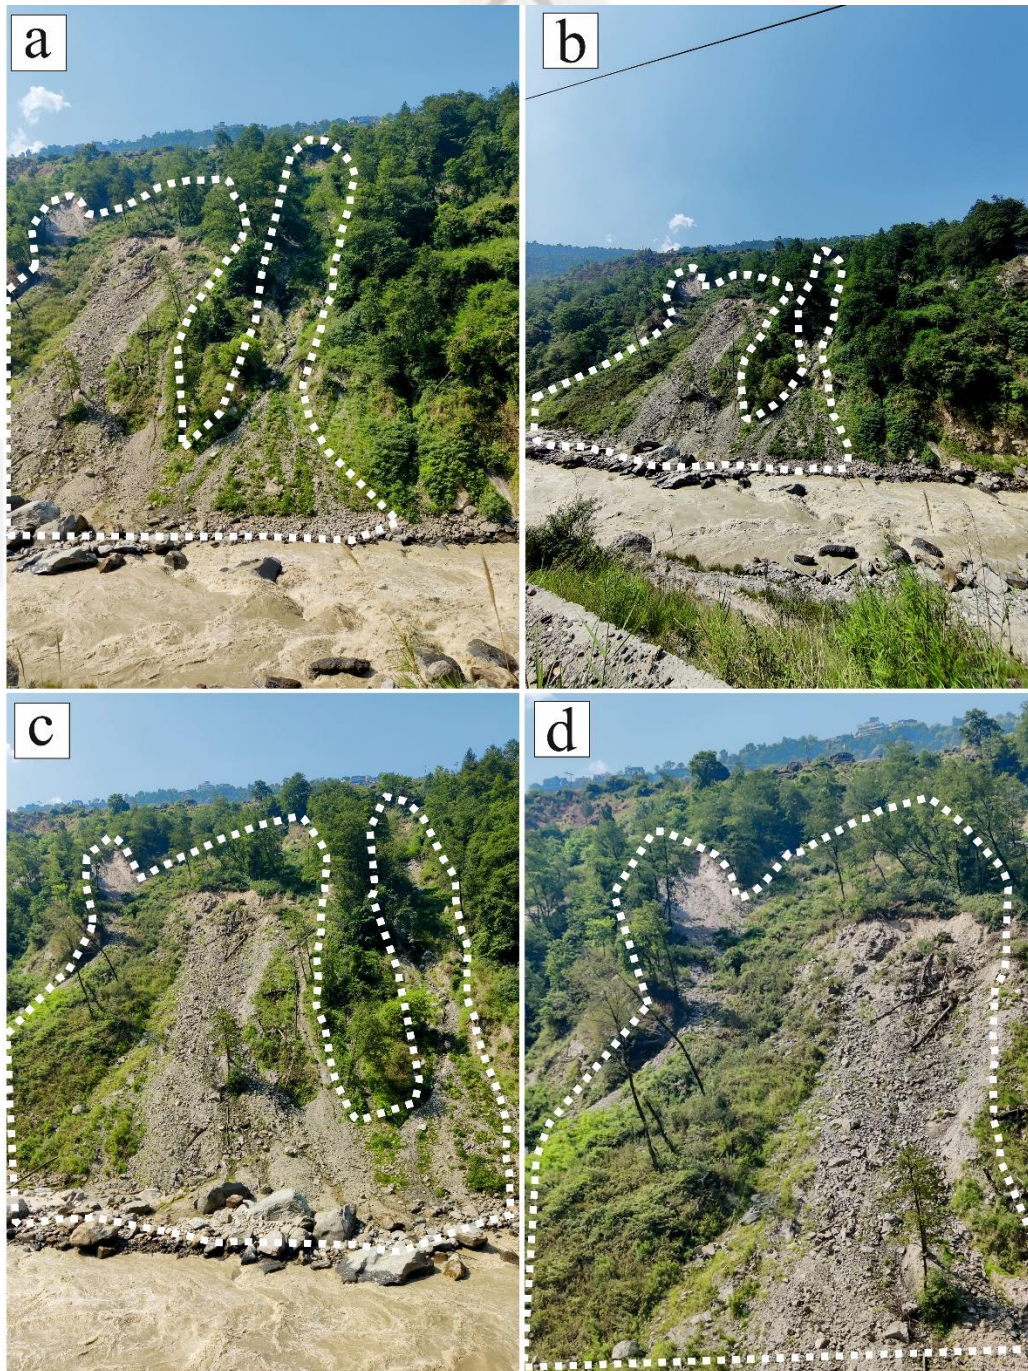
A debris slide is observed along the left bank of the River Alaknanda, covering an area of 19,729 square meters (**Table 1**), with a maximum length of 209 meters. The slope is primarily composed of debris material from old landslide or moraine deposits and is failing through a rotational mode of failure (**Figure 13**). The potential causes of this failure include toe erosion and drainage systems passing through the slope. Treatment of the slope is essential to prevent future slope failure and ensure the stability of the area.

**Figure 13:** Filed photograph of the landslide zone 06, along left bank of the River Alaknanda

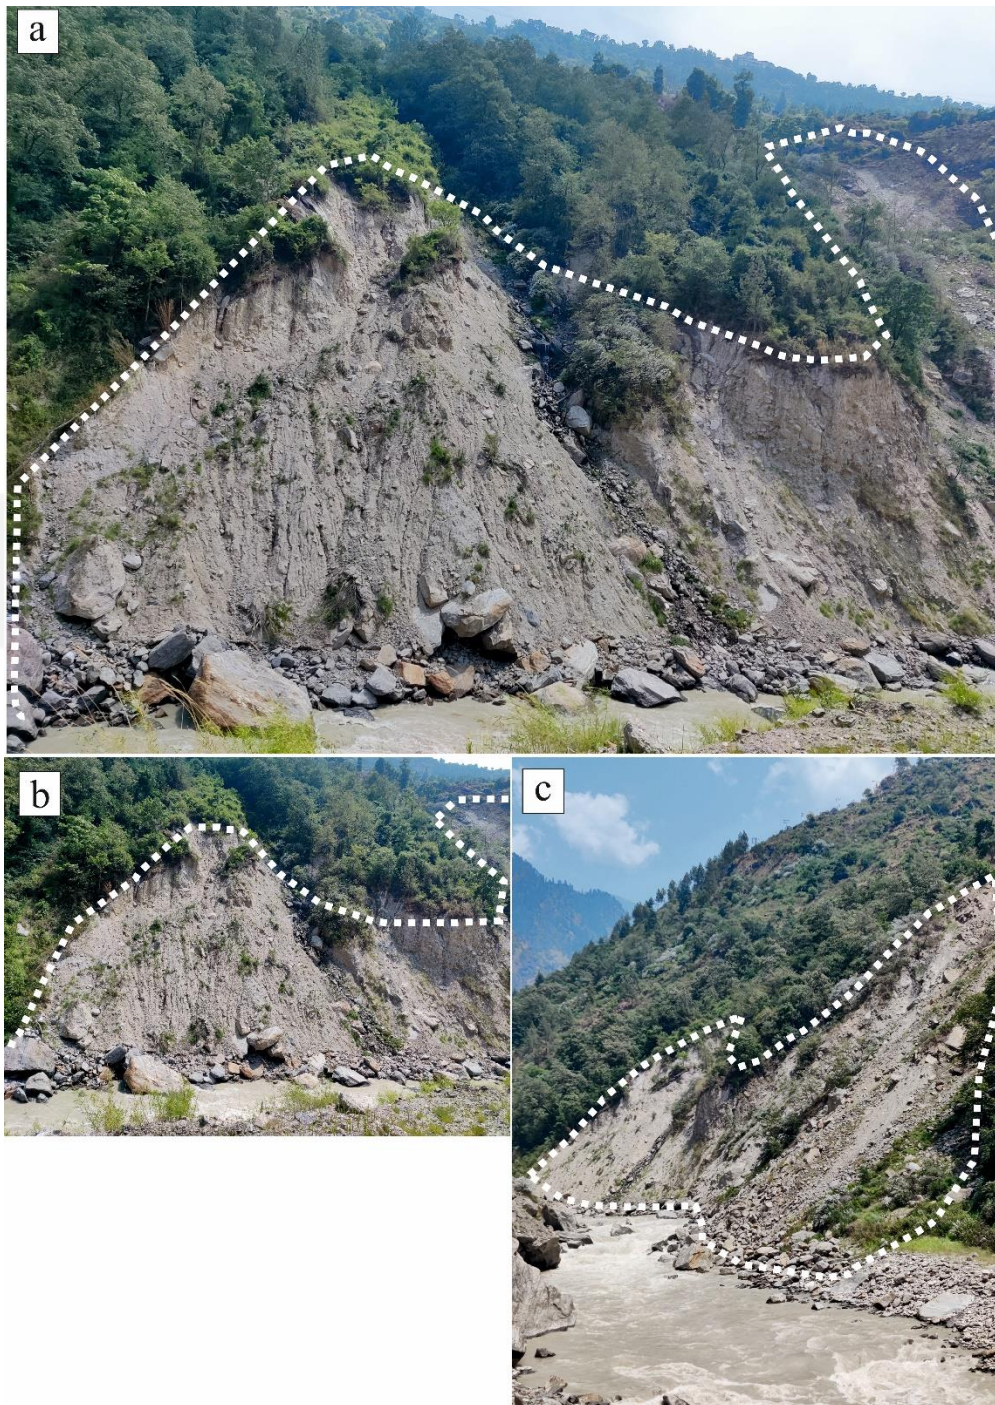
Another debris slide is observed near Vishnuprayag on the left bank of the River Alaknanda, between chainage 1583 to 1853 meters (**Figure 4; Figure 14**). The slide area covers 23,103 square meters (**Table 1**), with a chainage length of 263 meters and a maximum length of 209 meters. The slide material primarily consists of boulders, rock debris, and soil. Toe erosion is identified as one of the primary factors accelerating slope instability.

Figure 14: Field photograph showing landslide zone 7, along left bank of River Alaknanda, near Vishnuprayag.
