**Geological Report on 23rd August landslip
activity in Chandi Devi hills**

Uttarakhand Landslide Mitigation and Management Center

SEPTEMBER 2023

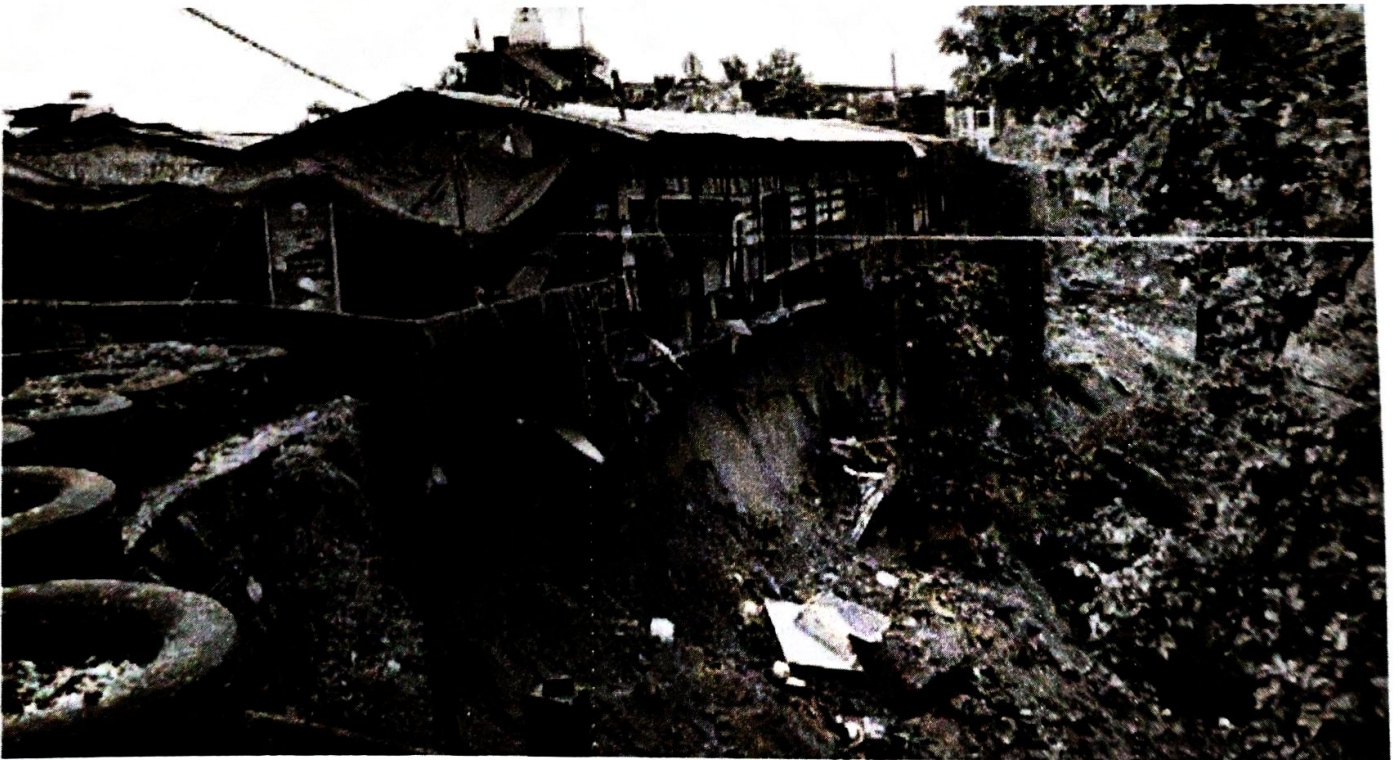
After the heavy rainfall on 23rd August 2023 , a part of the land at the top of the hill is washed away causing damage to four shops and the retaining structures , picture of which is depicting below. Since the landslide movement is of smaller scale therefore there is no damage occur to people however shops are at risk. Below are the pictures depicting the site scenarios and the topographic map is attached as fig 2.

- A part adjacent to the left side of affected area is already washed away few weeks back and construction of new retaining wall is going on.
- The fallen/ damaged retaining structure is about 4 to 5 m high and placed on the loose sandy soil without deeper foundation.

- The sandy soil have least cohesion and high permeability therefore susceptible to erosion when mixed with water which is the main reason of the current landslip event

1. Retaining structure may build in such a way to distribute the load at wider space. The stepped retaining structure may provide safety.
2. Retaining wall should have proper drainage holes
3. Regular maintenance of retaining wall is required
4. Shifting of water tank may be consider or the proper arrangement of water flowing away from retaining structure may keep so that minimize the water ingress into slope or below retaining structures .
5. Towards the right side of landslip affected area, drain may be build for proper dispose of water during monsoon in order to avoid further erosion.

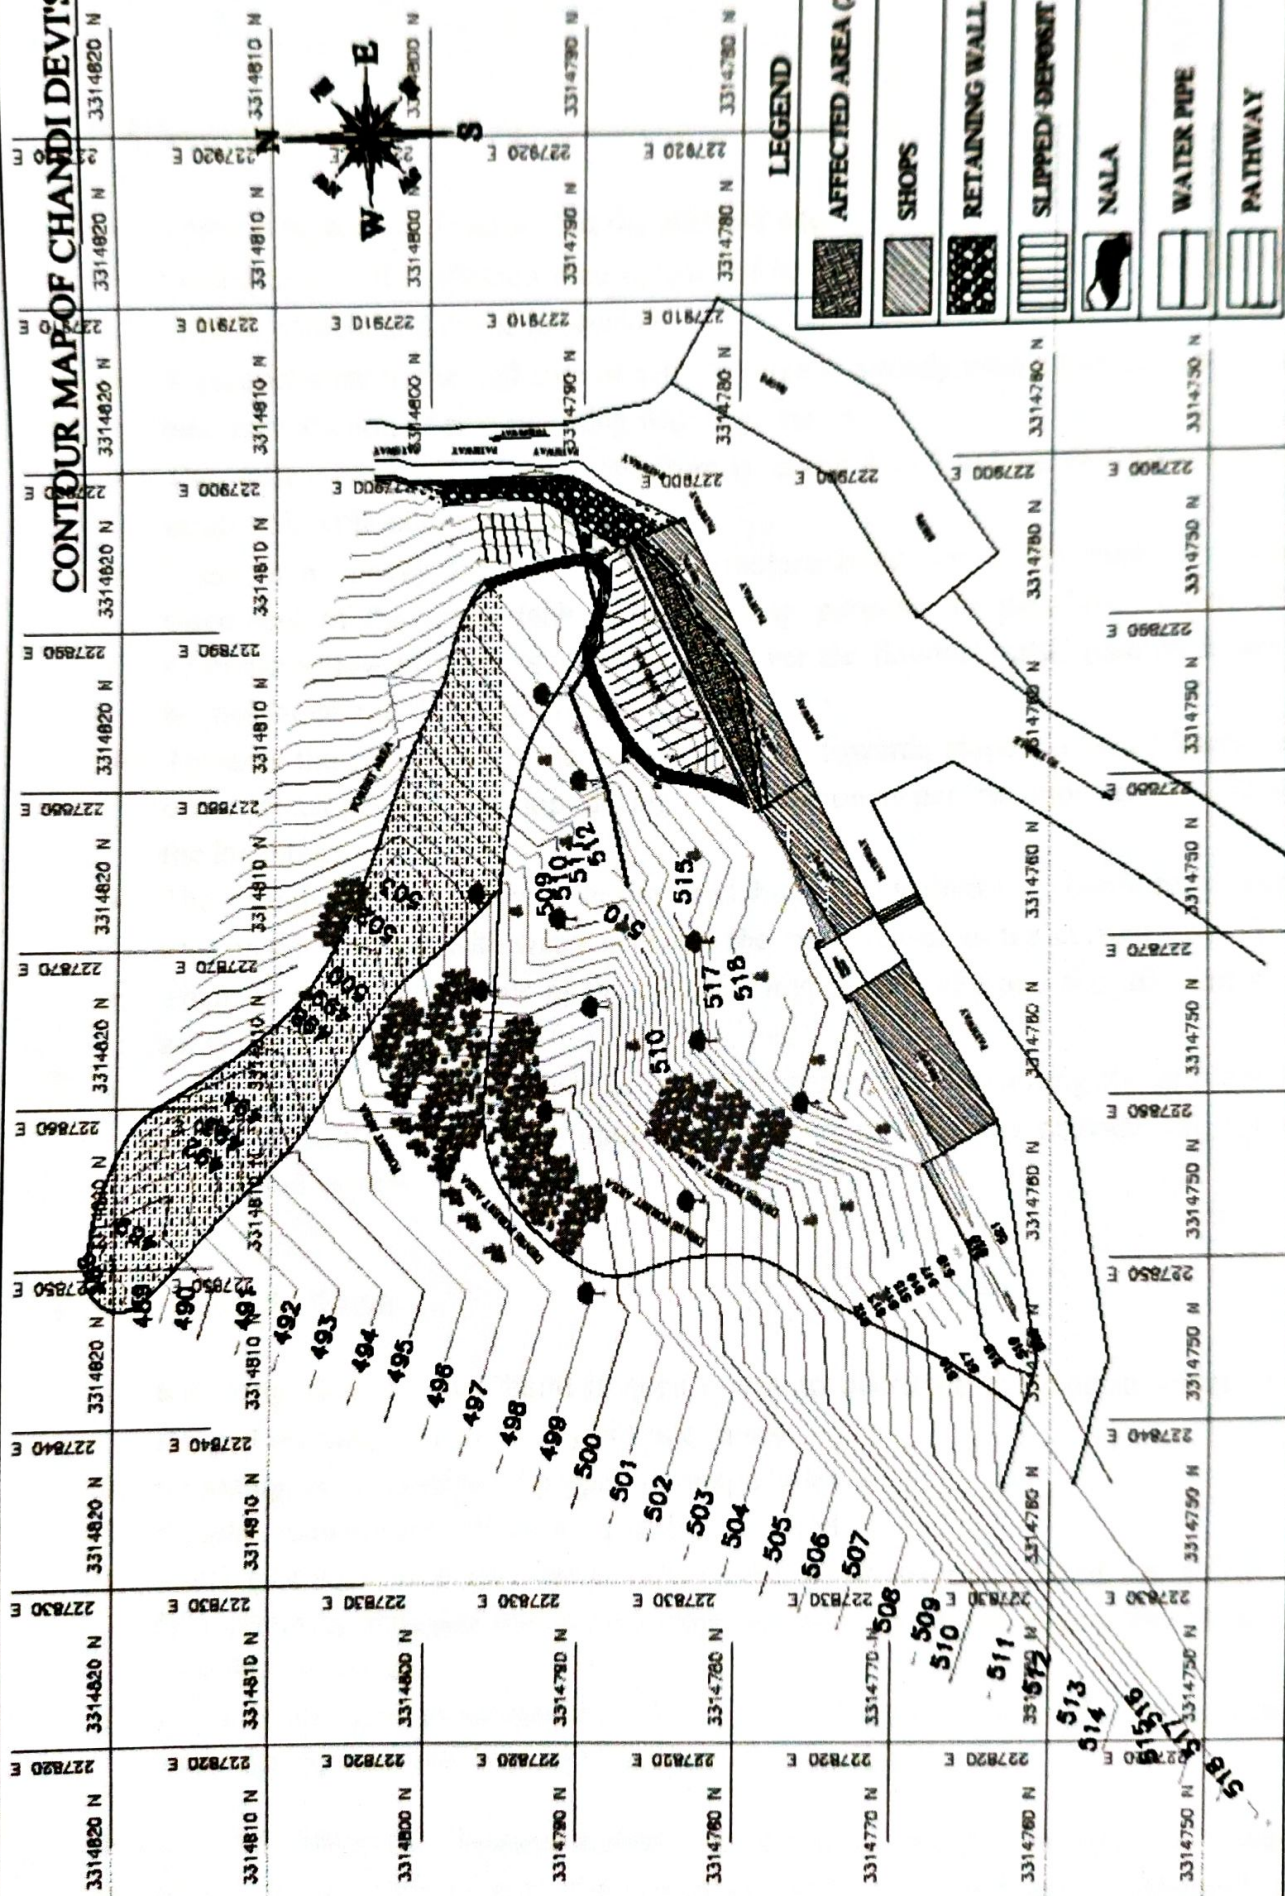
TITLE: CONTOUR MAP OF CHANDI
DEVIS LANDSLIDE AREA

AFFECTED AREA (28.42 M²)
	SHOPS
	RETAINING WALL
	SLIPPED/DEPOSIT SOIL
	NALA
	WATER PIPE
	PATHWAY
