**Preliminary Site Investigation of Landslides and Associated  
Distress along the Hill Bypass Road around Mansa Devi,  
Haridwar**

**Uttarakhand Landslide Mitigation and Management Centre  
Government of Uttarakhand  
August 2023**

### **PROLOGUE**

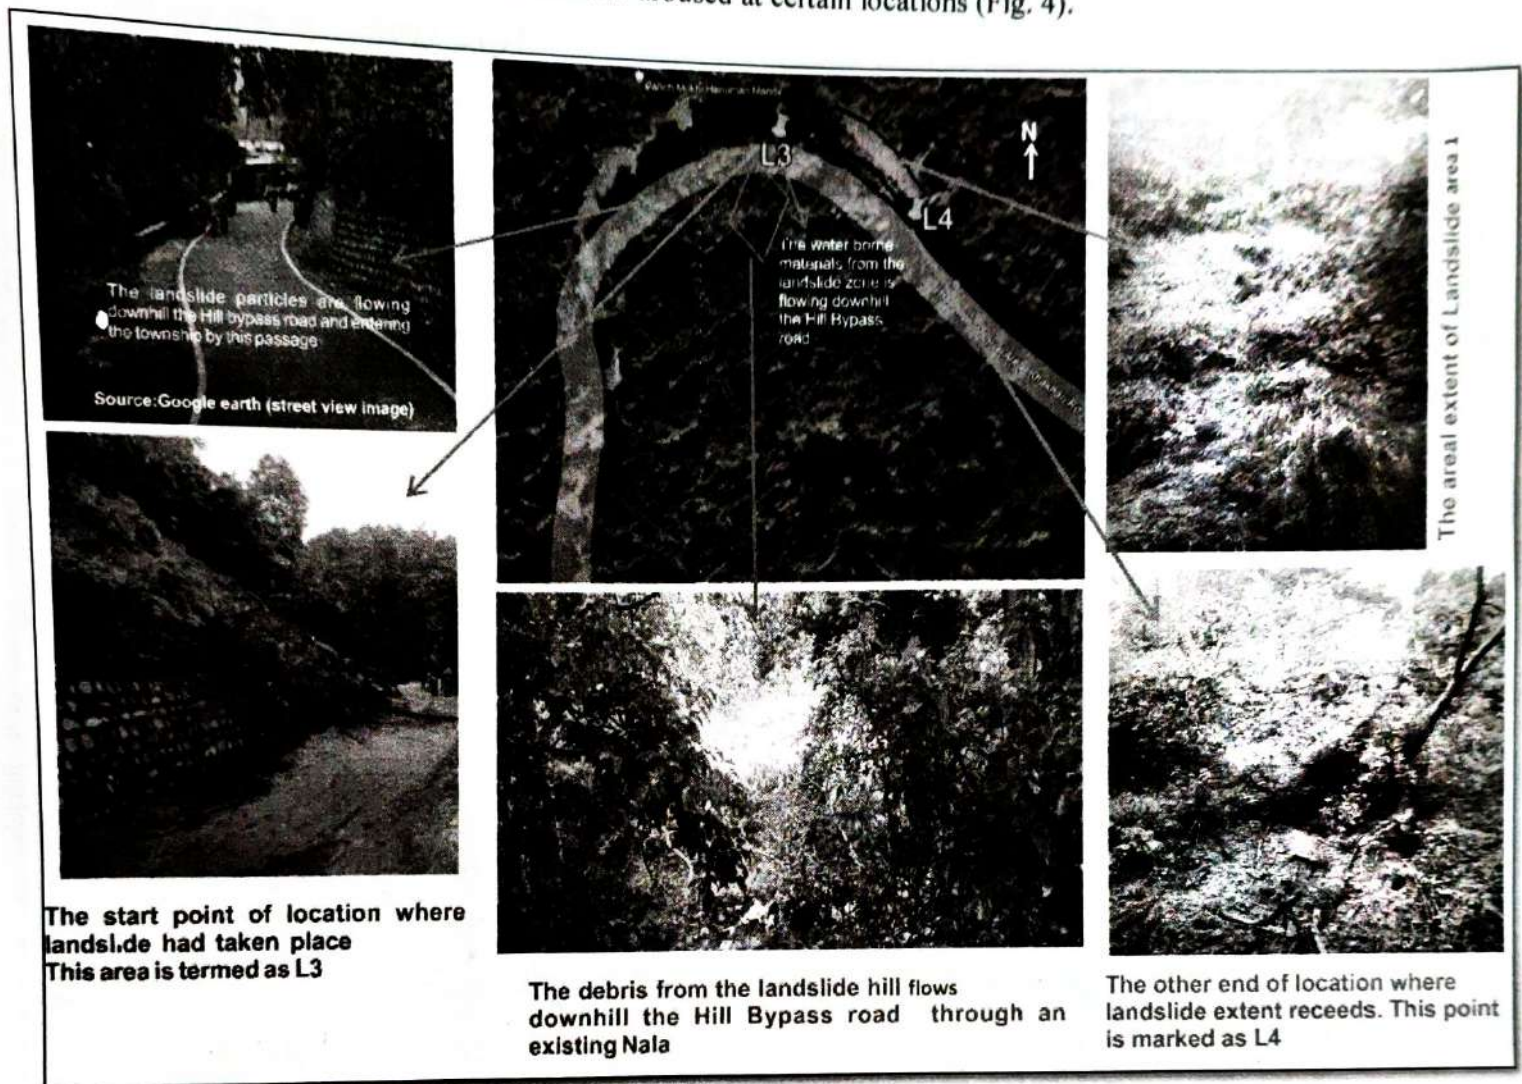
- i. **Landside Area 1:** This location is situated between the coordinates points L3 ( $29.955391^{\circ}$  N,  $78.163984^{\circ}$  E) and L4 ( $29.955241^{\circ}$  N,  $78.164254^{\circ}$  E) along the Hill Bypass Road, and is characterized by debris slide comprising mainly mud particles. The slope is estimated at  $\sim 80^{\circ}$  and of height  $\sim 30$  m. This landslide has affected the road and caused disruption in the commute of the pilgrims. The

saturated materials borne by this landslide are entering the locations situated downhill which has flustered the daily routine of Haridwar township locals. Due to such invasion, problems like water logging, cracks and subsidence have aroused at certain locations (Fig. 4).

**Fig. 4:** Google Earth image showing the location of the first landslide, situated along the Hill Bypass road, points L3 and L4 mark the start and end point of the landslide stretch. It is also observed that landslide materials accompanied by water are flowing downhill in S (continuing straight by the road into an existing Nala) and SW (down the road into the township) direction. Each point marked in the Google Earth image is explained with respect to field photographs.

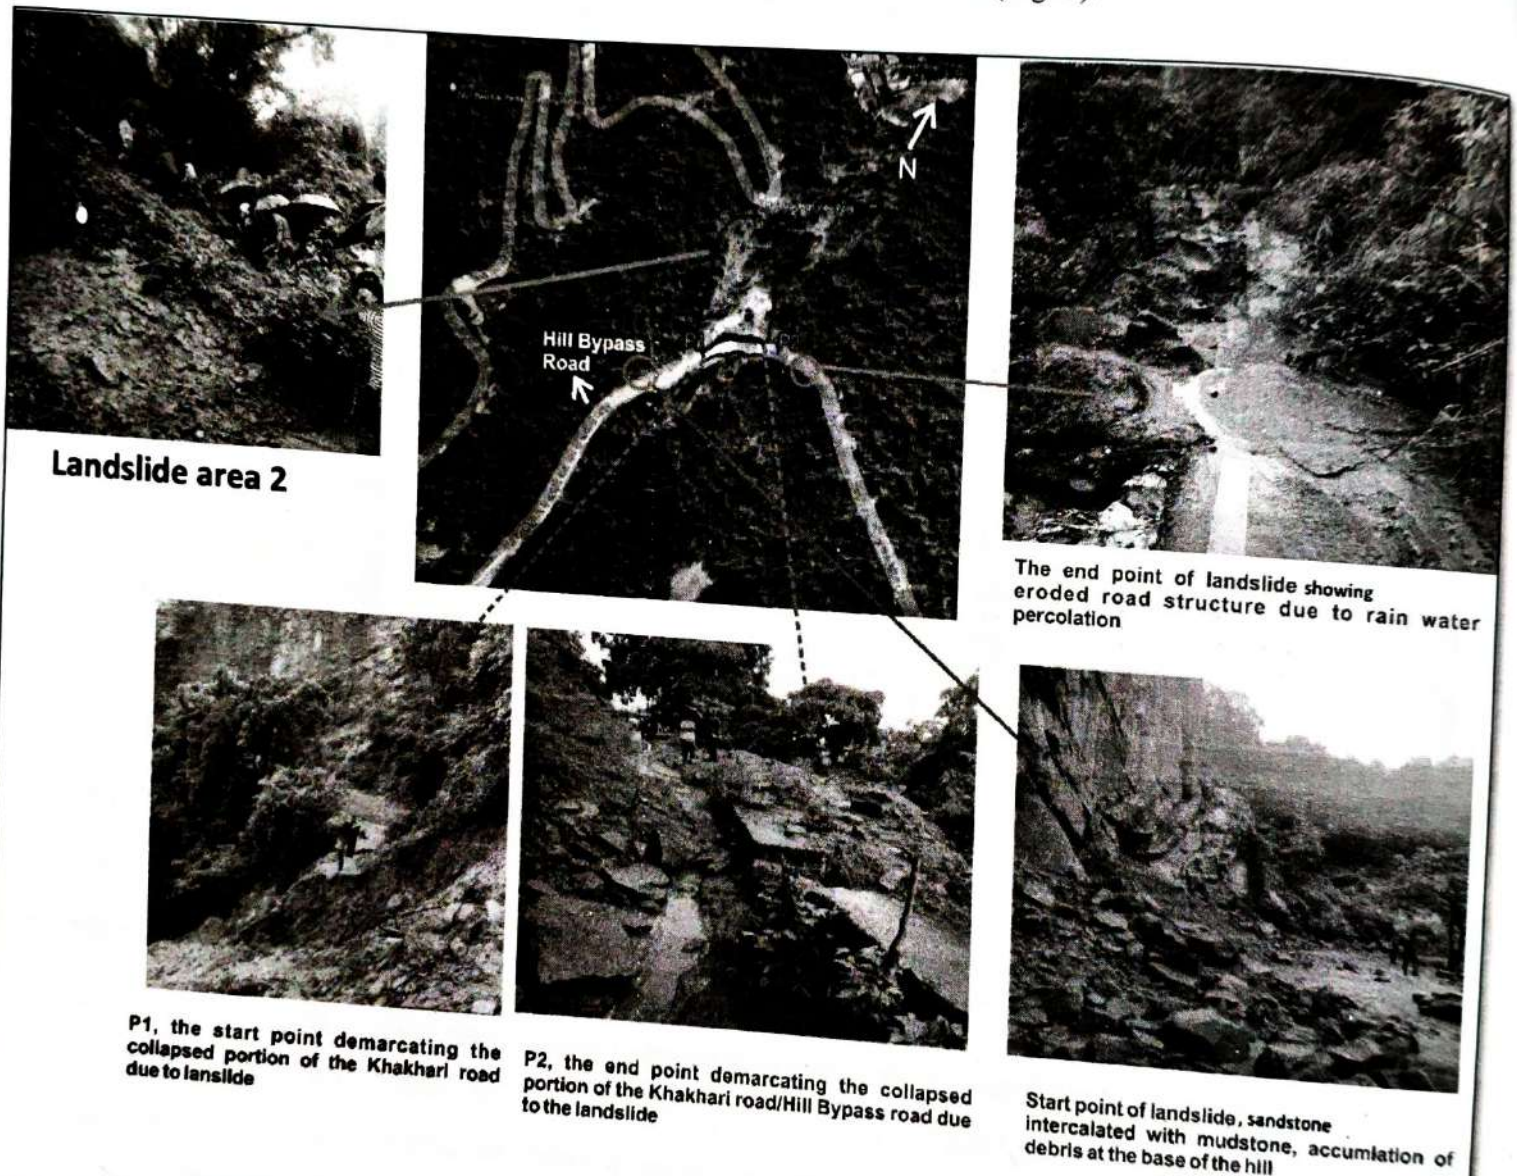
- ii. **Landslide area 2:** This location is situated between the coordinates points L1 (29.955853°N, 78.165664°E) and L2 (29.956259°N, 78.166019°E) along the Hill Bypass road, and is characterized by debris slide comprising mainly mud particles. The scarp of the landslide is ~ 120 m with a vertical height of around ~3 m, and a slope ~ 65- 70°.

Due to its influence a considerable length ( $\sim 80$  m) P1 ( $29.956016^{\circ}\text{N}$ ,  $78.165698^{\circ}\text{E}$ ) to P2 ( $29.956268^{\circ}\text{N}$ ,  $78.166006^{\circ}\text{E}$ ) of the Hill bypass road (lying below this landslide area) collapsed. In accordance with the geology of this region, the mudstone formation under the trigger of rainfall has gushed down the hillock. This landslide hill lies adjacent to the hilltop where Mansa Devi Temple is located and the distance between the scarp and the step of the temple is  $\sim 3.0\text{--}4.0$  m (Fig. 5).

**Fig. 5:** Google Earth image showing location of the second landslide, along the Hill Bypass Road, the points L1 and L2 mark the start and end point of the landslide stretch. It is observed that due to influence of this landslide a significant portion of Hill Bypass road has collapsed demarcated within P1 and P2 points. Each point marked in the Google image is explained in respect to field photographs.

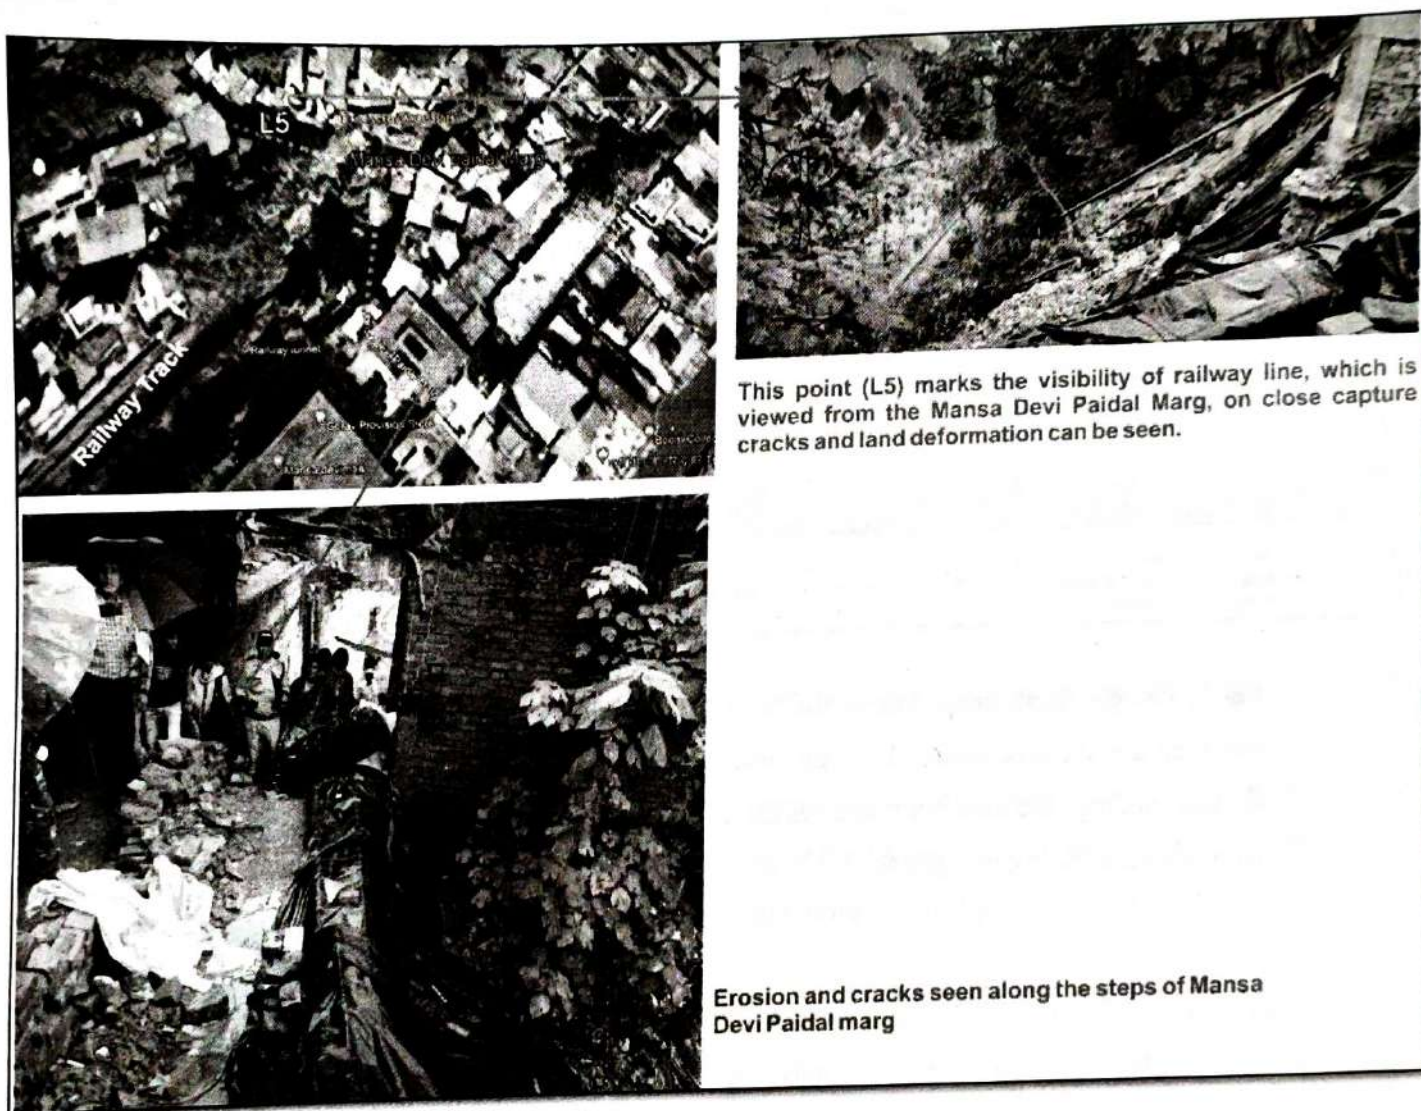
- i. **Mansa Devi paidal marg:** This location L5, is situated at coordinate points  $29.955352^{\circ}\text{N}$ ,  $78.167678^{\circ}\text{E}$  adjacent to the Mansa Devi Paidal Marg road. At this location, we saw prevailing problems like erosion in the areas around railway tracks, visible cracks along the steps of the marg. Such a situation might be the result of entry of the debris fragments and improper drainage planning in the township (Fig. 6).

**Fig 6:** Google Earth image shows location L5 situated along the railway track, which is visible from the Mansa Devi Paidal Marg. It is observed that around L5, there is an accumulation of moist rock and mud fragments which is apparently adding an erosion effect to the surrounding. Likewise, the steps of Mansa Devi Paidal marg are also eroded and cracks appear in places. Each point marked in the Google image is explained with respect to the field photograph.

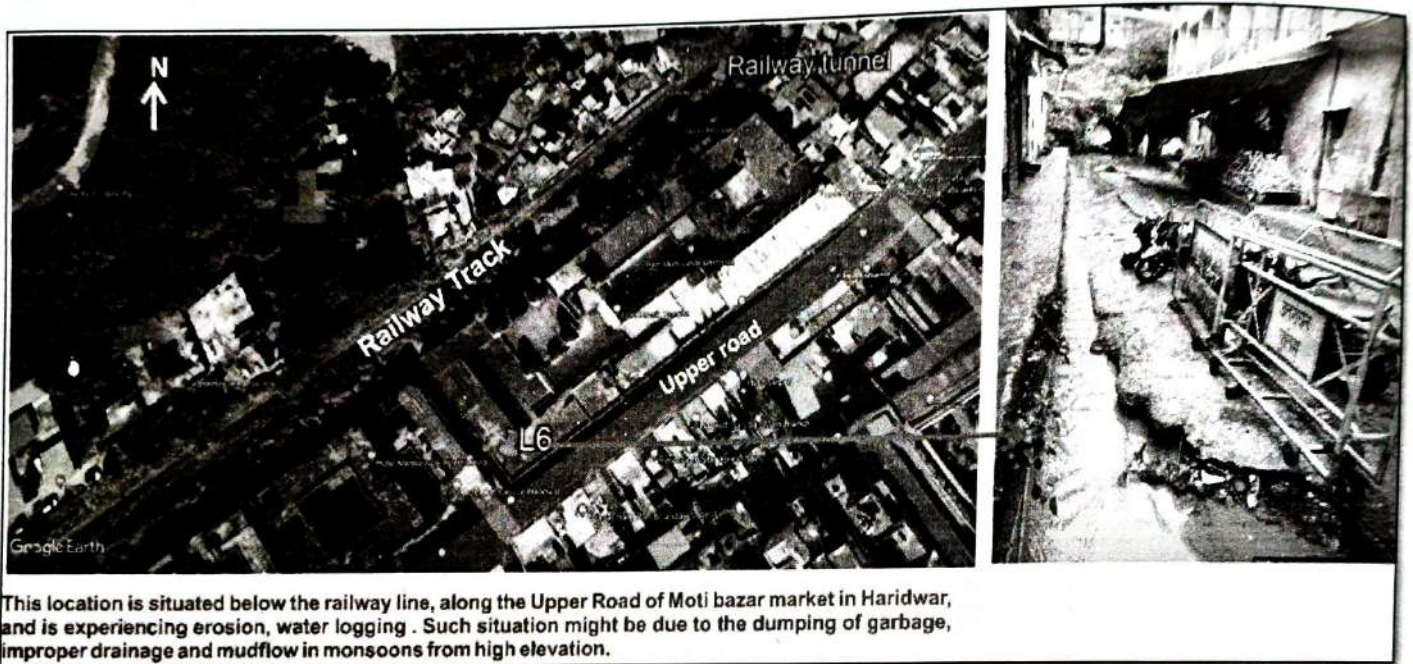
- ii. **Haridwar market area:** This location L6 is located at the coordinate points 29.954055°N, 78.166972°E below the Haridwar railway track. At this location, problems like water logging and erosion can be seen, which has also sparsely flooded the market areas too. Such a situation might be the result of the dumping of garbage and improper drainage planning in the township (Fig.7).

**Fig 7:** Google Earth image shows the location L6, situated just below the Haridwar railway track. It is observed that the area around L6 experiences a water logging situation that has led to an erosive effect on the surroundings and adjacent to the market area. The location point on the Google Earth image is explained with respect to field photographs.
