# Uttarakhand Landslide Mitigation and Management Center (ULMMC)

Letter No. 104 / 32 / ULMMC / 2025-26

**विषय:-** जनपद उत्तरकाशी में भागीरथी नदी के दाएं किनारे स्थित चडेथी एवं भटवाड़ी नाम स्थान पर भूस्खलन की सुरक्षात्मक कार्य हेतु भू-वैज्ञानिक सर्वेक्षण कराये के सम्बन्ध में।

**Preliminary visit to Chadethi (Bhatwari) landslide  
zone along right bank of the River Bhagirathi,  
Uttarkashi**

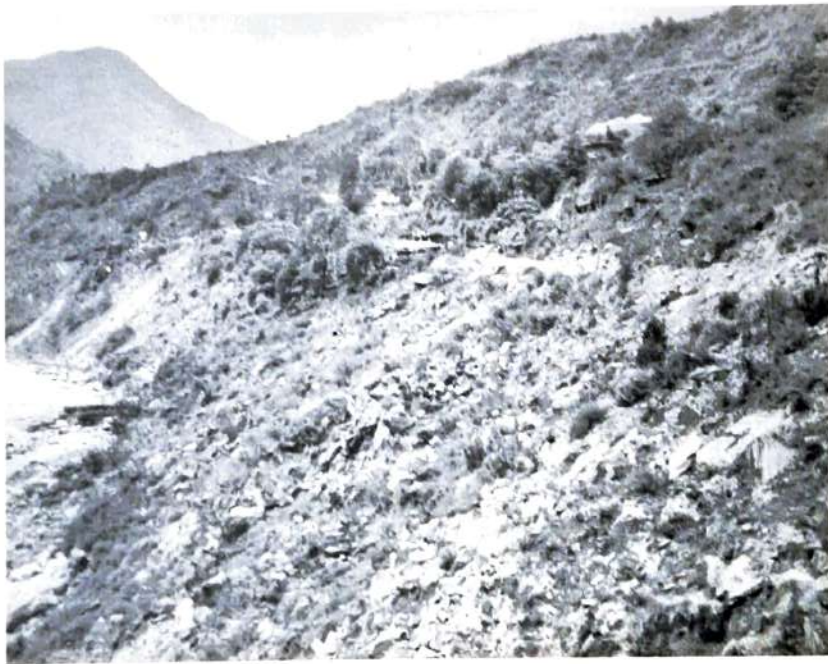
*Figure 1: Field photograph of the affected zone impacted by landslide/subsidence activity along NH 34.*

The landslides in the Bhatwari area exhibit a combination of rotational and translational failure mechanisms, contributing to frequent mass wasting events, including debris flows, rockfalls, and toe erosion induced by the Bhagirathi River. These slope movements have caused repeated damage to National Highway 34 (NH-34) and pose a significant threat to nearby settlements (Pant et al., 2015). Both natural factors (geological, geomorphological, and hydrological) and anthropogenic influences (construction, road cutting, etc.) are responsible for slope instability in this region. The following observations were made during the site investigation:

1. The slope material is primarily composed of colluvial debris and boulders of varying sizes, making it difficult to ascertain the depth to bedrock. Therefore, geophysical investigations (e.g., Electrical Resistivity Tomography, Seismic Refraction) and borehole drilling are suggested to understand the subsurface stratigraphy and determine the depth and nature of the underlying bedrock.

6. Based on the integrated findings from geological, geotechnical, geophysical, drilling, and topographical investigations, site-specific mitigation measures should be designed. These may include slope regrading, drainage improvement, retaining structures, or ground reinforcement depending on the local conditions and failure mechanisms identified.

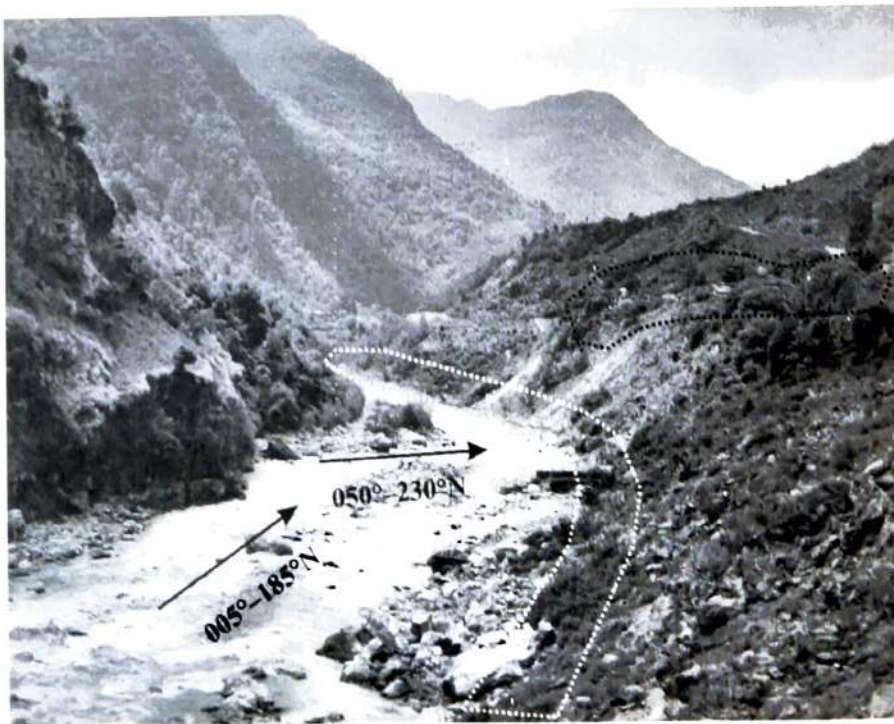
1. The settlements are at risk due to ongoing and potential slope movements include Bhatwari, Raithal, Kyara, Bandrani, and Natin may also be studied if any surface deformation observed and correlated with the subsidence zone.
2. The Bhagirathi River flows approximately north-south ( $005^{\circ}$ – $185^{\circ}$ N) but exhibits a pronounced bend near a local temple, changing course to  $050^{\circ}$ – $230^{\circ}$ N. The road alignment closely follows the river's course, which may exacerbate erosion and destabilize the toe of the slope (Figure 2).

*Figure 2: Field photograph showing of river shifting and adjacent human settlements.*

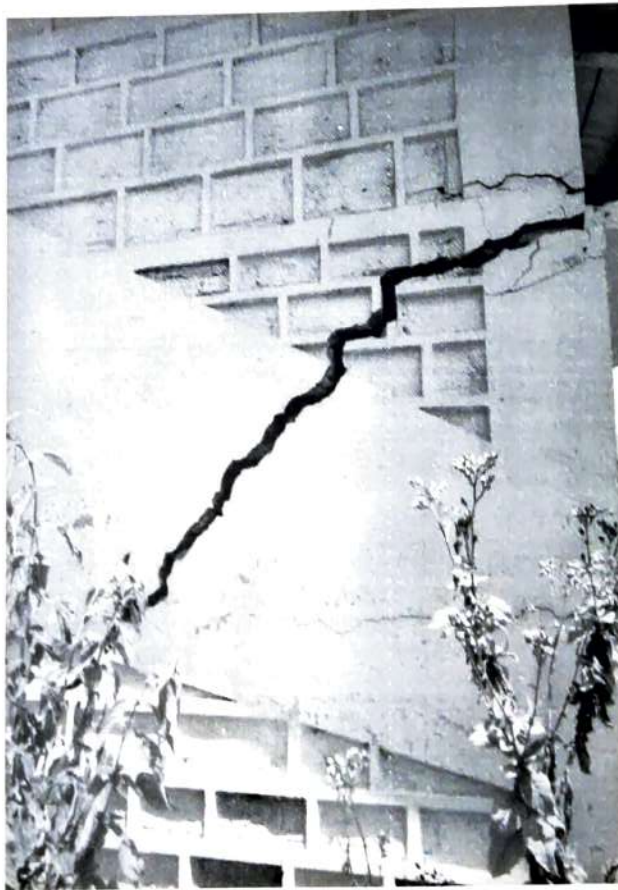
6. Structural cracks have been observed in several key structures, including the Patwari Chauki, LIU office, and Tehsil building, indicating active ground deformation. Additionally, numerous hotels, residential buildings, and shops in the area show signs of distress (Figure 3).

*Figure 3: Cracks observed in building structures during field inspection, suggesting potential differential settlement or ground movement.*

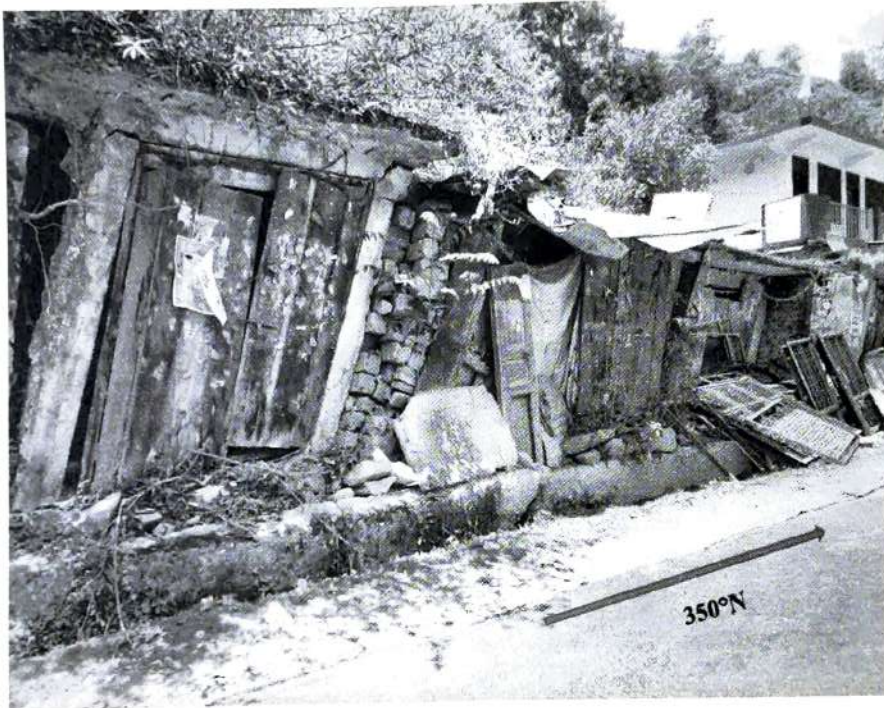
7. Some buildings exhibit tilting towards the upslope direction, suggesting the development of rotational slip surfaces within the debris- and boulder-rich material, indicative of circular (rotational) failure mechanisms (Figure 4).
8. The Baldev Market area shows visible ground cracks and displacement trending towards  $350^{\circ}\text{N}$ , further indicating slope movement in a northwest direction.

*Figure 4: Structural cracks observed in buildings at Baldev Market, highlighting signs of damage possibly due to subsidence or geotechnical failure*
