विषय:- टिफिन टॉप व चार्टन लॉज, नैनीताल में हो रहे भू-स्खलन के स्थलीय निरीक्षण के संबंध में आख्या।

टिफिन टॉप, नैनीताल में हो रहे भूस्खलन की निरीक्षण आख्या

चार्टन लॉज, नैनीताल में हो रहे भूस्खलन की निरीक्षण आख्या

Field Report on Tiffin Top

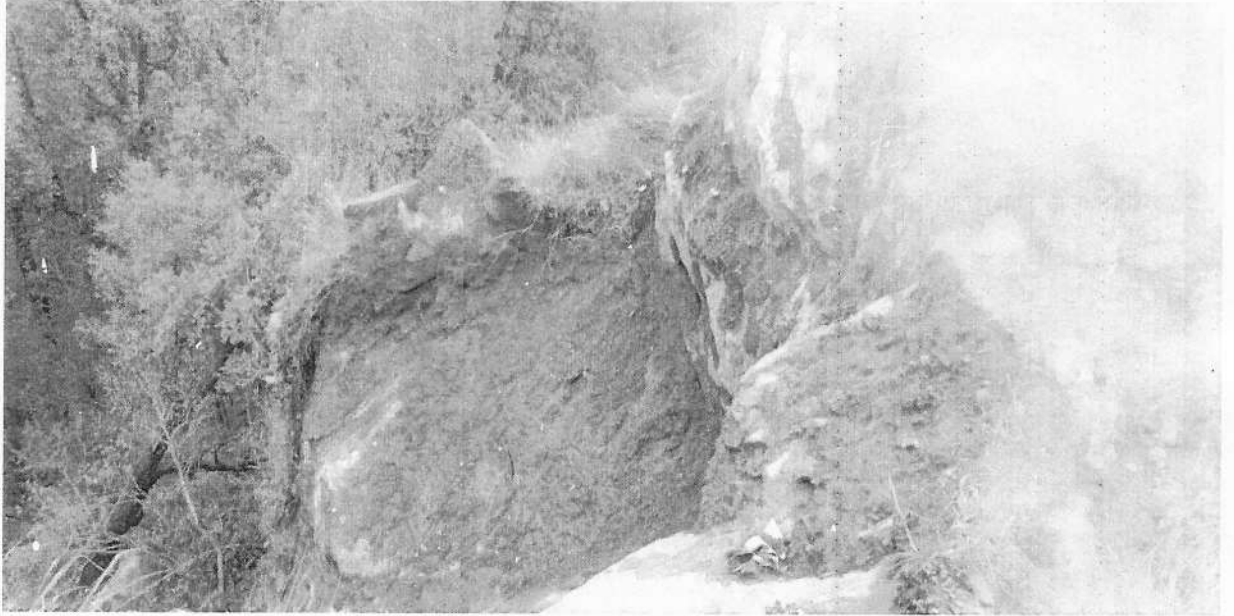
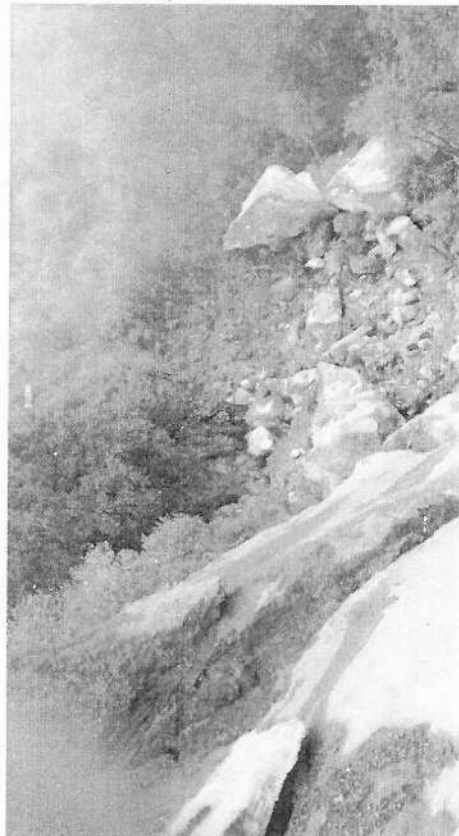
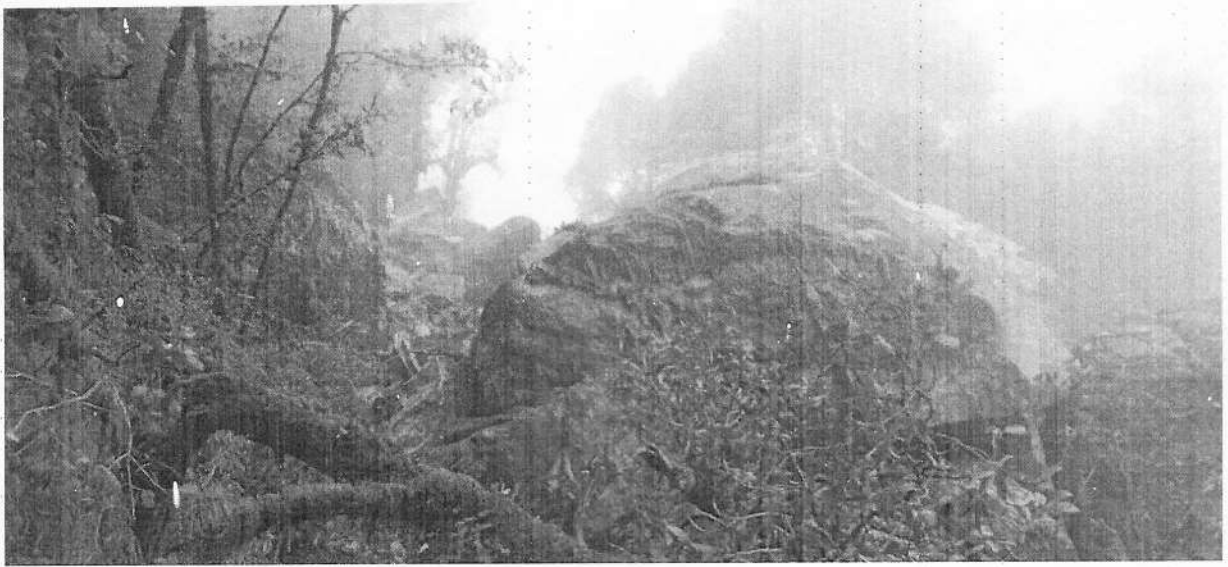
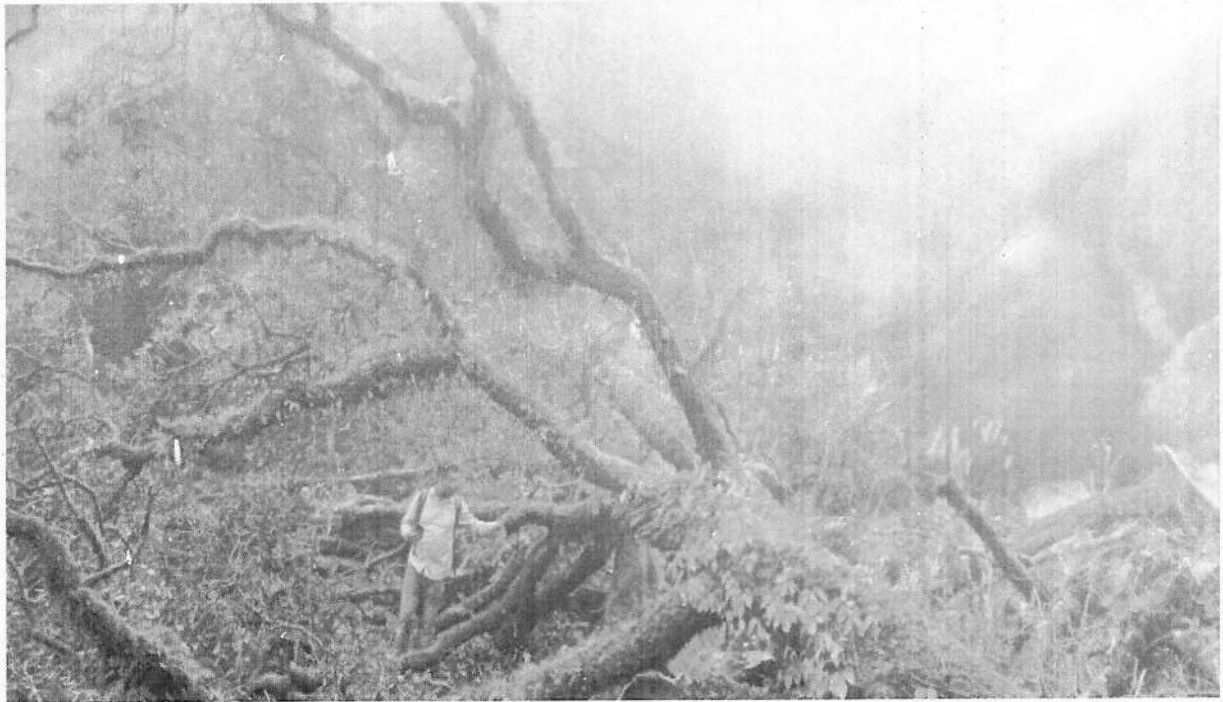
1. वर्ष 2024 में मानसून की अवधि में अत्यधिक वर्षा होने के कारण प्रसिद्ध पर्यटन स्थल टिफिन टॉप में बने प्लेटफार्म (Dorthy Seat) क्षतिग्रस्त हो गया।
2. प्लेटफार्म (Dorthy Seat) के नीचे स्थित बड़े बोल्टर अपने स्थान से विस्थापित होकर 20 से 30 मी० वैली की ओर खिसकें पाये गये।
3. आसपास आबादी क्षेत्र नहीं पाया गया।
4. आसपास घना वन क्षेत्र पाया गया।
5. प्लेटफार्म (Dorthy Seat) के नीचे स्थित बोल्टर के गिरने से कोई जानमाल की क्षति की सूचना प्राप्त नहीं हुई, अपितु वृक्षों को क्षति हुई है।

1. स्लीप के टॉप फेस पर कोई भी न्यूनीकरण का उपाय उपयुक्त नहीं होगा क्योंकि यह IN-Situ Rock नहीं है। Dolomite Limestone के बोल्टर हैं। अतः इसके ऊपर की सतह से न्यूनीकरण उपाय करना उचित होगा जो कि निम्न प्रकार है।
 - i. प्लेटफार्म (Dorthy Seat) के आसपास स्थित बोल्टर के बीच अन्तर में मिट्टी को साफ करके कंक्रीट भरा जाय ताकि भविष्य में उन अन्तर के बीच वर्षा जल के कारण मिट्टी का कटाव न हो पाये जिससे बोल्टर अपनी स्थिति में अखंड रहे।
 - ii. उसके पश्चात 100 मी०मी० मोटाई में Shot Create करने का प्रावधान उचित होगा, इससे बोल्टर की आपस में पकड़ बनी रहेगी।

2. उचित न्यूनीकरण के उपायों के लिये विस्तृत भूगर्भीय, भू-तकनीकी और भू-भौतिकीय सर्वेक्षण कराने की आवश्यकता है।
3. यू0एल0एम0एम0सी0 द्वारा पूरे नैनीताल शहर में विस्तृत स्थलाकृतिक सर्वेक्षण, ढलान स्थिरता विश्लेषण, भूगर्भीय, भू-तकनीकी और भू-भौतिकीय सर्वेक्षण कराने का प्रस्ताव है, जिस पर मानसून अवधि के पश्चात कार्य आरम्भ करा लिया जायेगा।

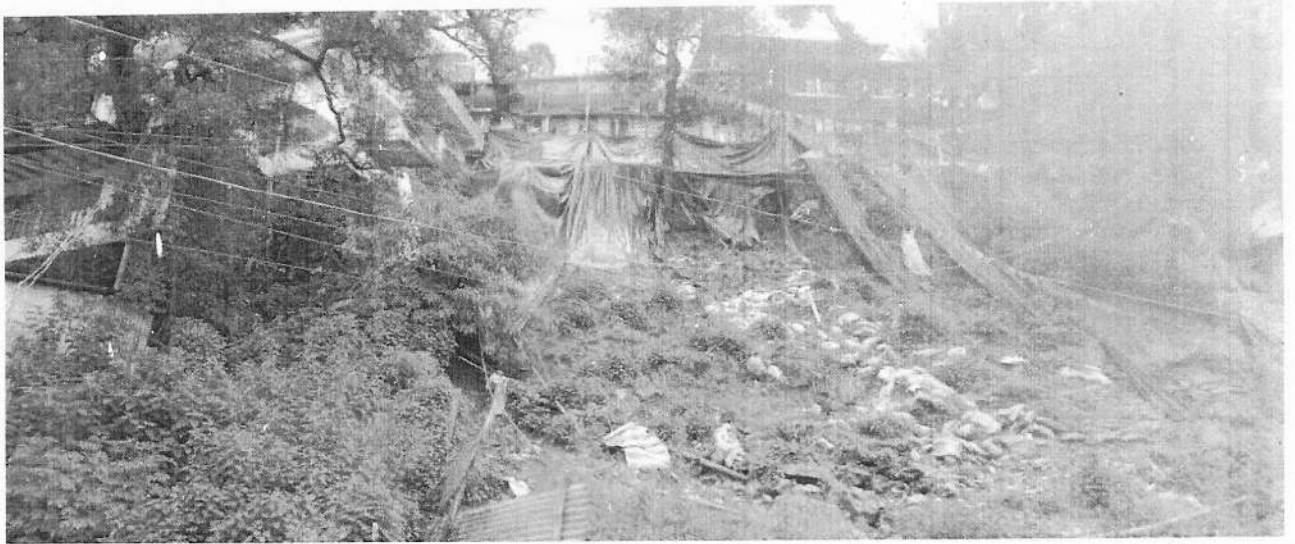
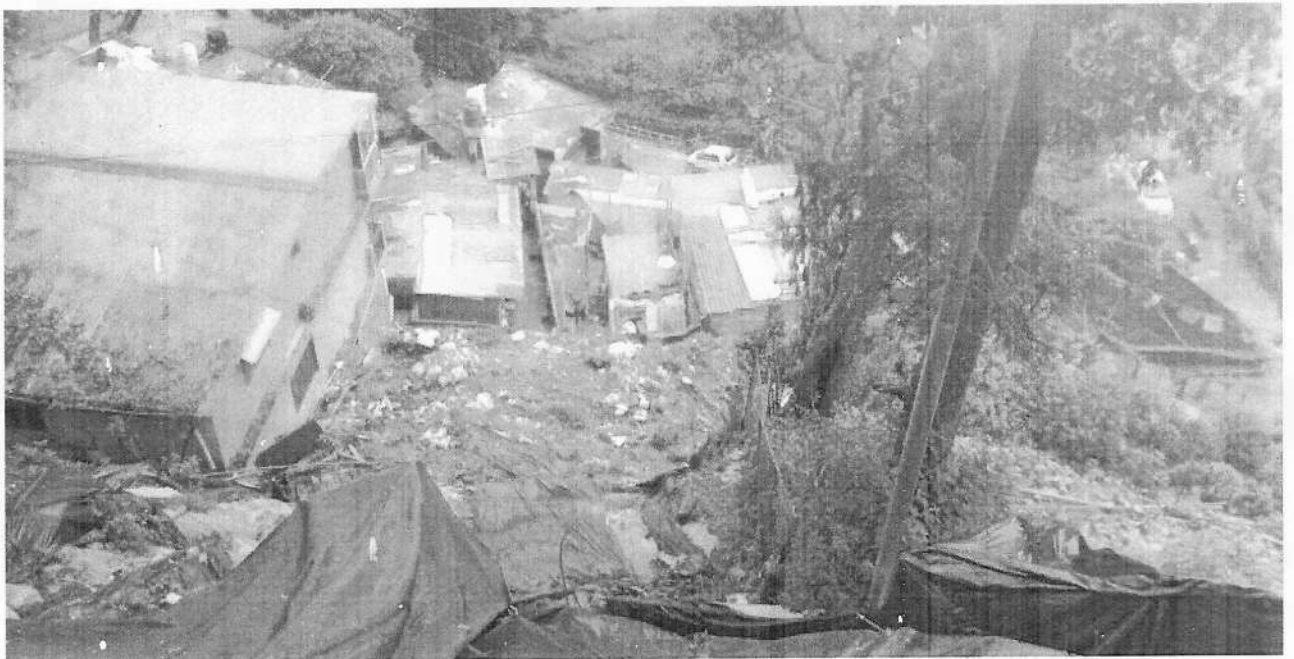
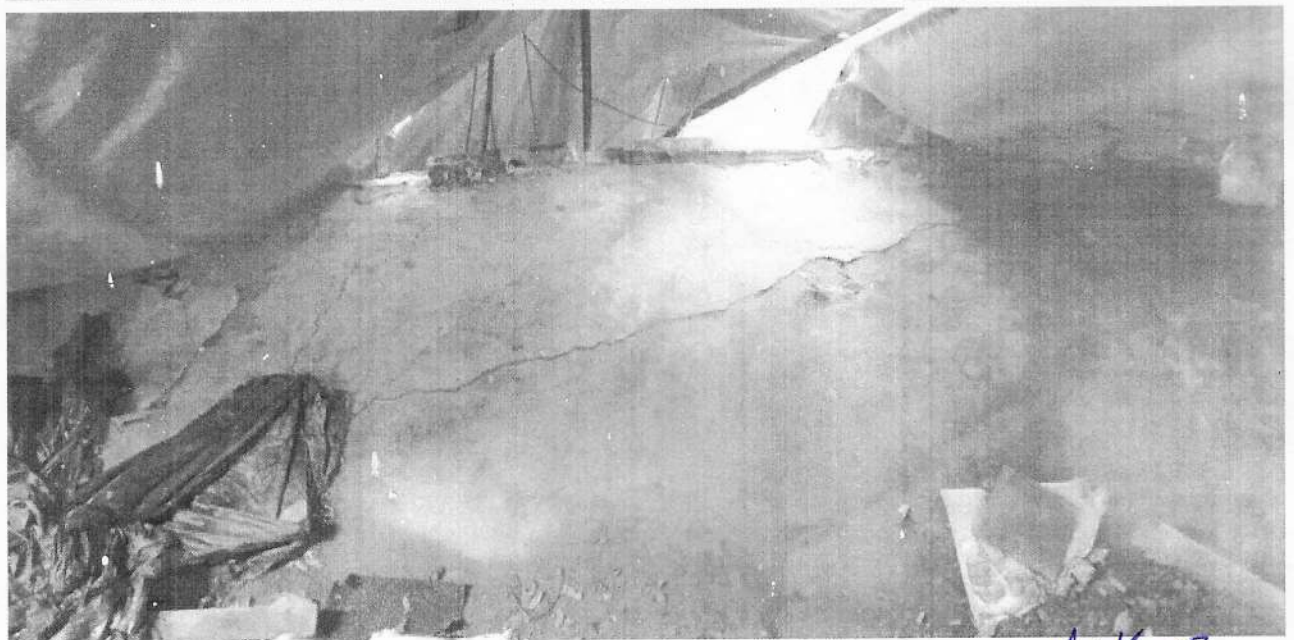
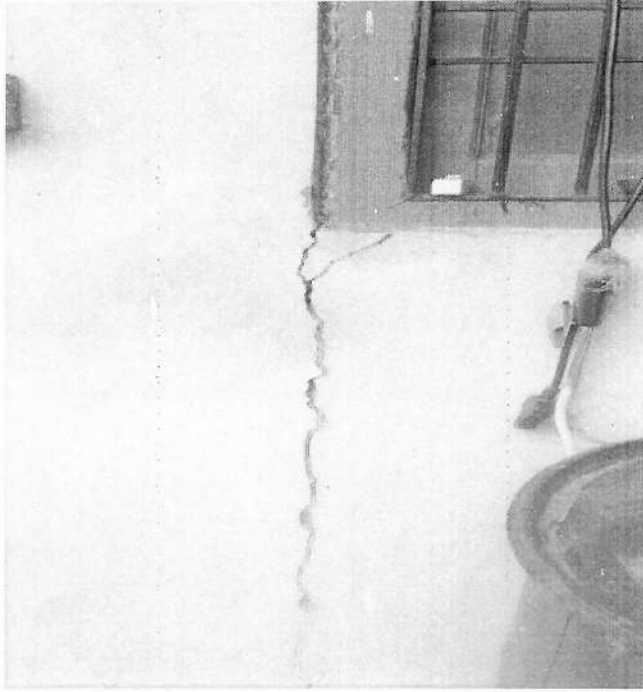
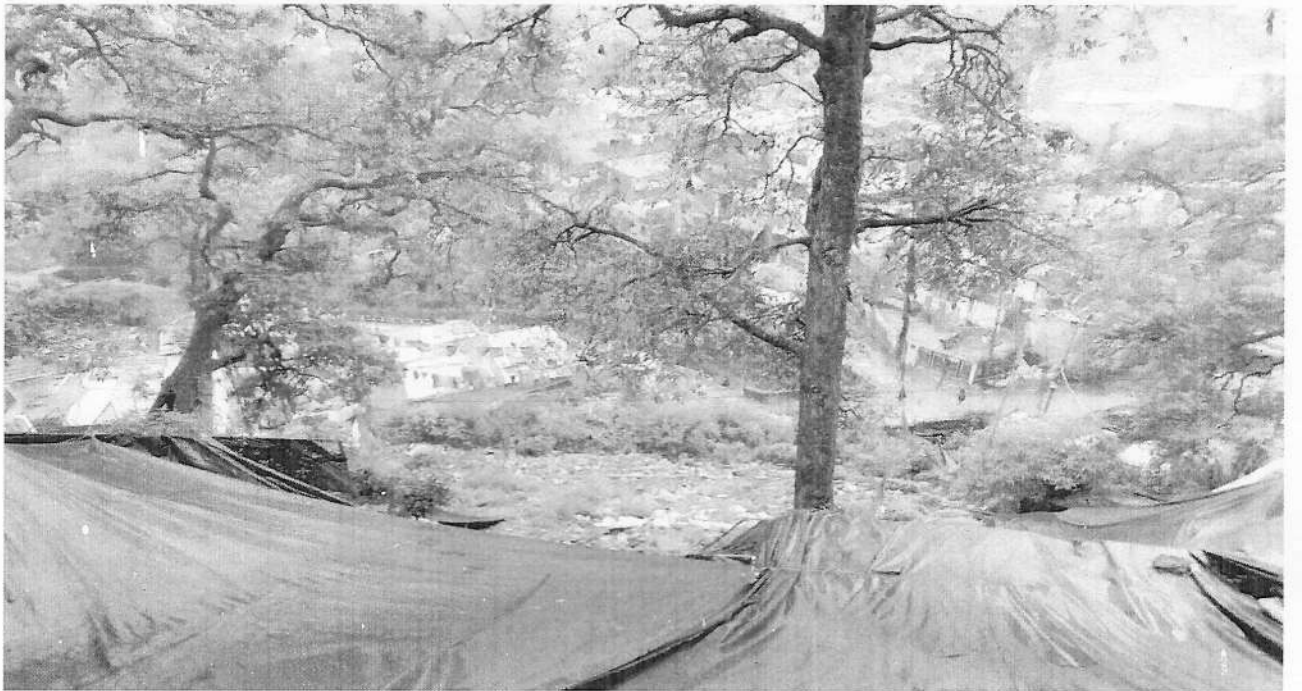
1. वन विभाग के अधिकारियों द्वारा अवगत कराया गया कि जुलाई, 2023 को भारी वर्षा के कारण चार्टन लॉज में भू-स्खलन की स्थिति उत्पन्न हुई।
2. भूस्खलन की चौड़ाई लगभग 25 से 30 मी० और ऊँचाई 12 से 15 मी० पाई गई।
3. भूस्खलन से एक मकान पूर्ण रूप से क्षतिग्रस्त पाया गया।
4. वर्तमान में भूस्खलन स्थल के ऊपर लगभग 8 से 9 भवनों को भूस्खलन के कारण खतरा बना हुआ है। भवनों में दरारें भी पायी गई।
5. वन विभाग के अधिकारियों द्वारा अवगत कराया गया कि भू-स्खलन के कारण सम्भावित खतरे के दृष्टिगत 12 से 13 परिवारों की सुरक्षा हेतु उनके आवासीय भवनों को खाली करा लिया गया है तथा सभी परिवारों को सुरक्षित स्थानों पर पहुँचा दिया गया है।
6. चार्टन लॉज में अस्थायी उपायों के लिये भूस्खलन प्रभावित क्षेत्र को तिरपाल तथा मिट्टी से भरे गनी बैगों का उपयोग किया गया है।

1. प्रथम दृष्टया भूस्खलन प्रभावित क्षेत्र में माइक्रो पाईल द्वारा उपचार किया जाना उचित प्रतीत होता है।
2. उचित न्यूनीकरण के उपायों के लिये विस्तृत भूगर्भीय, भू-तकनीकी और भू-भौतिकीय सर्वेक्षण कराने की आवश्यकता है।
3. यू०एल०एम०एम०सी० द्वारा पूरे नैनीताल शहर में विस्तृत स्थलाकृतिक सर्वेक्षण, ढलान स्थिरता विश्लेषण, भूगर्भीय, भू-तकनीकी और भू-भौतिकीय सर्वेक्षण कराने हेतु सहमति पत्र की प्रक्रिया गतिमान है, जिस पर मानसून अवधि के पश्चात कार्य आरम्भ करा लिया जायेगा।

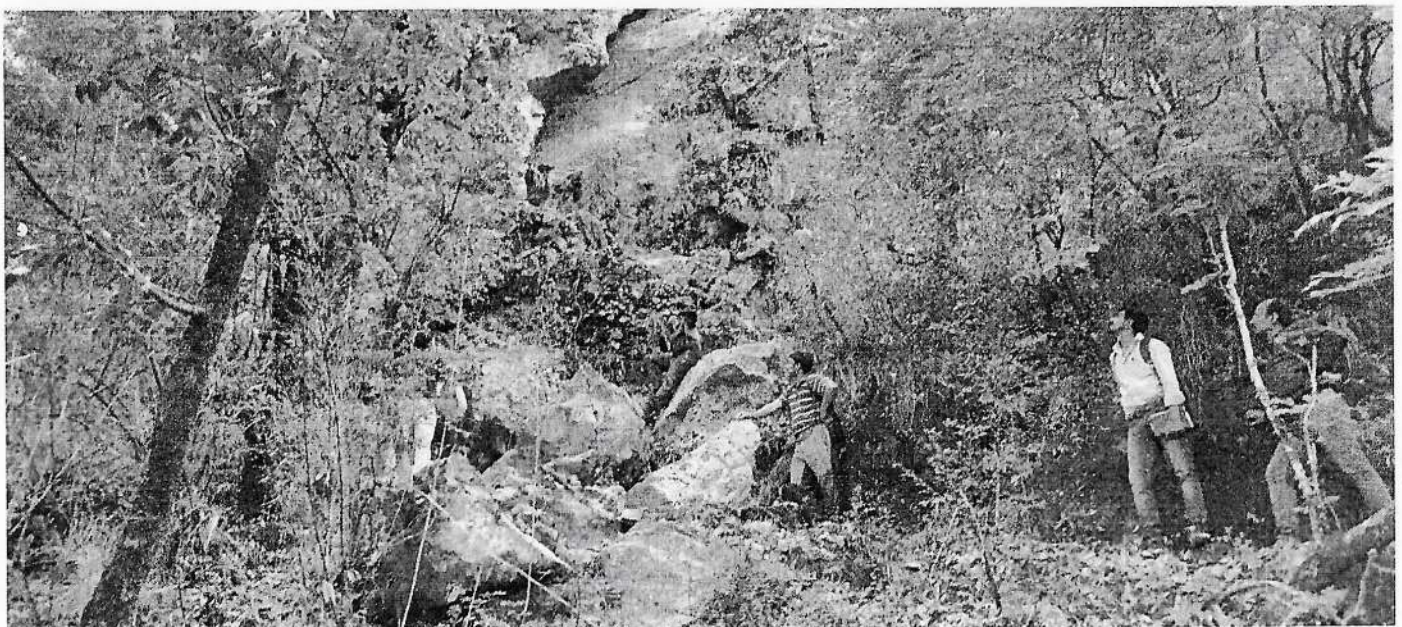
Figure1. visiting team member with local person (shopkeeper)

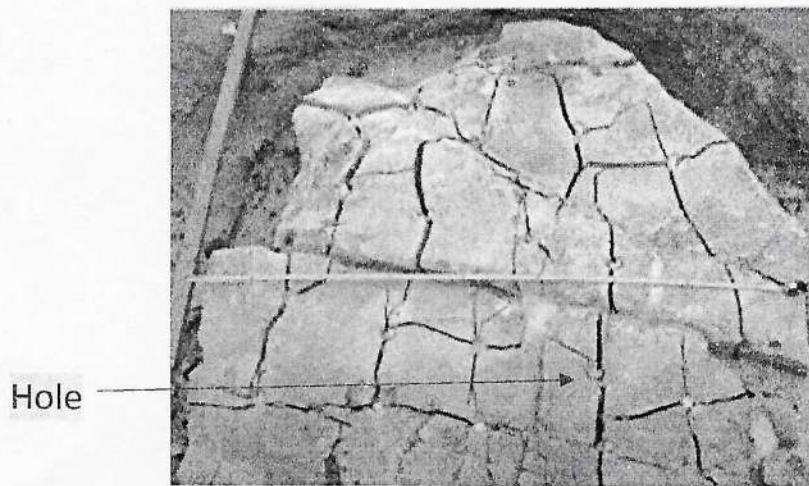
Figure 11. Breck unstable rock using drilling and crack making powder.

Best possible solution is that, to remove unstable rock by drilling a hole shorter pitch and filled crack making powder, when the crack has been developed on surface. then remove the cracked portion from mass, and safely dispose. Ref.Fig.4

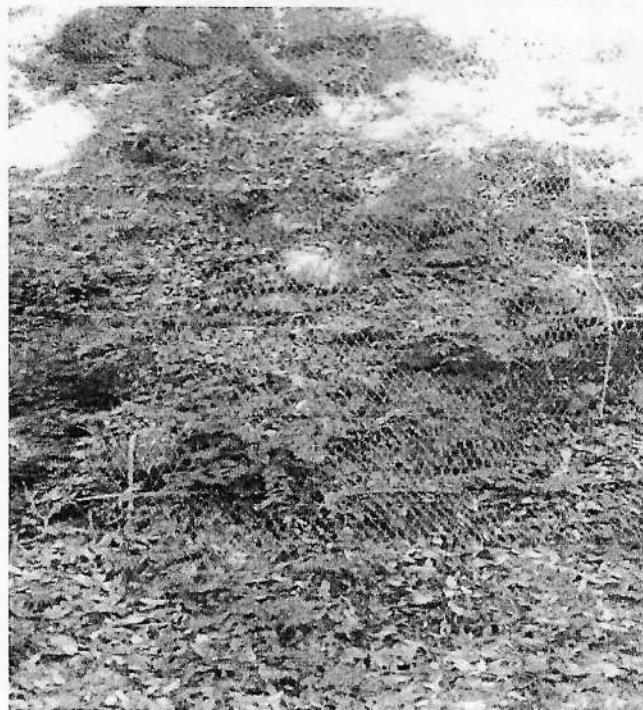
Figure 12 GI wire net in less vegetation area

For reduction the soil movement in small area, where the vegetation is very less in old land slide area for that fix G.I. wire net with G.I. anchor pin 10 to 20 cm long. Tightly fix along the existing topography no reshaping is required. (Ref fig.12)

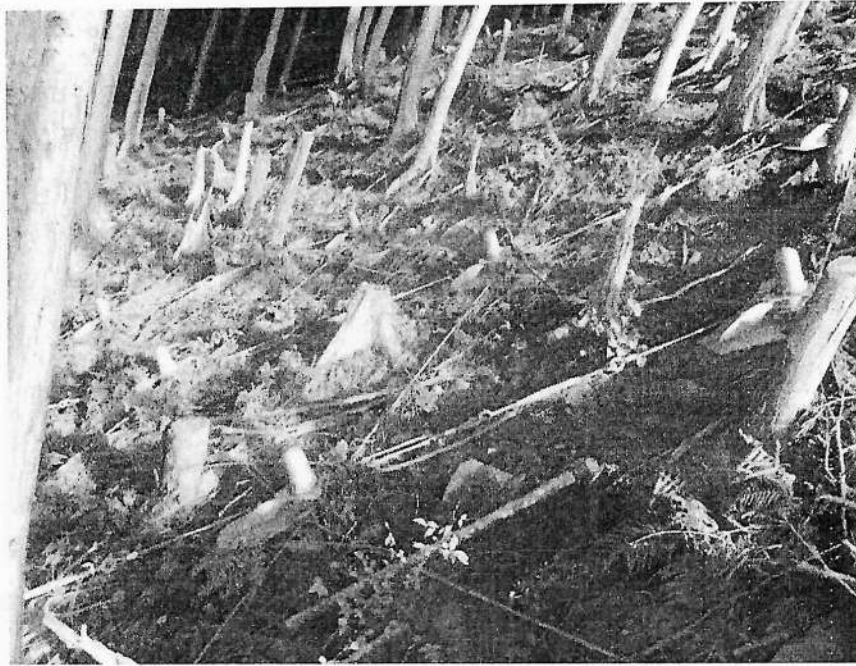
Figure 13 GI wire net in less vegetation area

If soil mass movement in dense forest area. On that area installed anchor bar by drilling and hitting method, depth up to 1 to 2 meters with spacing 1.0-to-1.20-meter centre to centre and supported by anchor cap with pressure plate. each anchor connects with wire than apply the design tension on it. (Ref.Fig.13)

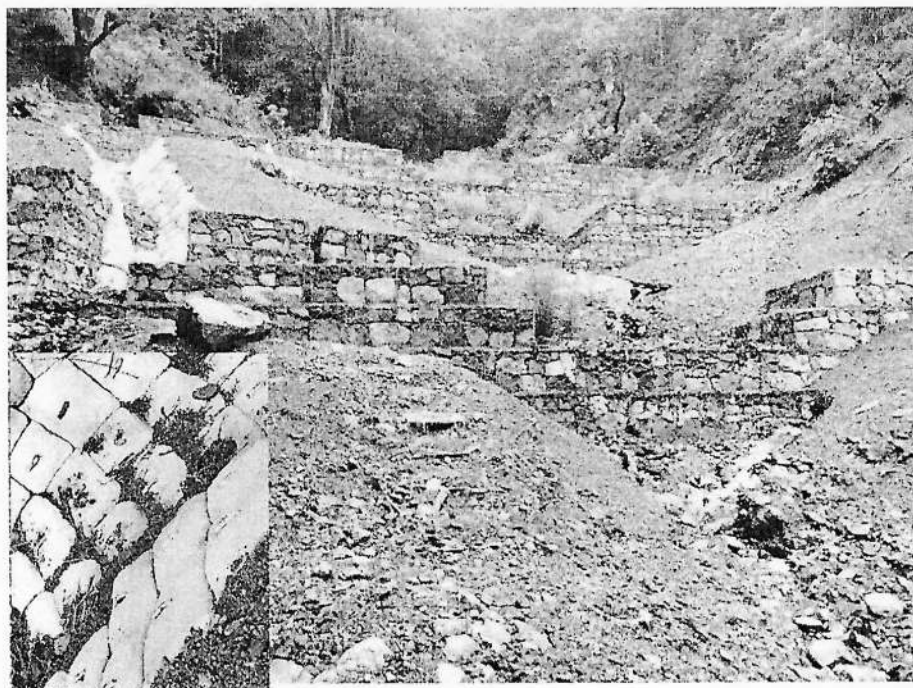
Figure14. gabion networking with Geo bag channel filled with local soil.

Some places installed gabion wall with networking in suggestive place of slope for safe disposal of rainwater by bio friendly channel also can planned in area (old land slide area). Fig.14

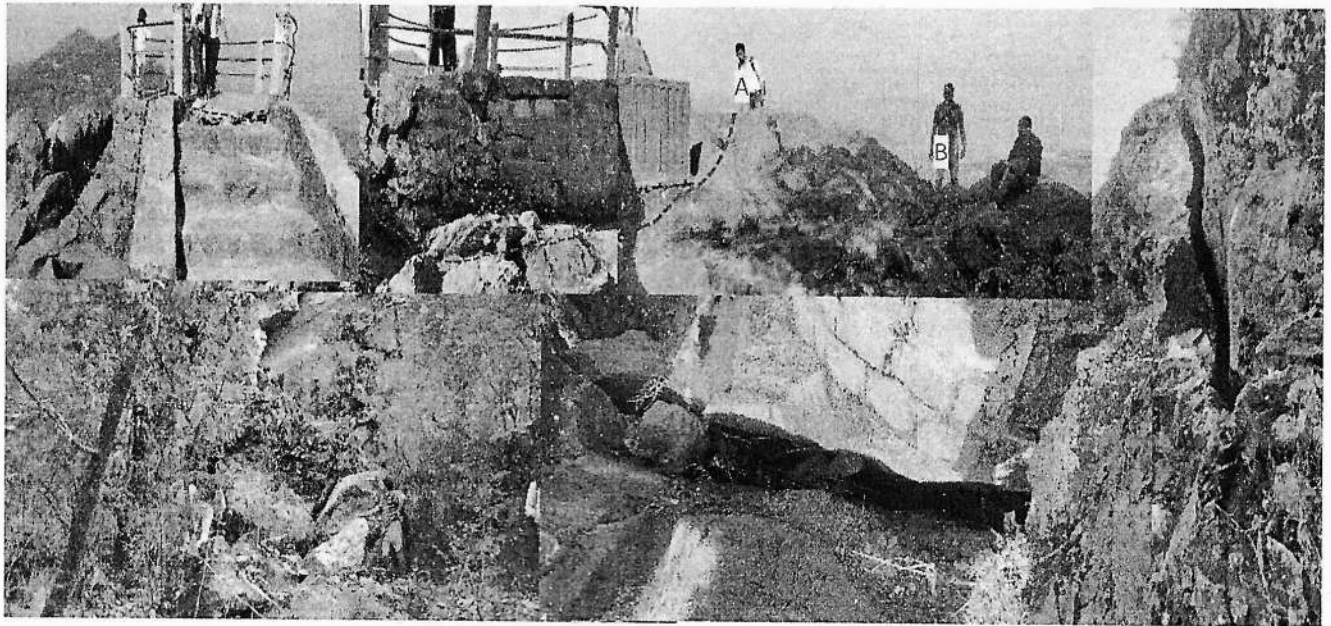
on investigation, it was found that there many open joints on vertical cliff on hill slope, in which gap of crack A marked on is more than ($>$) 30 cm crack B along with its gradually increases. (Ref. fig.4)

Mainly crack, A part has separated from hill slope while Crack B part still in its early stage.

Figure.7 investigation of open joint alignment on tiffin to hard strata

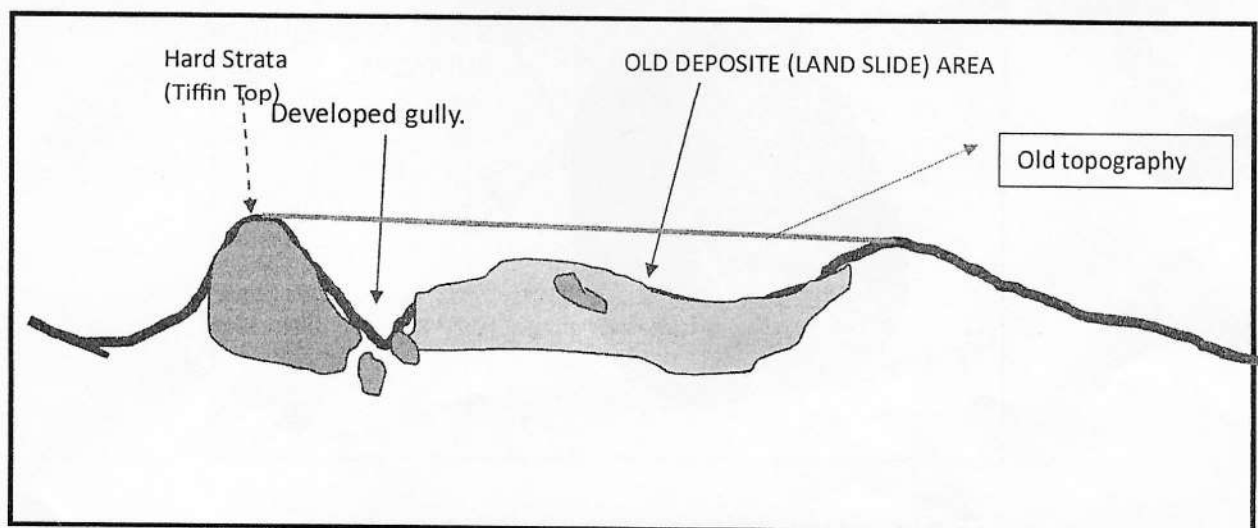
It is understood from the field observation that the Tiffin Top slope is an old landslide. There may be a possibility that when the landslide occurred in the past, the hard strata remained vertical, and the soil mass settled down forming a gully through which run-off is continuing. (Ref.fig.8)

Figure 8 Typical cross section of old landslide area A-A (ref. fig.4)

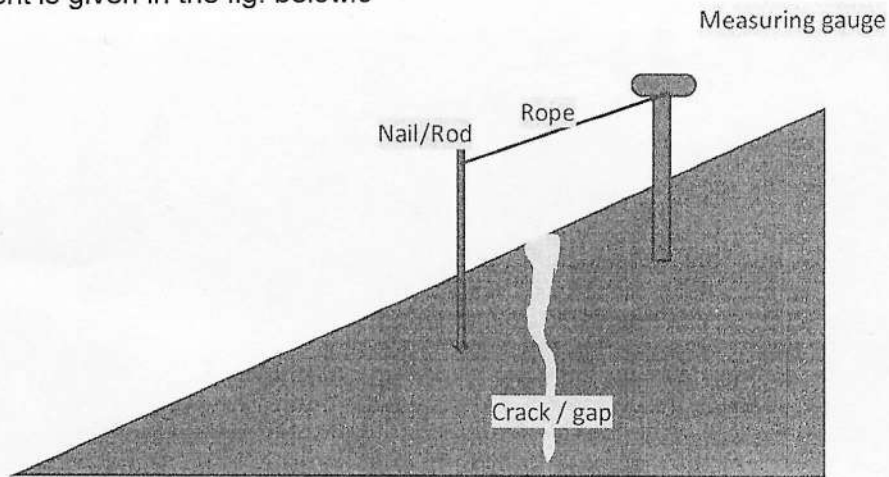
Figure.9 Gap/ Crack Measuring Instrument

Detailed topographical, geological, geophysical and geotechnical investigation has to be conducted to arrive at the desired mitigation measure to control the sliding and rock fall activities. Crack measuring instruments may be installed at different locations, so that periodic observation data can be collected to obtain the enlargement of cacks. A schematic diagram for crack measurement is given in the fig. below.9

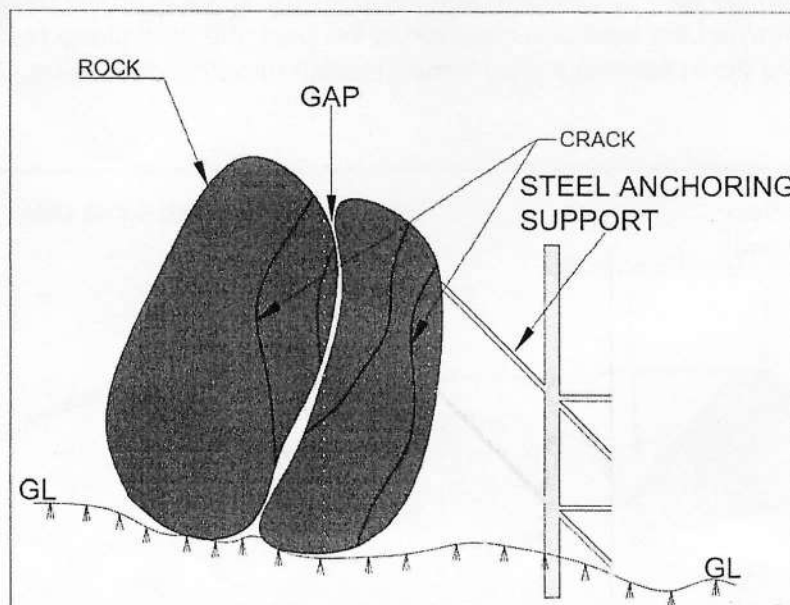
Figure10 supporting arrangement during monitoring.

short term countermeasure to support detached hill part by mechanically. i.e. anchor supporting on it and observe. Movement. Ref. Fig.3

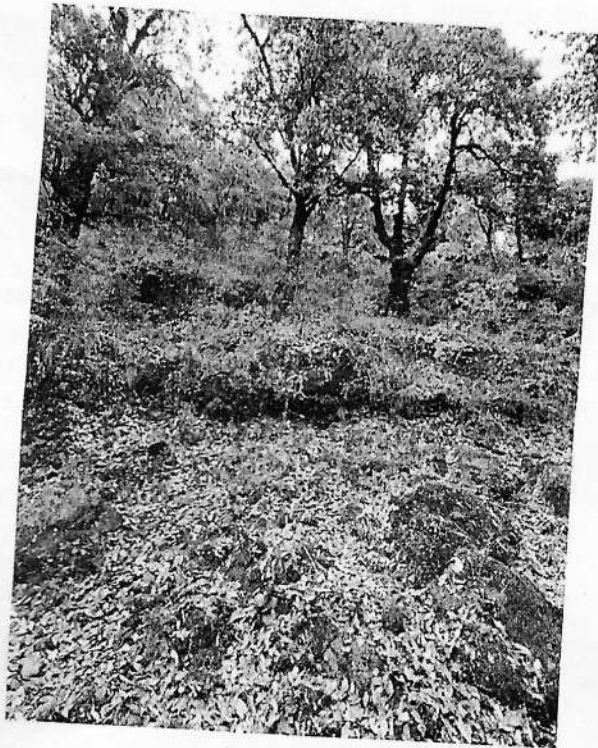
Based on available data observation, site investigation is started on 17/05/2023 and checked crack on old land slide deposit area that is clearly visible on track route. (fig.5.) the same condition has been found on top deposit area. (fig.6)

it might be possibility, in rainy season deposit area has some settlement.

Figure 5. crack on track route of tiffin top

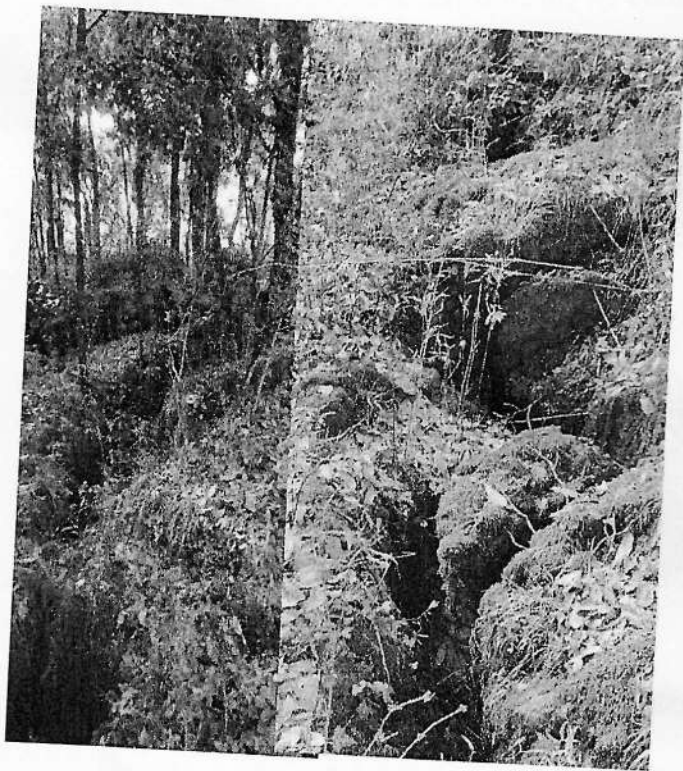
Figure 6. crack on Top deposit area

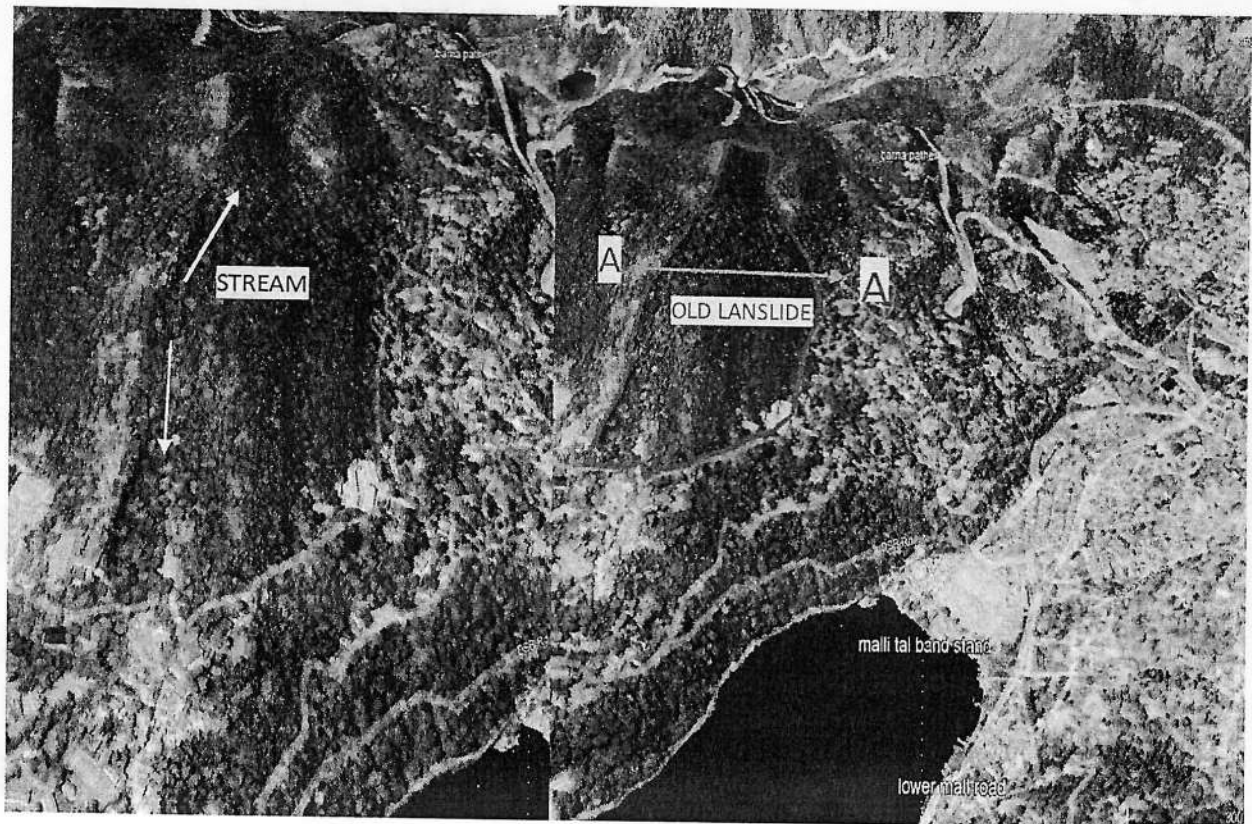
After detailed study of available document, it appears that this area is very old landslide. fig.4 (right side). it might be possibility, due to road and other construction hill slope will unstable, and continuous excessive rain and geological reaction the soil movement would be increasing in that area and crack is developed in old deposit area.

it also appears, after land slide topography was changed from tiffin top point stream has been created due to water flow from high altitude to low altitude on old landslide area. Ref fig.4 (left side)

Figure.4 Ridge line of slope left side; right side old landslide.

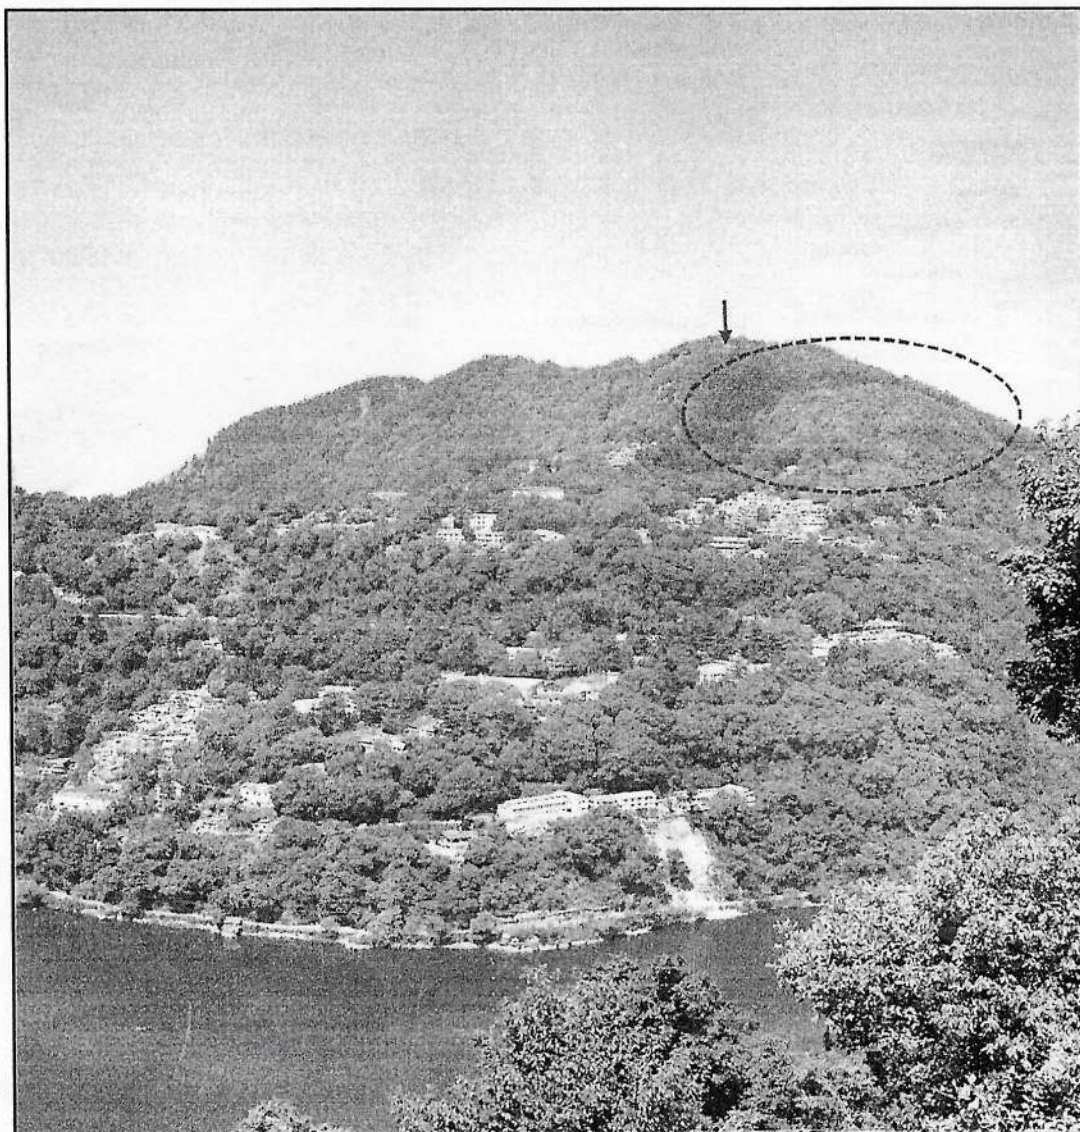
The area divided in to two-part one vertical cliff (ref fig. arrow 2) geo. reference location is 29°23'0.23"N, 79°27'2.06"E and second is old land slide (ref fig.2 circle) which is bounded with latitude 29°23'0.23"N, 29°23'0.45"N, 29°23'10.15"N, 29°23'12.24"N, 29°23'6.61"N longitude 79°27'2.06"E 79°27'14.57"E, 79°27'8.93"E, 79°26'58.07"E, 79°26'51.12"E. the tiffin top situated at western end of Naini lake at a distance of 4 Km from Nainital bus stand. this area completely covered by forest which comes under the Nagar Palika Range. just because well forest cover landslide activity happening at a very slow pace.

Figure .2. (Front view of Tiffin Top red circle is old landslide and arrow shows vertical cliff)
