Preliminary Field Investigations of landslides at Toli and Tingad villages, Tehri District, UTTARAKHAND

UTTARAKHAND
LANDSLIDE MITIGATION
AND MANAGEMENT
CENTER (ULMMC)

8/14/2024

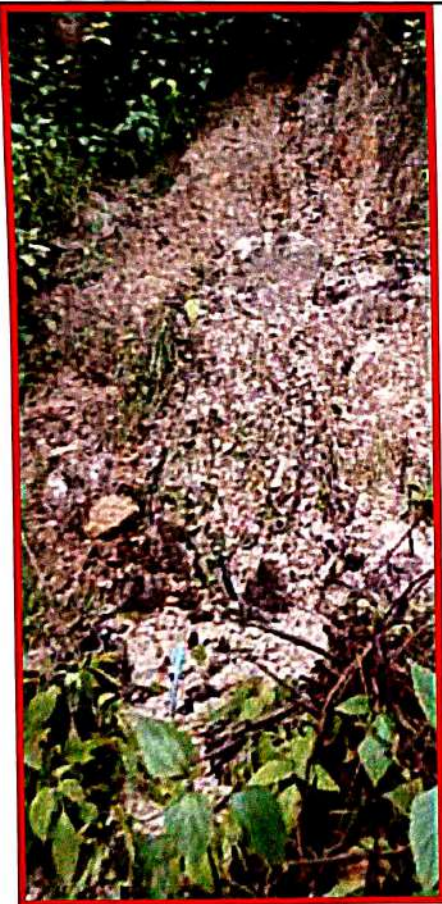
Figure 2 exhibits presence of shear zone just before Tingad village on roadside

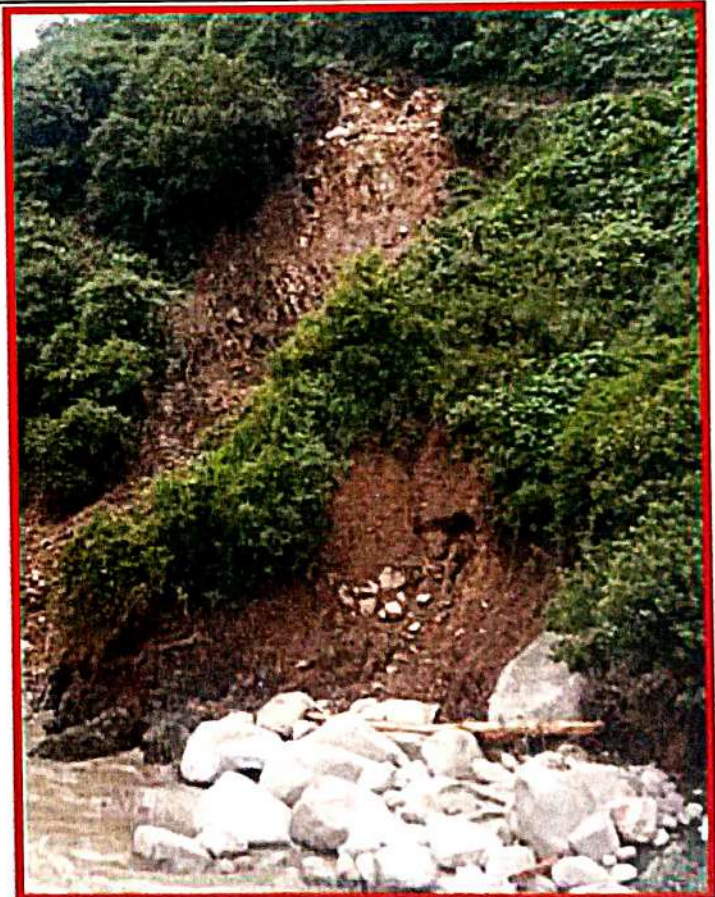
Figure 3 shows the exposure of sheared metabasics at base of hill and toe cutting by river Balganga below Toli vill

In several locations along the new road cutting approaching Jakhana Village, cataclastic rocks is observed (Fig 5), accompanied by the development of multiple landslide scarps. Just below Toli village, along the riverside, sheared and weathered metabasics are exposed, displaying evidence of toe cutting and erosion caused by river water. The absence of metabasics bands on the opposite side of the river suggests the presence of a fault or thrust. Further evidence of faulting is indicated by the change in the dip direction of the sheared and crushed rock outcrops on both sides of the river.

Flood protection walls are necessary on both sides of the river near Toli and Tingad villages. Alongside this, the bridge abutments in the vicinity should be repaired to prevent further structural deterioration.

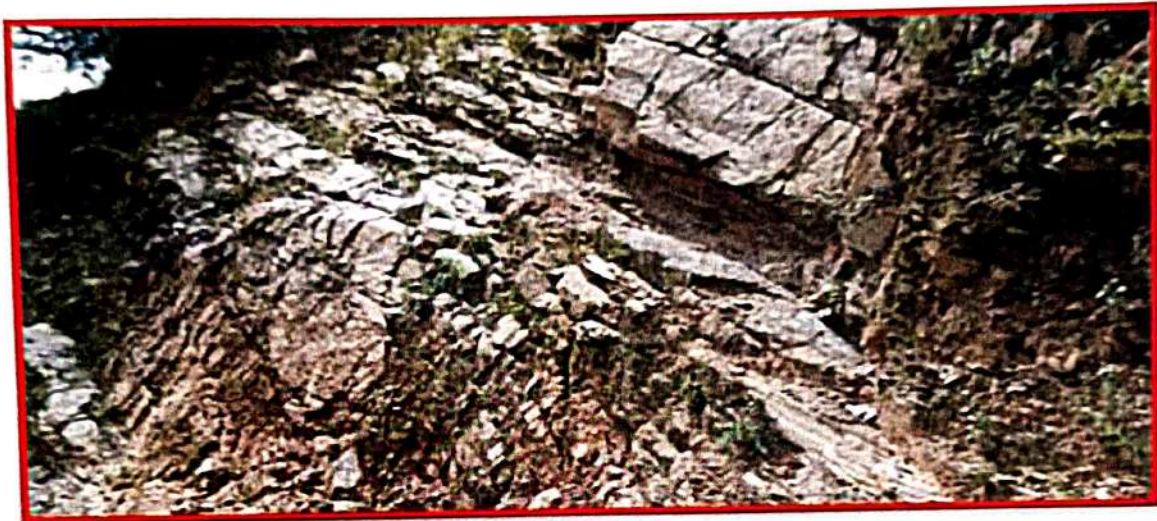
The predominant rock types exposed in the area are coarse-grained biotite granitic gneiss and granite with bands of metabasites. The granitic gneiss outcrop is prominently exposed above Toli village along the new road cut, where the rocks dipping towards North with a dip amount of 40° (Figure 4) . In contrast, to the east of Tingad Village, a vertical outcrop of sheared granite is observed, along with evidence of recumbent folding

Figure 4 . An outcrop of dipping Granitic Gneiss exposed at new road cutting above Toli

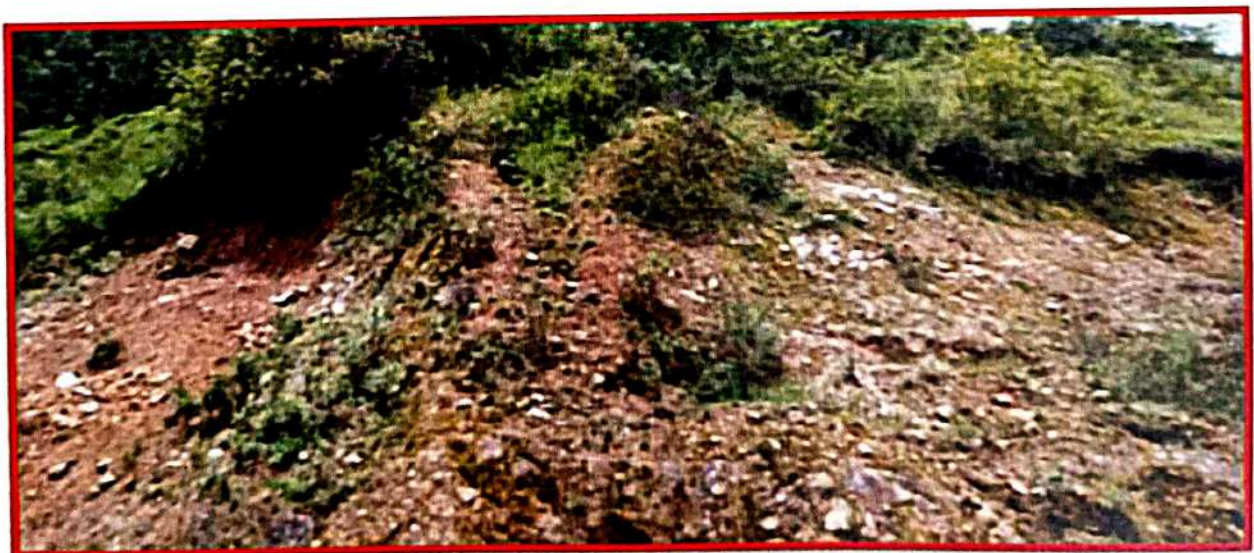
Figure 5 exhibit the presence of fractured and cataclastic rocks

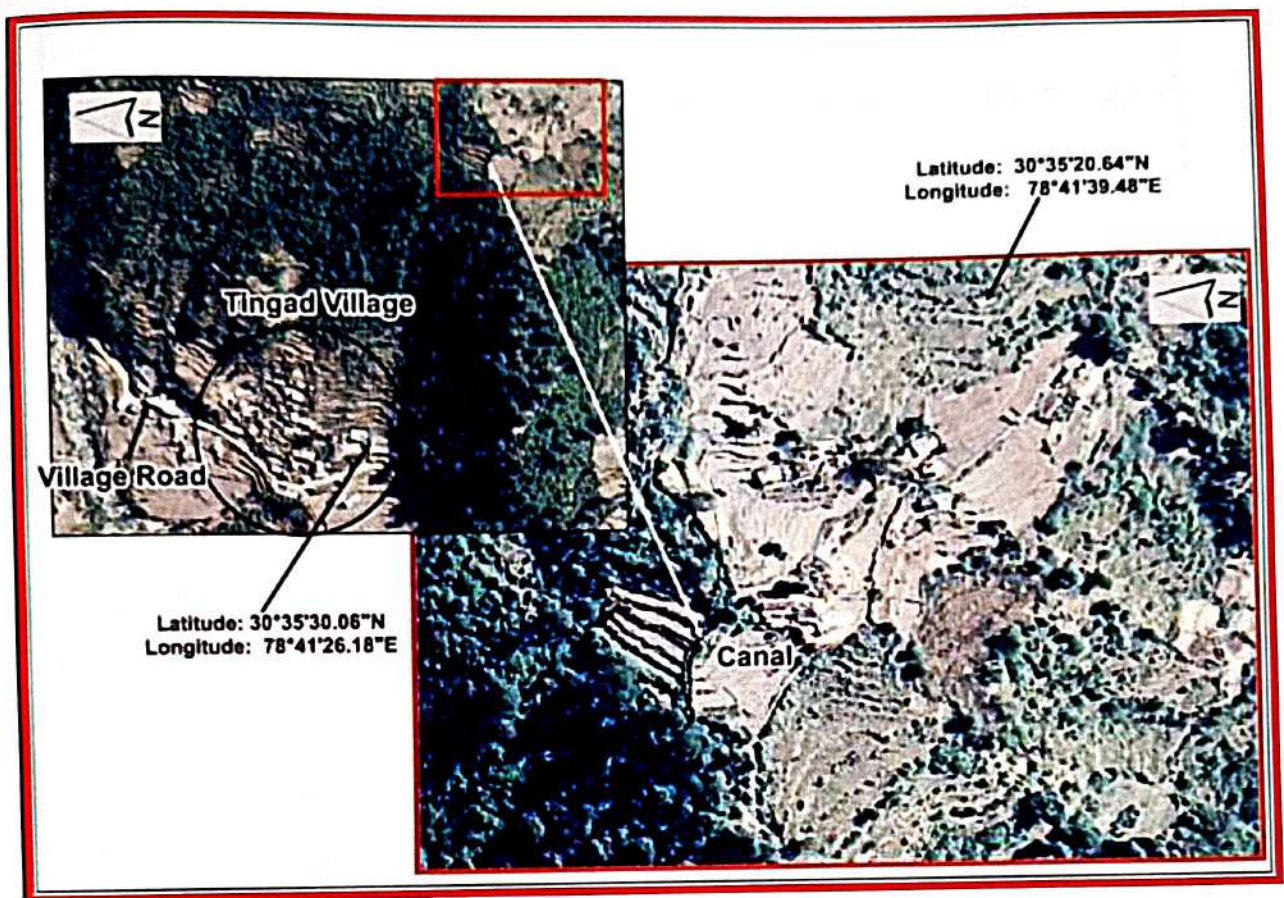
Geomorphologically, the area around Tingad village exhibits a gentle slope near the ridge, where a canal is observed on satellite imagery or Google Maps, running towards the periphery of the hill near the village of Bachdobha. The canal's alignment just above Tingad Village is difficult to track due to the thick vegetation covering the area. The slope above Tingad village becomes steep, followed by flatter lands at the base of the hill, which are used for agricultural purposes. The Balganga River is situated at a considerable distance from the settlement. In contrast, the terrain around Toli Village is characterized by a moderately steep hill with no distinct slope break.

Figure 6 : Location of Canal above Tingad Village

An inspection of the canal above Tingad village is required to check for any signs of seepage. If seepage is detected, immediate repair is recommended. Additionally, it is crucial to ensure that water does not infiltrate the slope direction towards Toli village settlement. Personnel involved in the inspection and repair must exercise caution and avoid entering any areas that show signs of being affected.

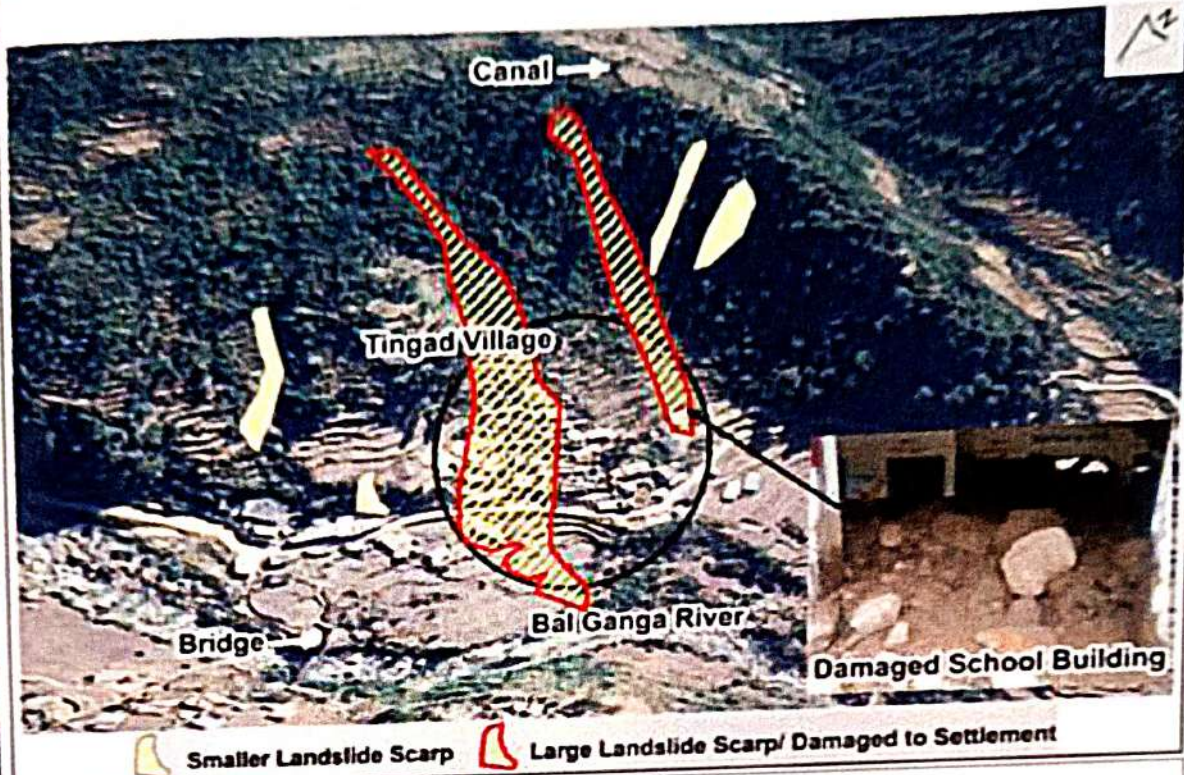
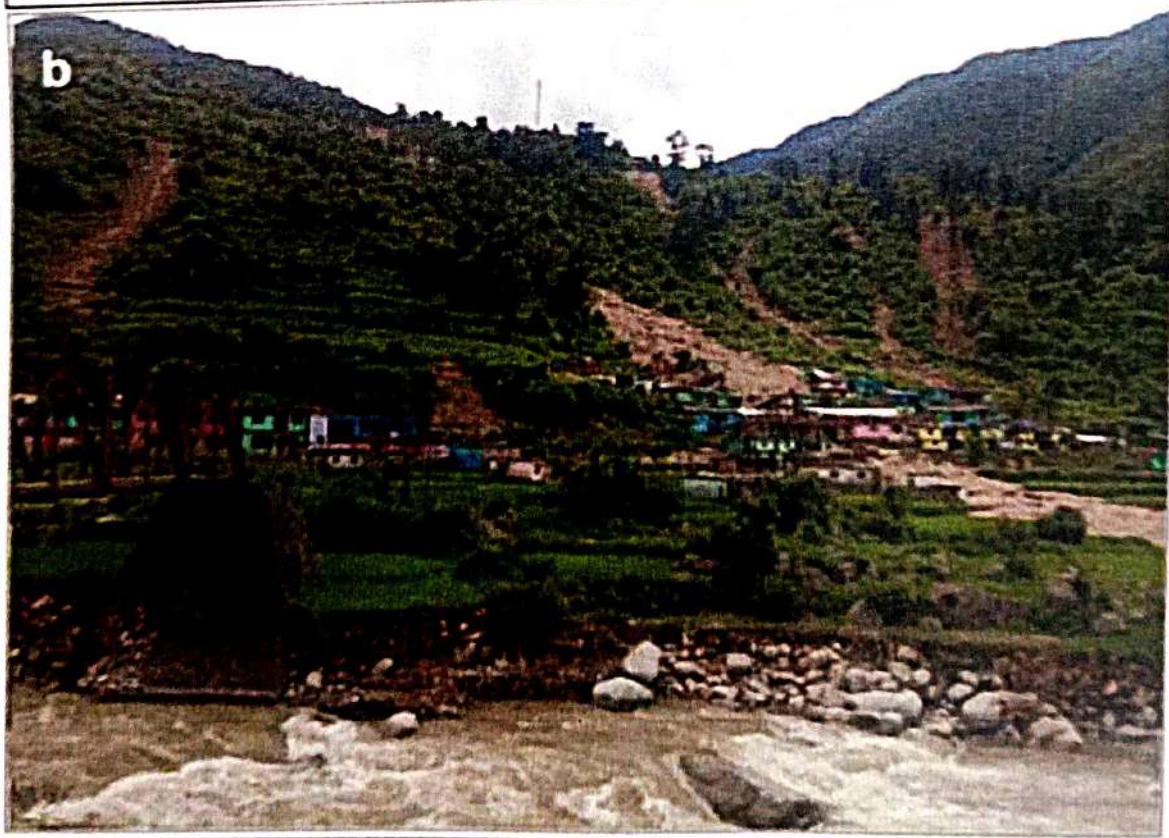
TINGAD VILLAGE: At Tingad Village, six scarps were formed where hillslope soil and sediment were stripped away by debris flows on the afternoon of July 28, 2024, following heavy rainfall. The debris flows were relatively shallow and occurred in two major events spaced one hour apart.

The first debris flow originated at an elevation of 1780 meters, traveled approximately 120 meters, and deposited sediment and debris at a primary school. The school premises sustained

Figure 7: Six Landslide scarps developed at Tingad Village

significant damage due to the deposition of a highly saturated clay-sand mixture containing large boulders of granite and granitic gneiss. Continuous water flow from the scarp suggests either oversaturation of the ground or seepage at some point. The volume of the debris from this event is estimated to be around 1500 cubic meters.

Tingad village has been observed to have multiple scarps, two of which have caused damage to the settlement area. To protect the village, it is recommended to install debris barriers at various elevations. Additionally, flow paths for debris should be channelized to direct potential landslide material away from populated areas.

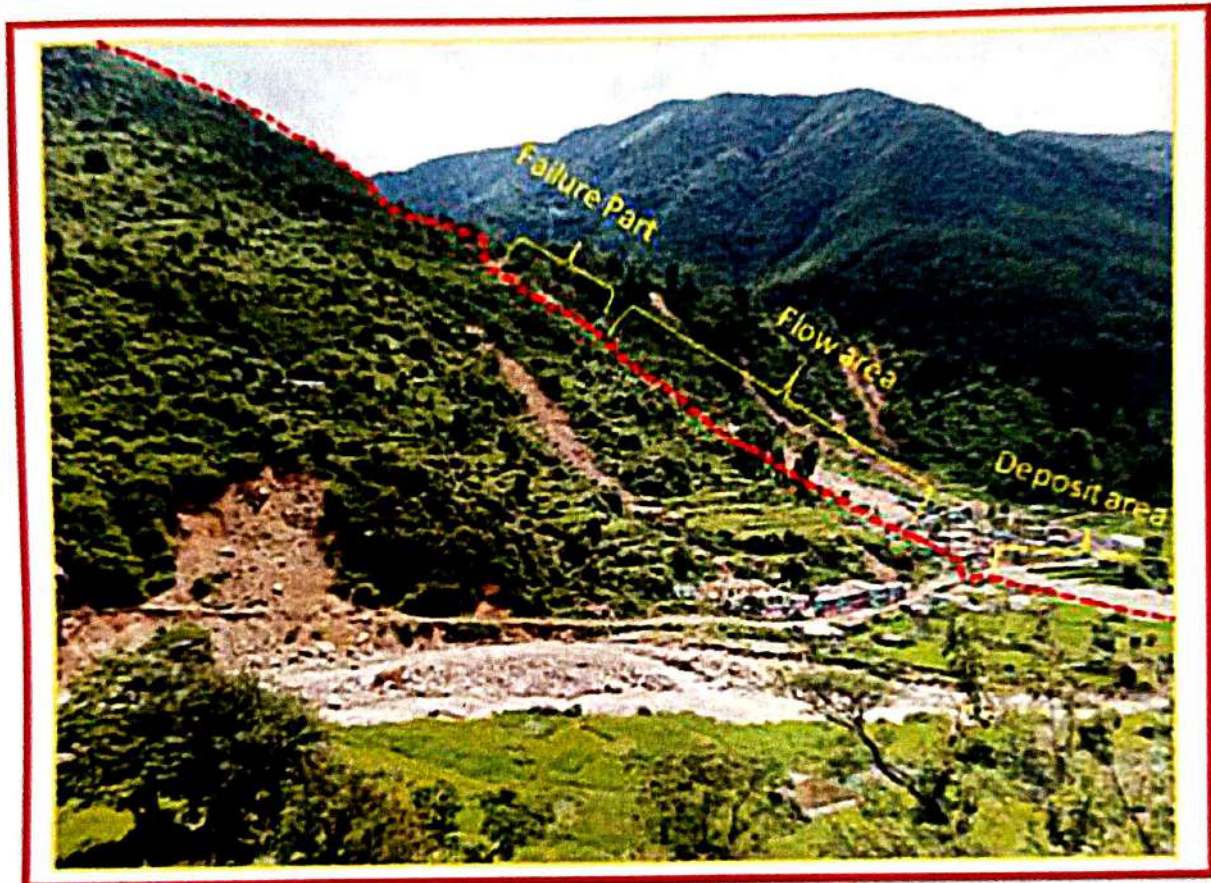
Figure 8 marks the area of failure, Flow and Deposition of debris

agricultural lands. The estimated volume of debris deposited in the main settlement is approximately 3000 cubic meters, with large boulders included in the deposition (Fig 8). Similar to the first scarp, continuous water flow was observed through a narrow channel within the landslide-affected area. Satellite imagery reveals the presence of a canal, locally known as the "Basa Canal," located at the top of the hill.

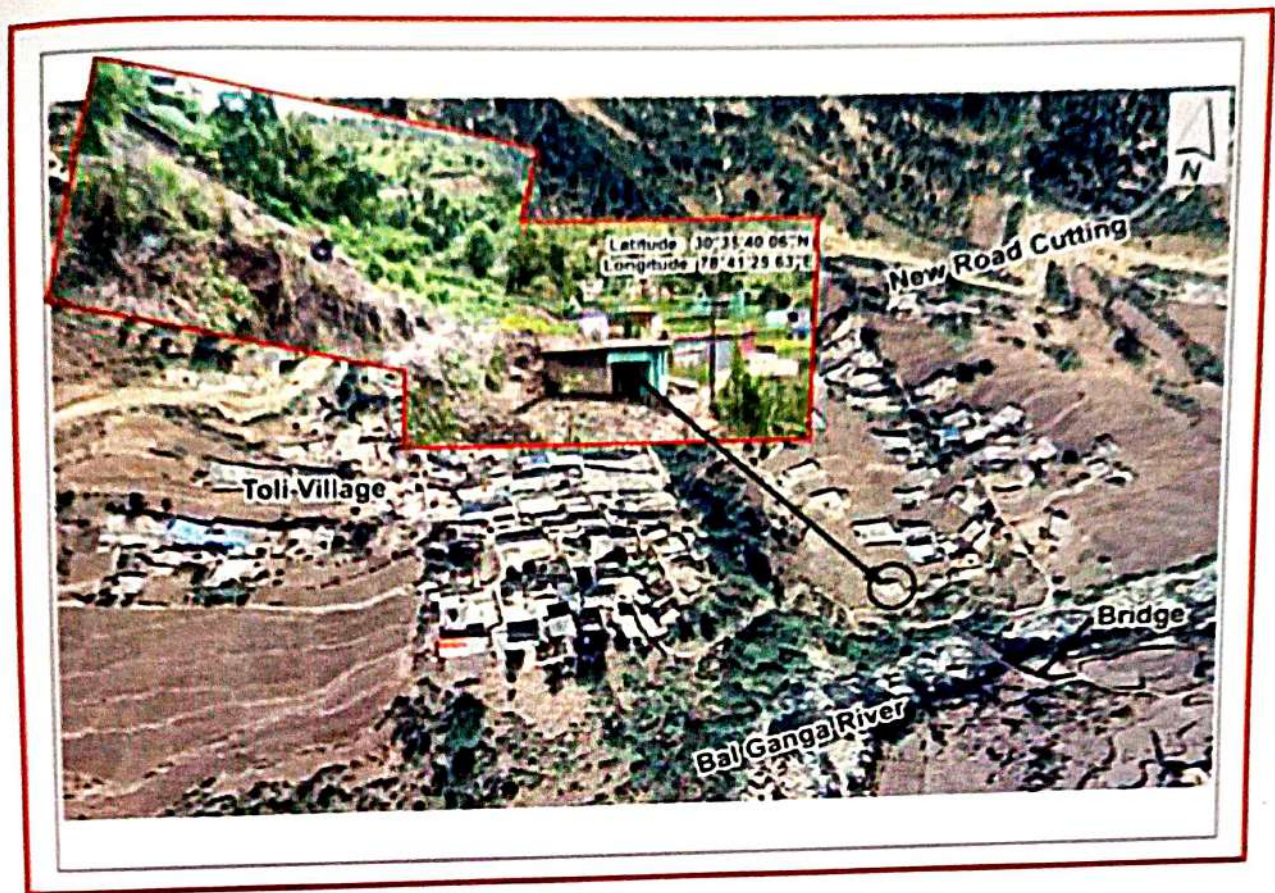
Figure 9 : Location of damaged house of Toli Village above which small scale andslip occurred

A small-scale debris slide occurred at approximately 2:30 AM on July 27, 2024, in Toli Village. The debris slid towards a house, damaging the back wall and tragically burying two individuals, while one person was injured (Fig 9). No other issues related to subsidence, poor drainage networking, or seepage were observed in Toli Village, and no new scarps were identified near the settlement, except for gully erosion observed on the right side of the metalled bridge.

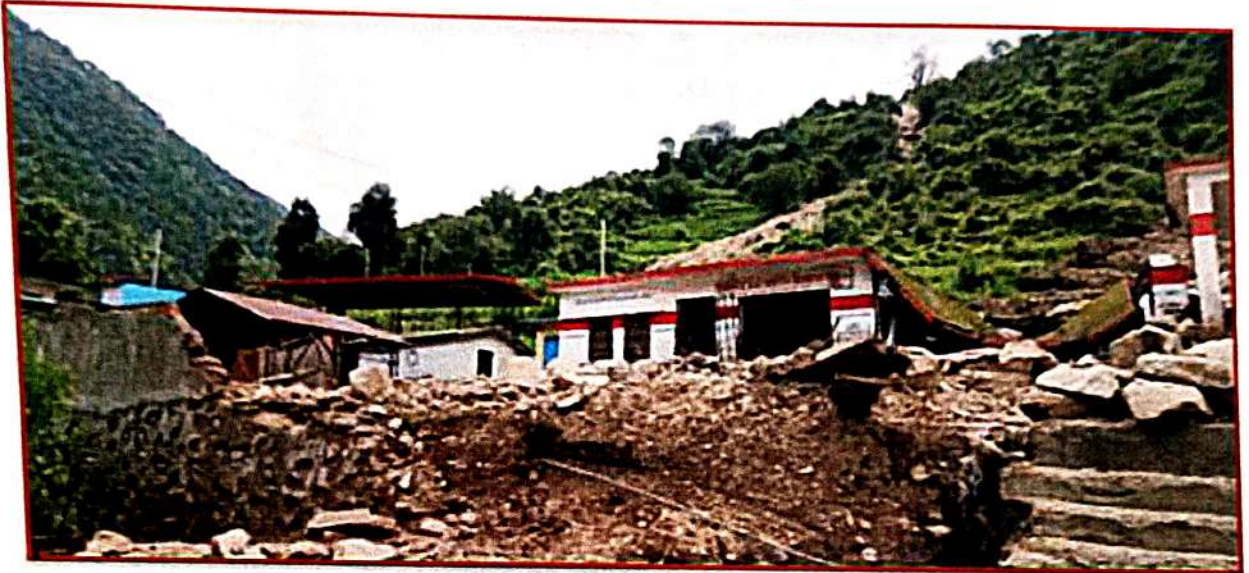
- The landslide in Tingad Village caused severe damage to the primary school, where the walls of the school building were broken, and debris consisting of mud, sand, and large granite boulders settled on the school premises. (figure below)

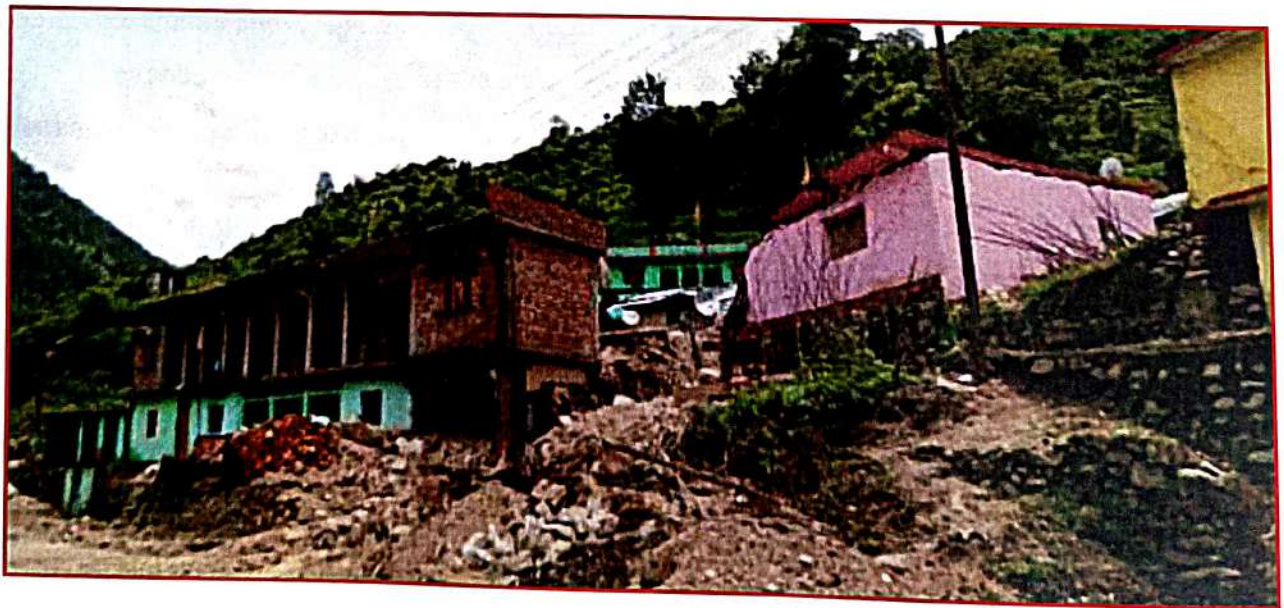
- To the right of this scarp, another landslide occurred, severely affecting several houses belonging to 68 families. (Figure below) The debris from this slide settled on the flat agricultural land below.

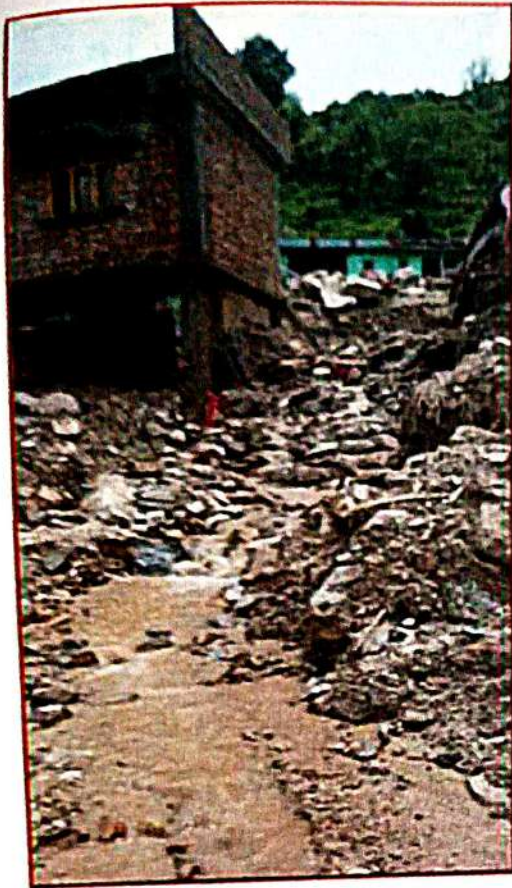
Water flowing from the Landslide Scarp towards the Settlement

- The landslide debris remains fully saturated, and continuous water flow has been observed. (figure above)
- The right abutment of a bridge in the area was damaged, though this damage is unrelated to the landslide activity and was instead caused by side cutting from river water.

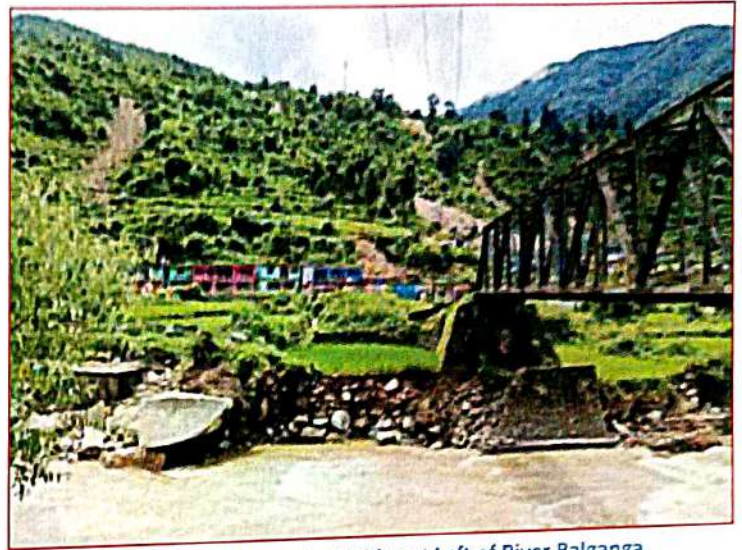
Damaged abutment of Bridge at Left of River Balganga

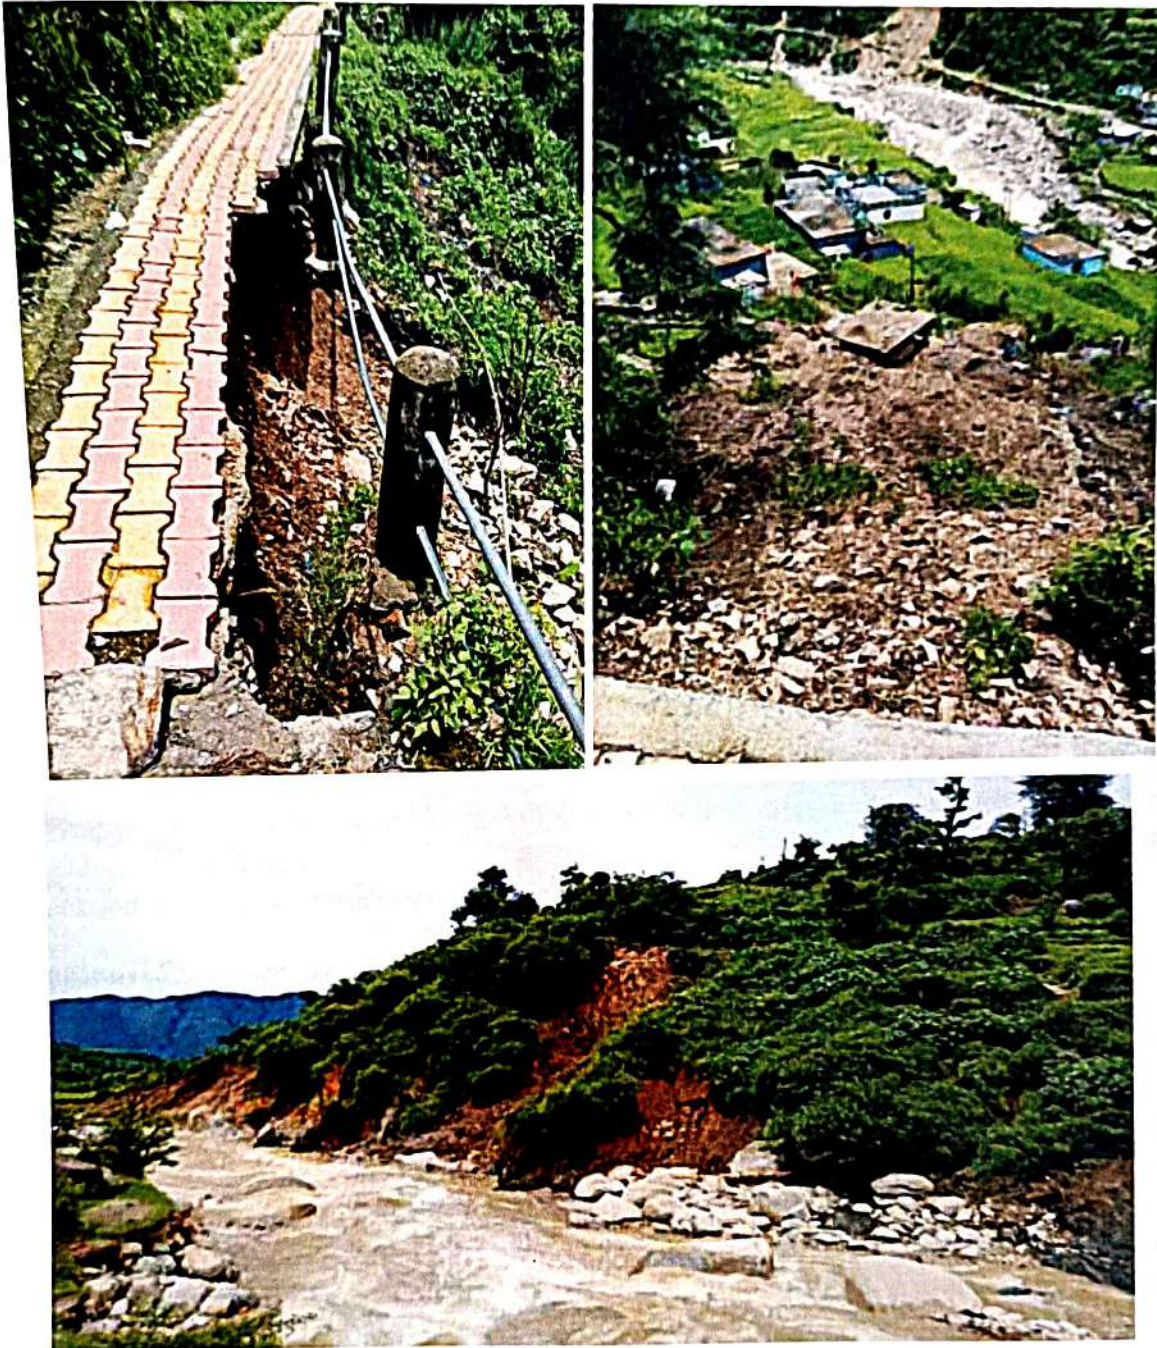
- A house is damaged with reporting of two persons dead and one injured.
- Toe cutting is observed just below Toli village in the vicinity of Balganga river

Crown of landslide scarp , buried house and Toe cutting at Toli village

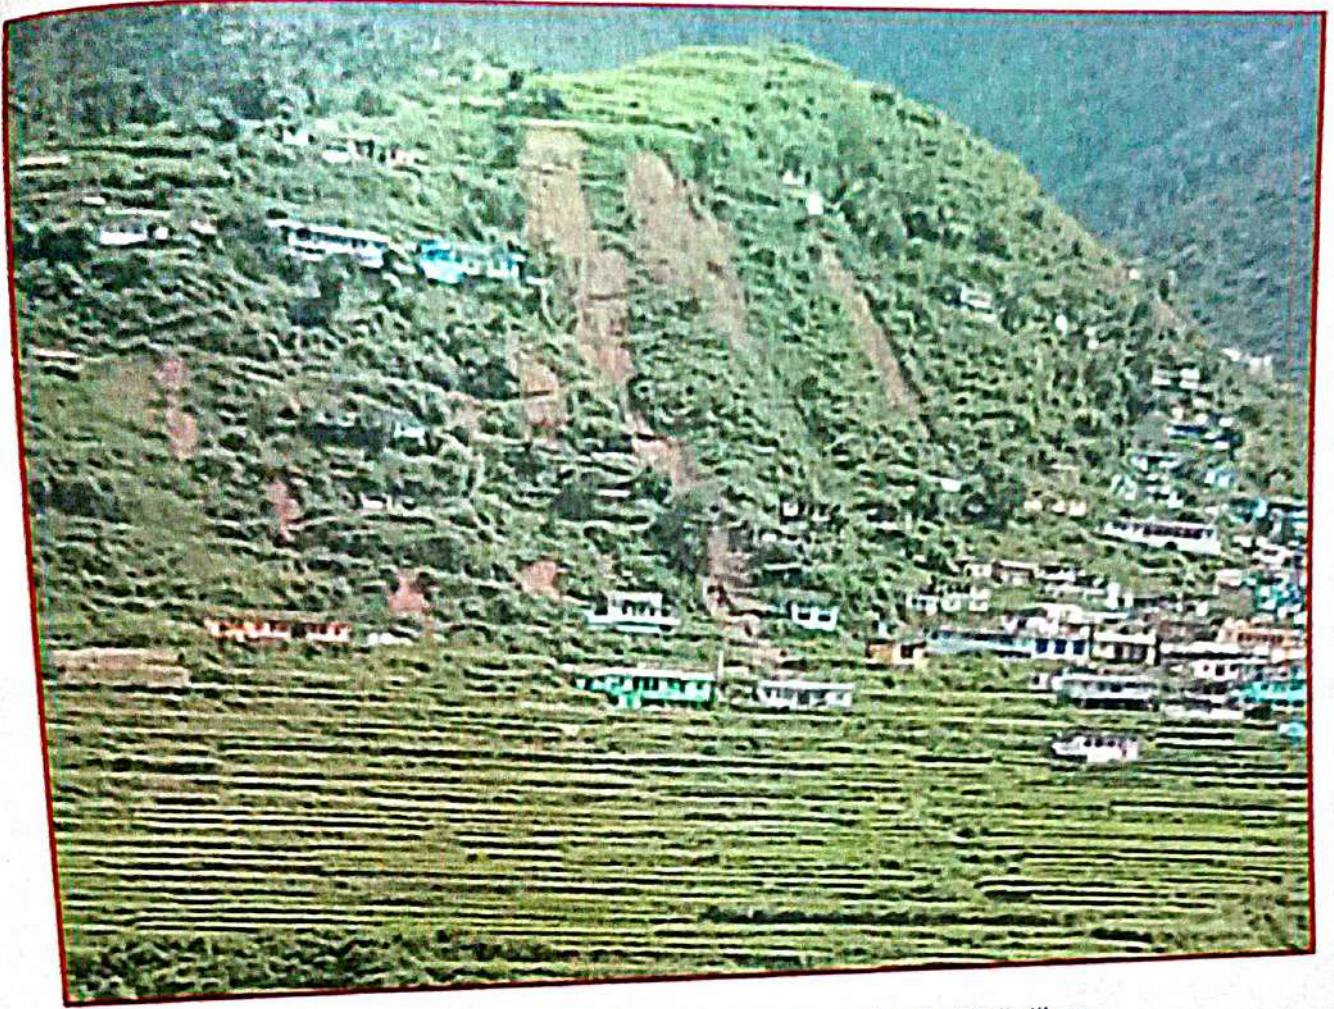
The Kot village located to the west of Toli village, has recently developed three new scarps. This area has a history of landslide-related fatalities, with three deaths recorded during 2018 and collapsed of several houses. The new scarps indicate that the area is under significant stress and requires immediate attention. In addition to this, area around Bhikun village is also showing earlier sign of instability in form of road cracks, subsidence and development of new scarps and require attention. Mitigation measures including landslide prevention strategies along with early warning system should be implemented promptly to ensure the safety of the residents at critical sites.

Three new scarps developed at Kot village, located west of Toli village

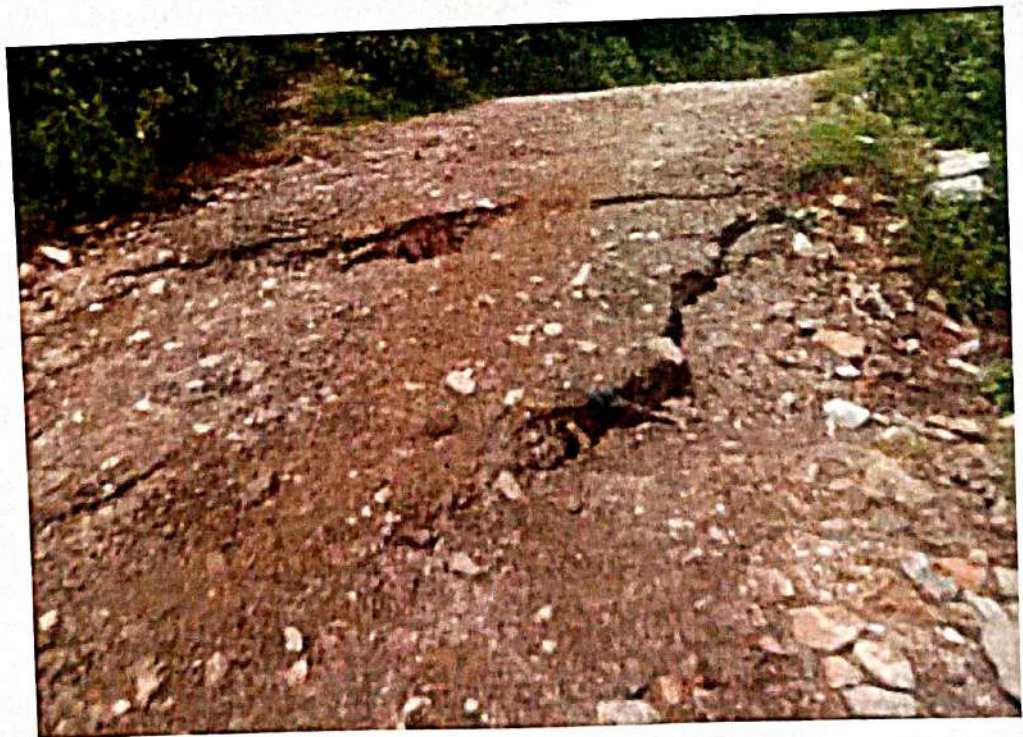
Cracks on roads near Bhigun village
