Survey Report on Mastari Village, Uttarkashi District

Uttarakhand Landslide Mitigation and Management Center (ULMMC)

August 2023

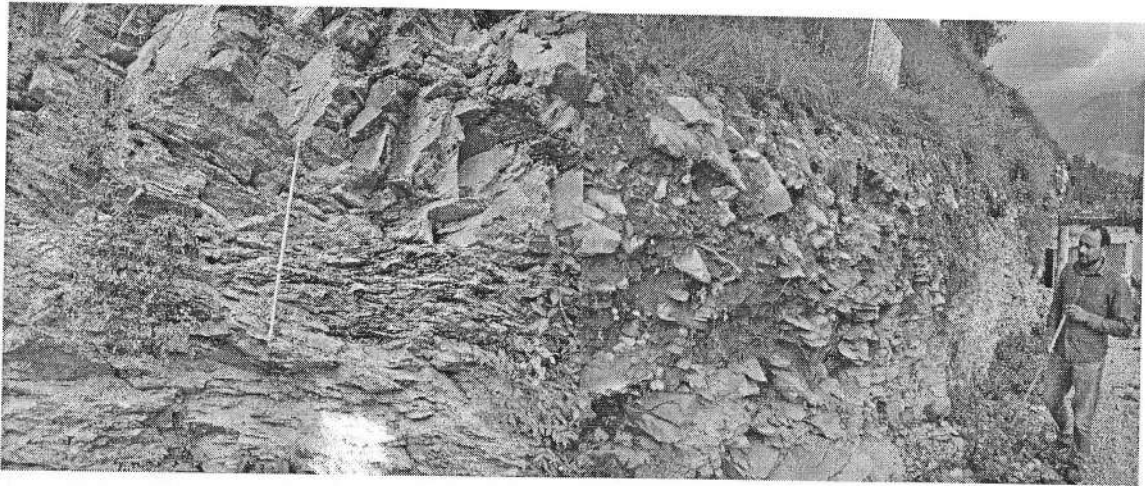
- 3-: In the eastern part of the village, quartzite rock formations are visible, while in the central part of the village, large boulders were observed, suggesting the possibility of an old landslide.

Figure 1- Weathered rock formation on the north-eastern side

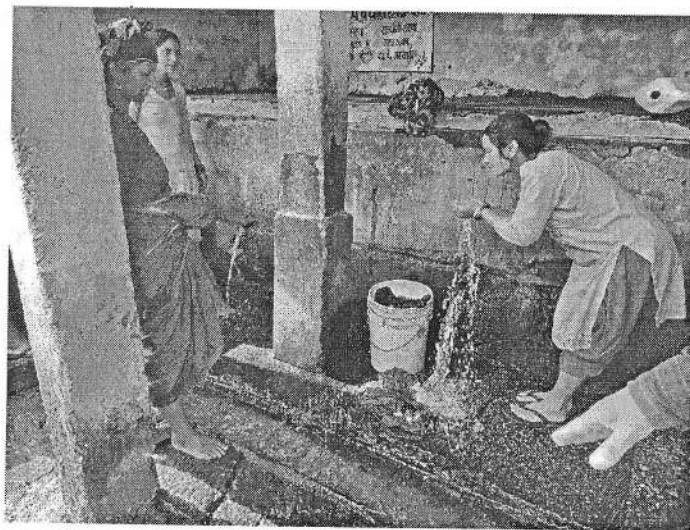
- 4-: In the central part of the village, near the Nagrajara temple, there is a natural water spring with two outlets, ranging in diameter from 15 mm & 50 mm. During the rainy season, the discharge of water increases, but during the dry season, only as much water flows as from a 15 mm diameter hole, as informed by the villagers.

Figure -2 Natural spring at the center of the village

3-: The water used for irrigation and exiting from the houses, as well as the water from springs, should be safely disposed to downstream through well-constructed channels.

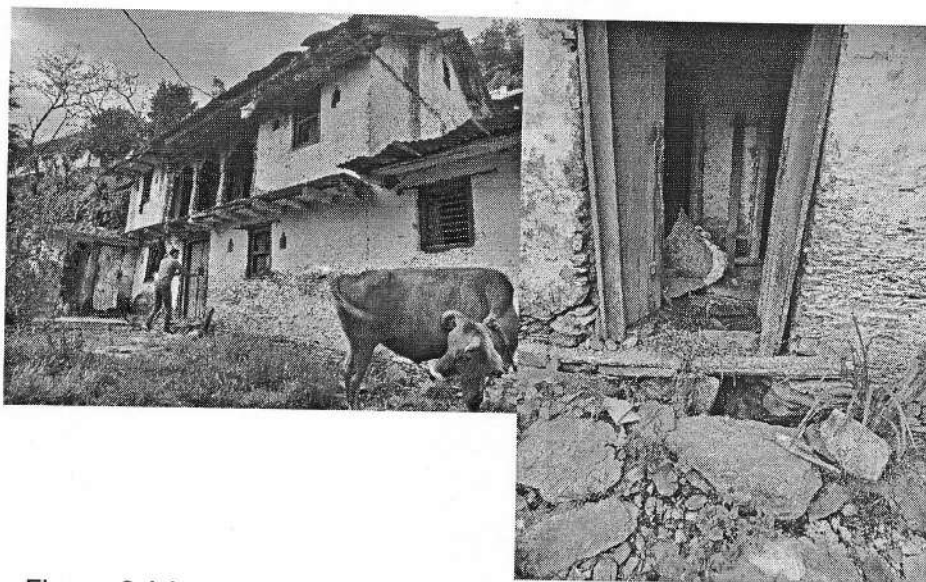
- 5-: In the village, two houses were found where there is a natural spring water flows beneath the floors. It has also been noted that the water flow occurs only during periods of heavy rainfall, as both of these houses are situated on the lower side of the natural spring. These houses are more than 40 years old.

Figure -3 A house with water seeping out from beneath its floor.

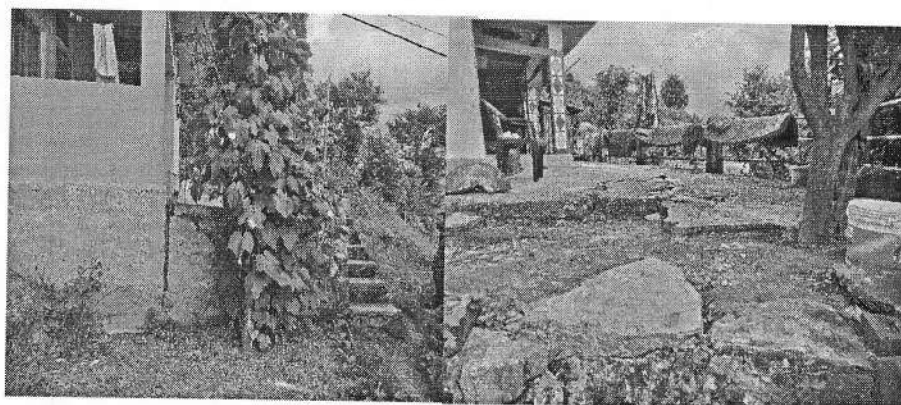
7-: Cracks have been observed in 3 to 4 houses in the village, particularly affecting areas where new construction has been joined onto existing structures. Most of these houses are located towards the eastern side of the village.

Figure -4 Minor Crack on the outer courtyard

2-: If possible, the cracks can be measured between the rainy and dry seasons by some simple technique may be installing some crack meters. This will indicate whether actually the development of cracks is associated with rains and sub-surface water flow.

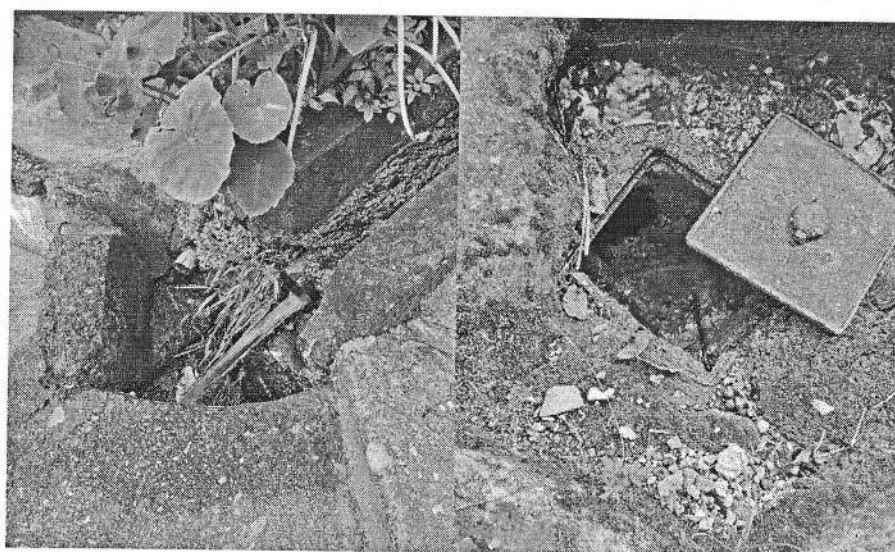
8-: During the dry season, for the extraction of water from the natural spring, a 300x300mm chamber along with a 100mm PVC pipe has been constructed in the interior part of the village. Additionally, provisions have been made to cover the pipe during the rainy season to prevent overflow, with the use of cement concrete channels.

Figure-5 Spring water flowing through a PVC Pipe with Chamber.

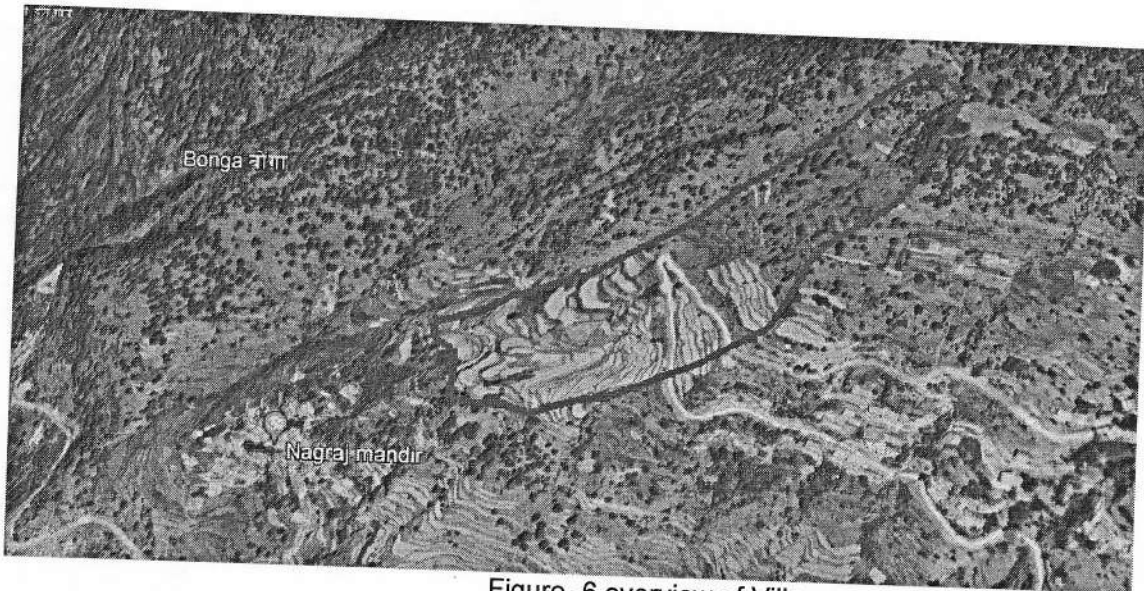
Figure -6 overview of Village
