Technical Report on 27th August 2024 Gufiyara Landslide activity, Uttarkashi District, Uttarakhand

On August 27, 2024, a landslide occurred in the Gufiyara region, east of Vrunavat Hill, with no damage reported to the residential areas downhill. Given the proximity to nearby settlements and the area's history of a major landslide in 2003, a joint inspection was done by nominated persons from THDC, GSI and ULMCC to assess the situation, determine the cause, and suggest remedies.

Ruchika Tandon, J.R kothari, Neha Kumari, Pankaj Uniyal, Vinay Purohit
Technical Report on
9/24/2024

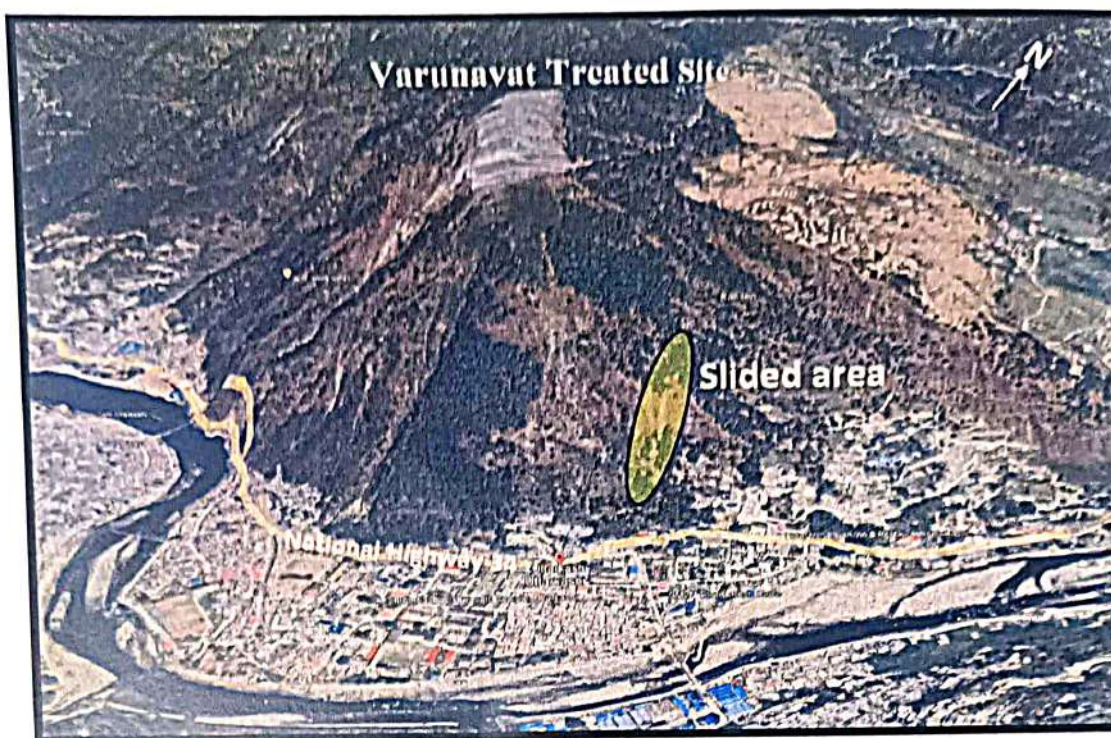
On 27th August 2024 at 11 p.m., a landslide occurred in the Gufiyara region, east of Varunavat Hill (marked in yellow in the fig1). While no damage was reported to the downhill residential areas, the proximity to settlements and the area's history of the 2003 Varunavat Hill landslide draw attention to the need for an urgent technical survey to assess the situation, determine the cause, and recommend remedial measures. A team visited the area from 6th to 8th September 2024 and following are the observation and suggestive measures of the team members

Figure 1: 3D Google view of Varunavat hill with marked recent slided area

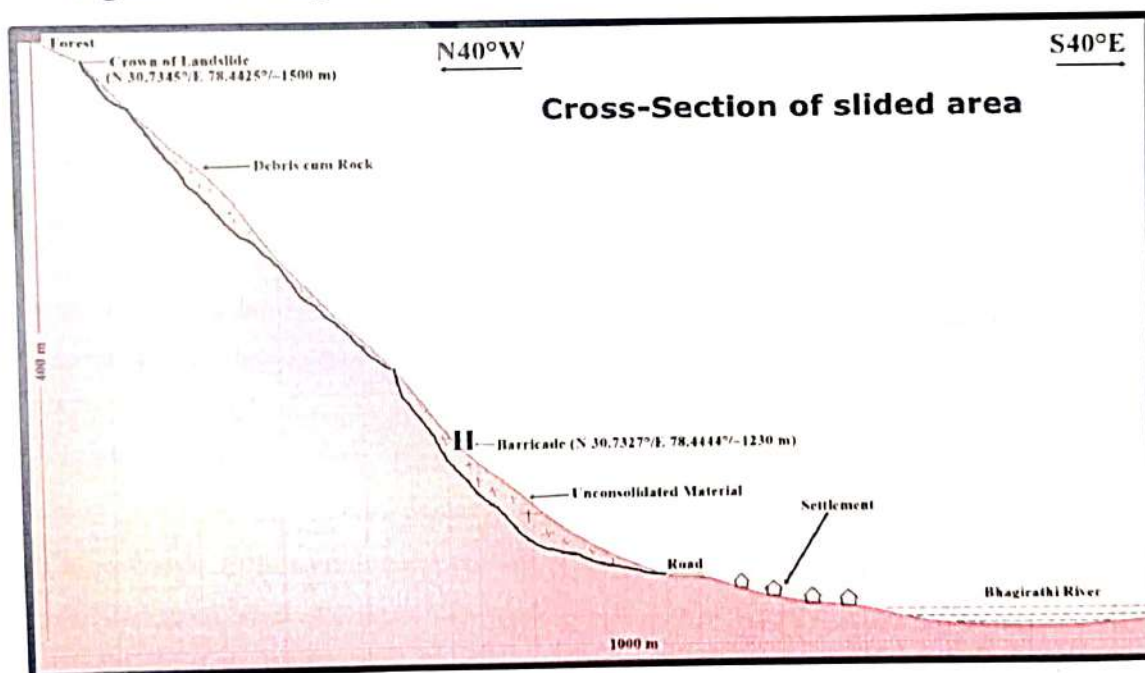
1. Location of Slided Area: The landslide area is located to the east of Varunavat Hill, above the Gufiyara Jal Sansthan colony between the lat/long of $30^{\circ}44'5''\text{N}/78^{\circ}27'37''\text{E}$ and $30^{\circ}43'55''\text{N}/78^{\circ}26'39''\text{E}$. It is quite distant from the Varunavat treatment site and is not connected or extension of the previous landslide activity at Varunavat Hill. The crown of the landslide area is situated at an elevation of $\sim 1,470$ meters above mean sea level, while the toe is at approximately 1,230 meters. Debris cum rock failure has been reported from where the ground slope changes from $35^{\circ} - 40^{\circ}$ to $70^{\circ} - 80^{\circ}$. Below the toe of landslide, there is a vegetated region, followed by the national highway and settlements (Fig. 2).

Figure 2: Cross section of Gufiyara slided area

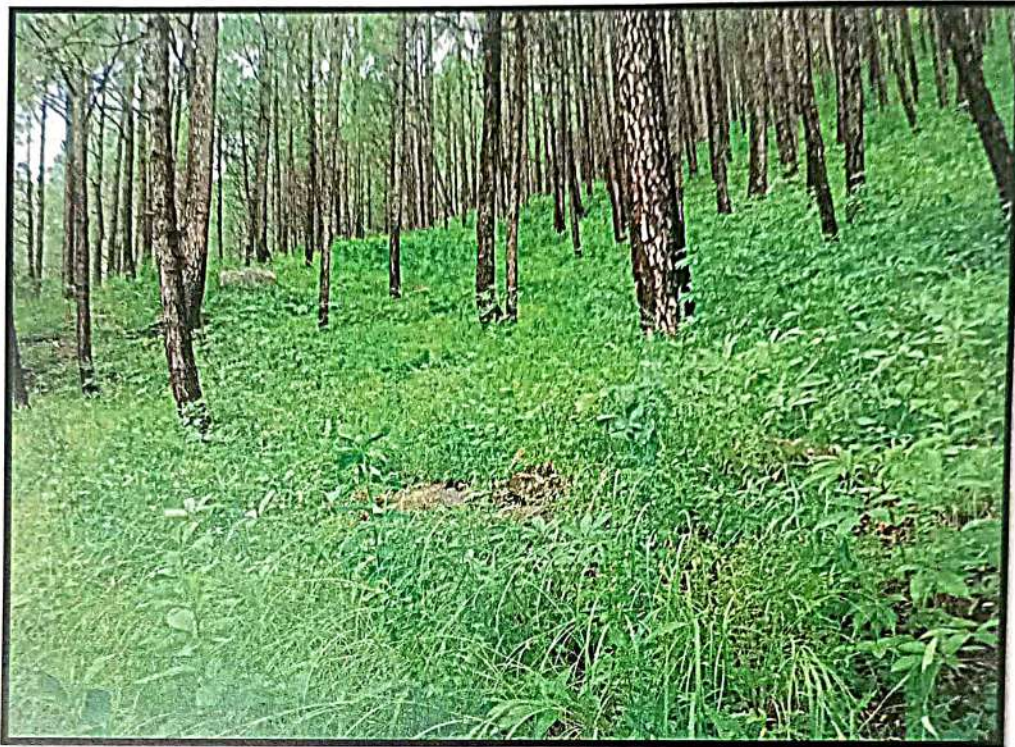
2. Above the Crown area: The crown of the landslide is located at a slope break at about 1470 m, above which the slope is covered with thick vegetation, including grasses, cacti, and pine trees. No tensional cracks have been observed above the crown, and the slope above crown has an angle of 35-40 degree. Due to the moderate gradient, the estimated slope cover is 5-10

meters and consisting of cohesive, wet, clay-rich soil (Fig 3) above crown. No tilted trees were observed above crown.

Figure 3: Moderate slope gradient above crown with no sign of instability

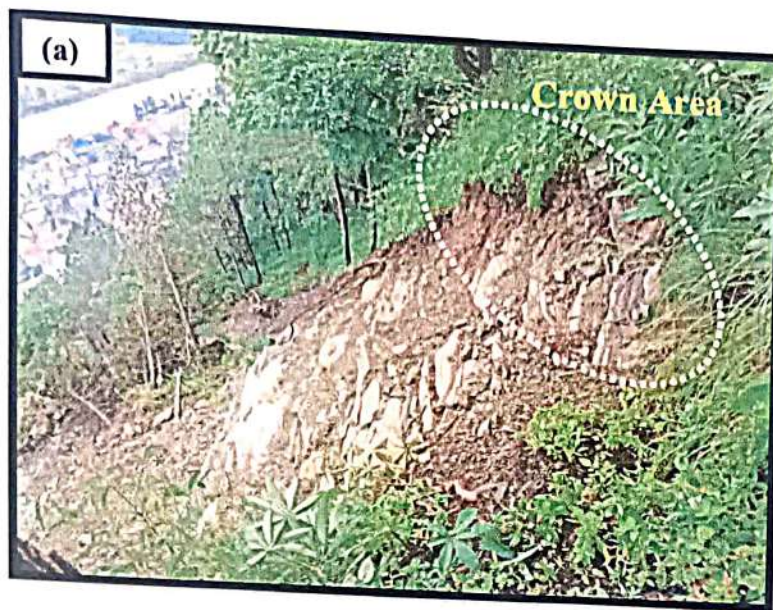
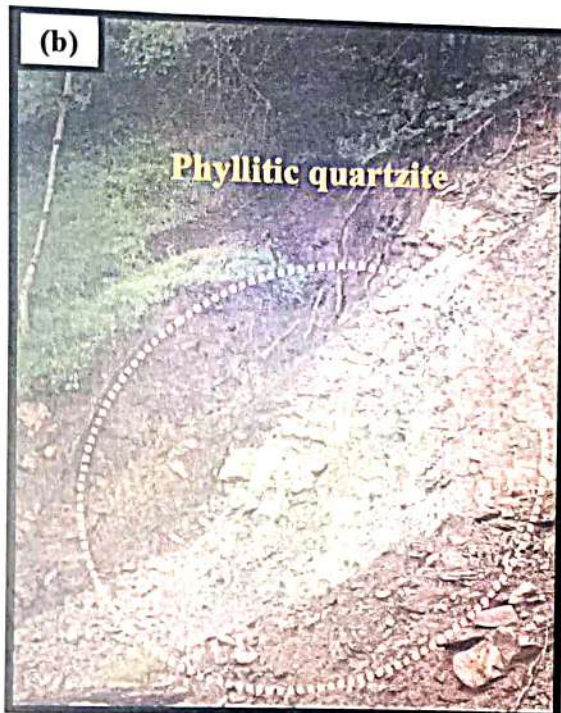
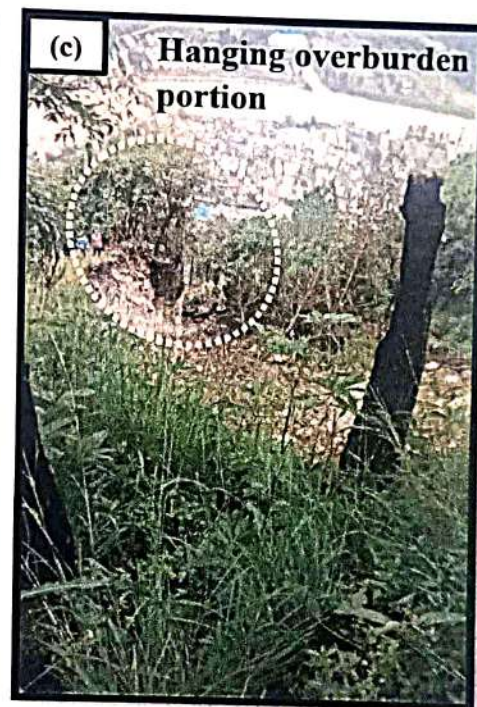
At the crown of the landslide, outcrops of quartzite and quartzitic phyllite are present. The inhomogenous and interbedded quartzite and phyllitic quartzite are well exposed in the upper and middle sections of landslide and sizes of quartzite bands ranges from several mm to few cm. (Fig 4) In contrast, highly fractured phyllitic quartzite is found on the ^{left} side of the landslide (Fig. 4b), which is more prone to failure. As a result, the possibility of the landslide expanding towards sides cannot be ruled out. The quartzite at the center is compact and sub horizontally aligned, with one prominent orthogonal sets of joints that are tight in nature but one dips towards outward direction. Due to steep slope and inaccessibility of exposed section, joint mapping could not be conducted. The width of the landslide scarp is approximately 10 meters at the top (at the crown) and 20-25 meters in the middle of the upper exposed section and depth of overburden is about 1-1.5 m at this site.

Figure 4: exhibiting middle portion of upper section where quartzite are exposed (Fig. 4a) and crushed & shattered phyllitic quartzite present at left portion (Fig. 4b) of landslide crown with hanging overburden (Fig. 4c)

- 1. Removal of Loose Material:** Immediate removal of loose debris/ hanging material with cautions from the landslide area, particularly from the crown, is necessary. Care should be taken during this process to avoid triggering additional landslides. Accumulated debris and boulders behind steel barricading at EL±1230 required to be removed for making free space to arresting fresh slide if any.
- 2. Strengthening of Barricades:** Existing barricade at EL± 1230m needs to be strengthen by welding and installing a slanting ISMB (300x140mm) with vertical post (Fig. 13).
 - High tensile chain-link fabric (50x50mm) needs to be welded behind the existing barricade to arrest debris/boulders of smaller size and needs to be extended towards Gufiyara nala by ± 100m approx. in stretch length (Fig. 14). Small gaps in between two barricades at regular interval is recommended

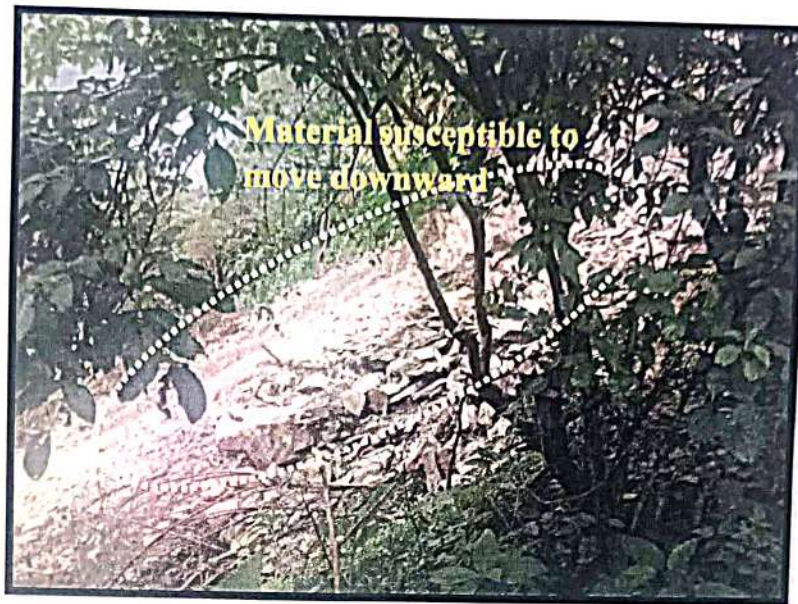
4. Transported Area: Detached debris from the crown portion, consisting of quartzite boulders embedded in a sandy-silty matrix, is present throughout the slope. This debris is susceptible to further move towards downhill, especially under the influence of water during rainfall or seismic activity (Fig. 5).

Figure 5: Loose debris consist of fine matrix with boulders of 1-3 ft rests on slopes and susceptible to move downward

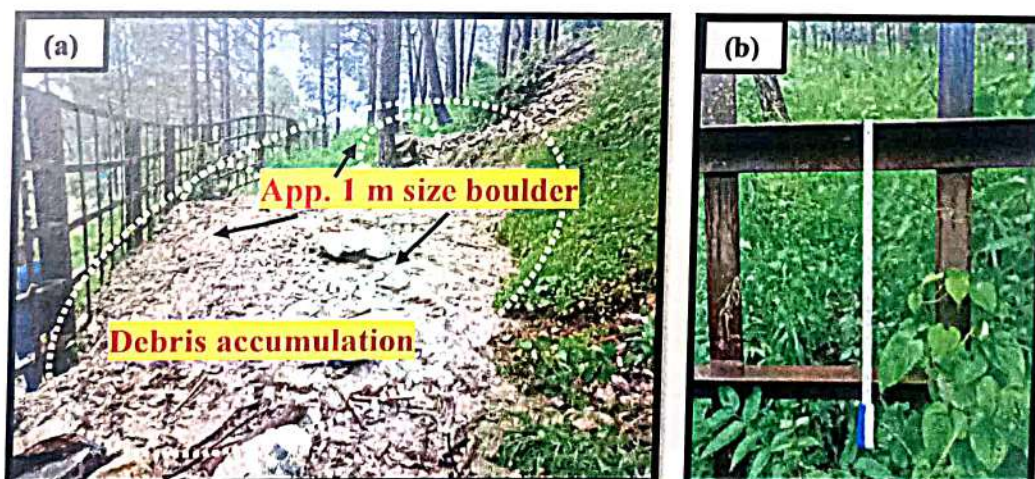
5. Toe Area: The debris moved downhill was struck in barricade being constructed for the protection of downhill area (Fig. 6). The debris with boulders of medium size has been accumulated in stretch upto 1m height behind the existing barricade structure of app. 3 m height. However few boulders of size less than 1 ft and fine matrix was lying loose on the slope outside the existing steel barricade (El \pm 1230) indicating the need of strengthening and expanding of protection walls/barricade for safety of downhill settlement and NH.

Figure 6: (a) Figure depicting the debris accumulation zone near barricade at elevation of about 1230 m and (b) size of opening of Barricade (app. 2x2 ft.)

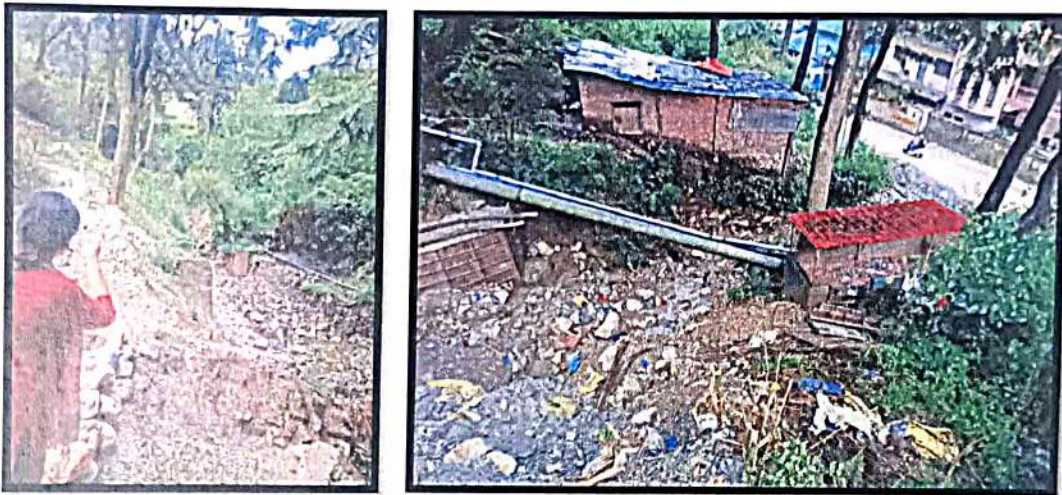
- Gufiyara Nala, located approximately 100 meters from the landslide site, exhibits evidence of side cutting and poor maintenance (Fig. 7).
- The absence of proper outlets has resulted in the accumulation of loose material, which frequently obstructs the road.
- Existing retaining structures have suffered significant damage.
- Settlements in the vicinity of Gufiyara Nala are present

Figure 7: Condition of Gufiyara Nala

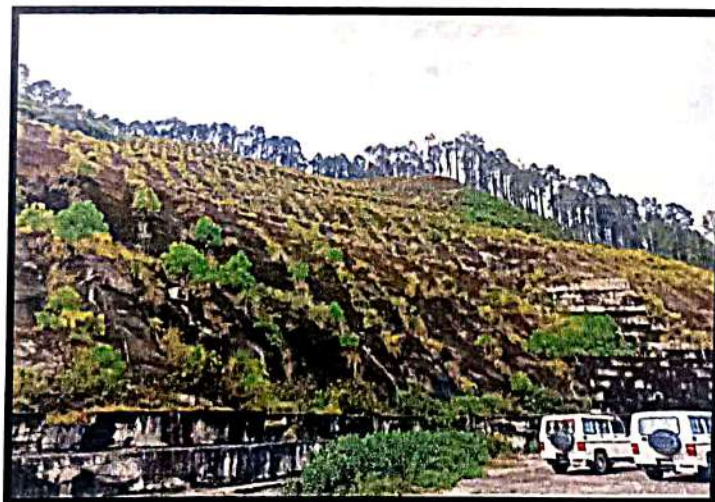
Figure 8: Varunavat mitigation site

To assess potential linkages between the earlier landslide site at Varunavat Top and the current landslide activity at Gufiyara, the site was visited and followings are the findings (Fig. 8):

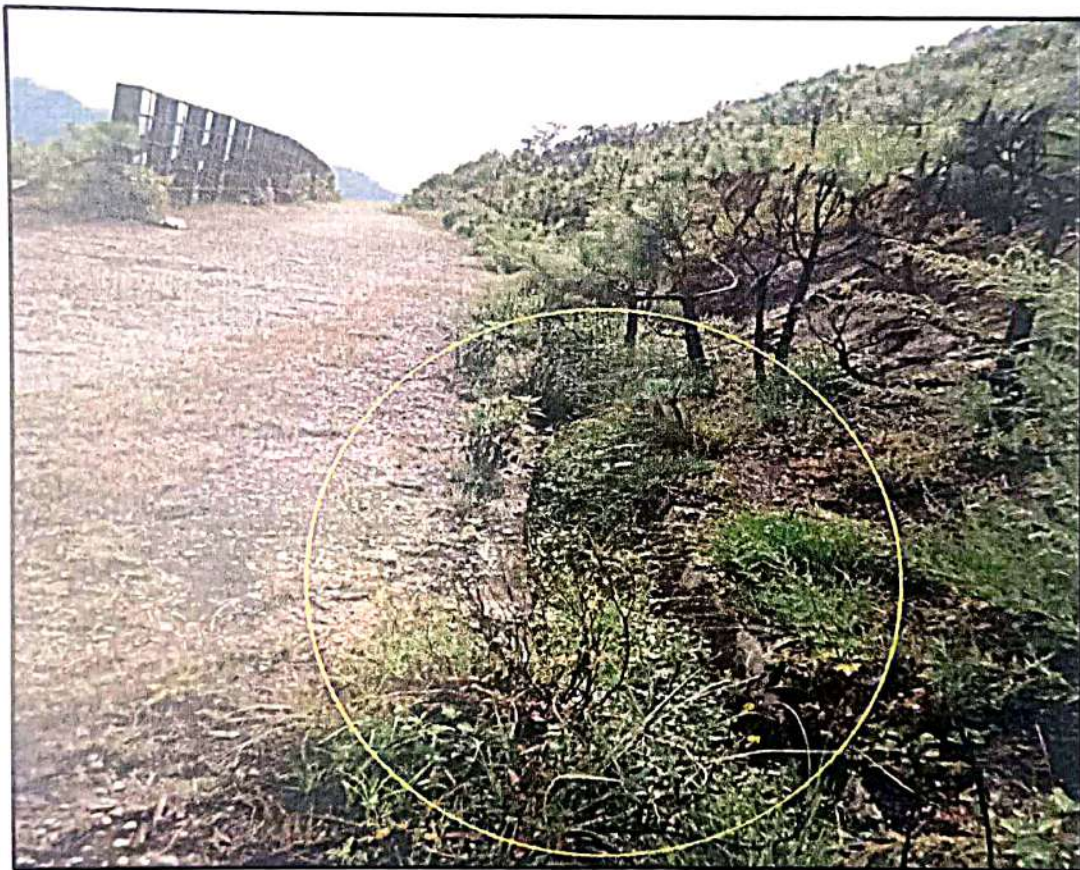
- The toe contour drain was found choked with pine leaves and vegetation (Fig. 9).
- The vegetation/pine are grown in the longitudinal groves between shotcrete and in contour drains (Fig. 10)
- MS drainage pipes provided at EL±1670 and EL±1660 for diverting rain discharge collected at toe catch drain were found choked (Fig. 11).
- Construction material (sand) and some loose boulders were left by Tambakhani Chute treatment work contractor at edge of bench EL ±1660M (Fig. 12).

Figure 9: Choked catch drain

1. The toe contour drain should be cleaned periodically.
2. The Vegetation/small pine plants from the longitudinal groves between shotcrete and treated area should be periodically cleaned in order to facilitate smooth discharge from slope and to release pore pressure.
3. MS drainage pipes provided at EL±1670 and EL±1660 required to be opened to prevent flooding of rainy water towards Tambakhani chute.
4. Construction material and loose boulders left at bench EL ± 1660M need to be removed.
5. Regular cleaning of drains and grooves at treated area of Varunavat Parvat crown are essentially required. It must be carried out especially during rainy season. It must not be ignored for long time.

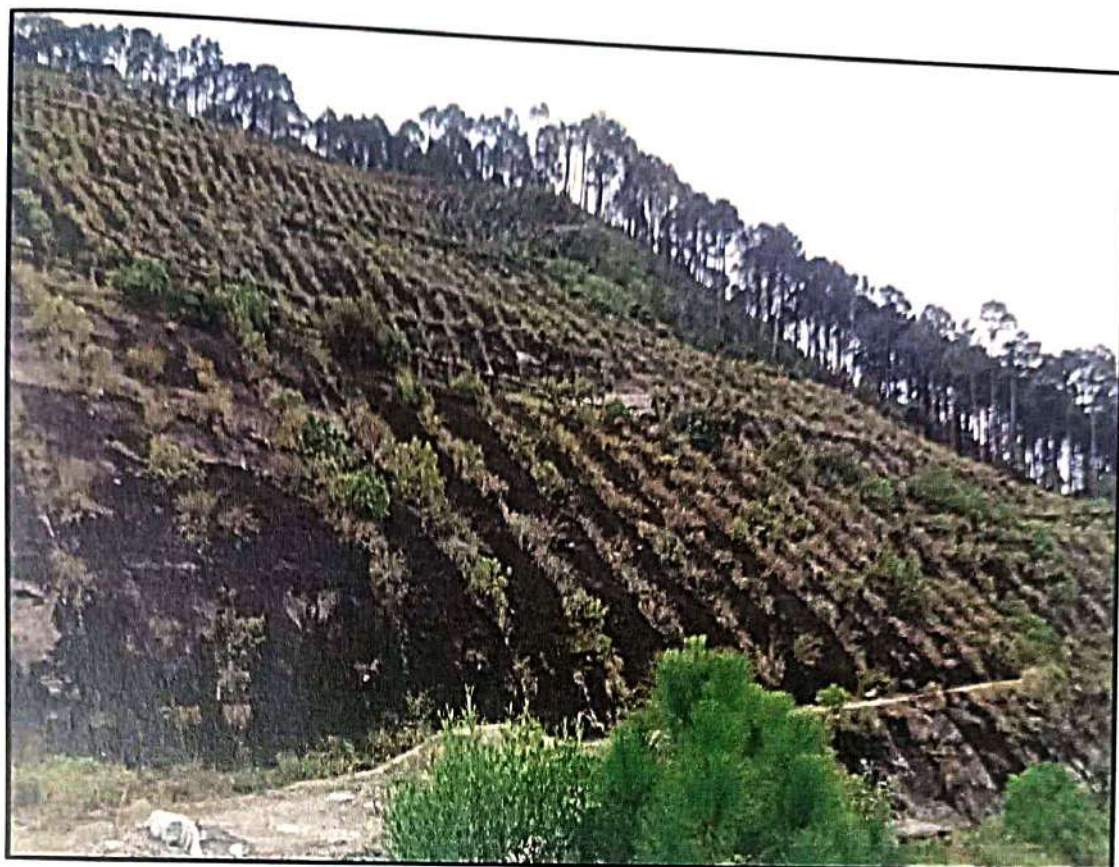
Figure 10: Vegetation/small pine plants growing in the longitudinal groves

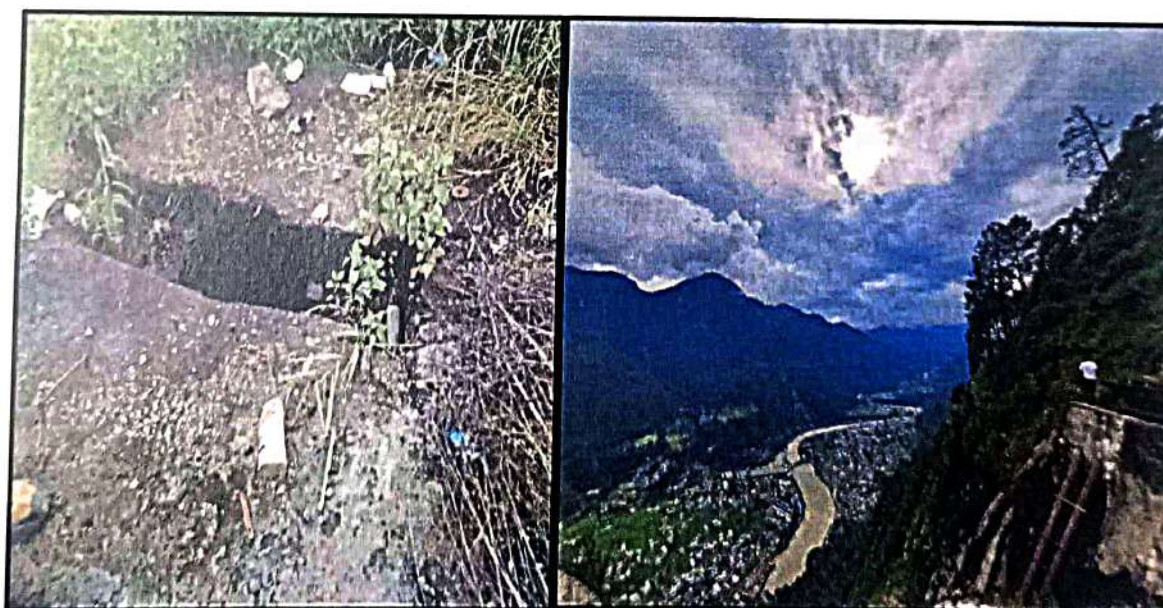
Figure 11: The catch drain is choked require to be opened at platform at EL \pm 1660m.

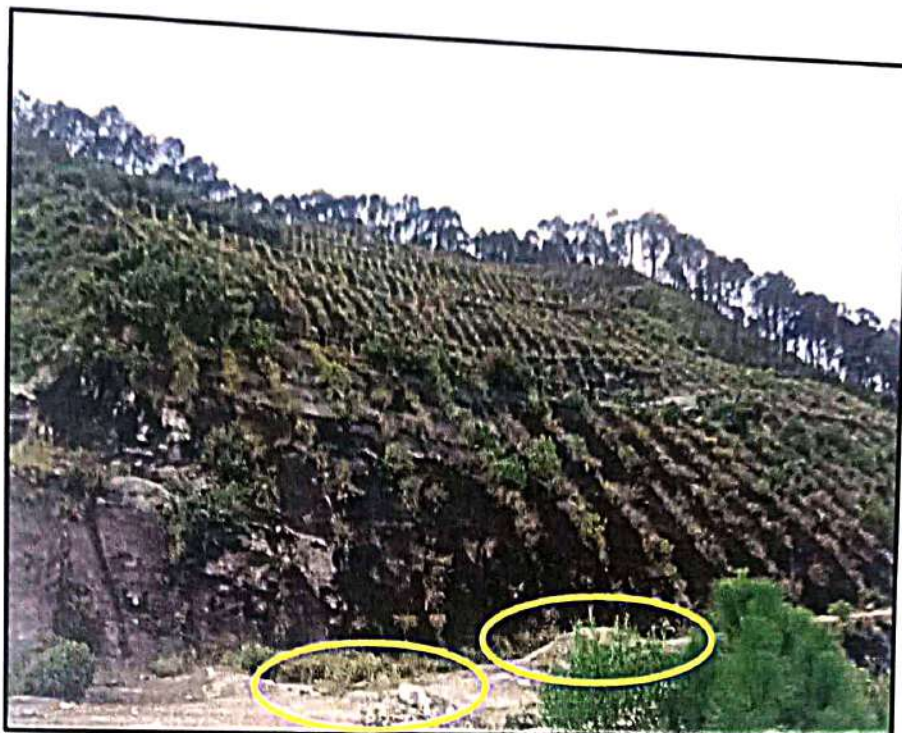
**Figure 12: Construction materials sand and boulders were left at the edge of the bench.
It has to be removed**
