Field Visit Report

Site: Dhurma- Kundi Road (KM-2), Nandanagar (Ghat), District - Chamoli

Site: Churagad to Sutol-Kanol Road, Nandanagar (Ghat), District - Chamoli

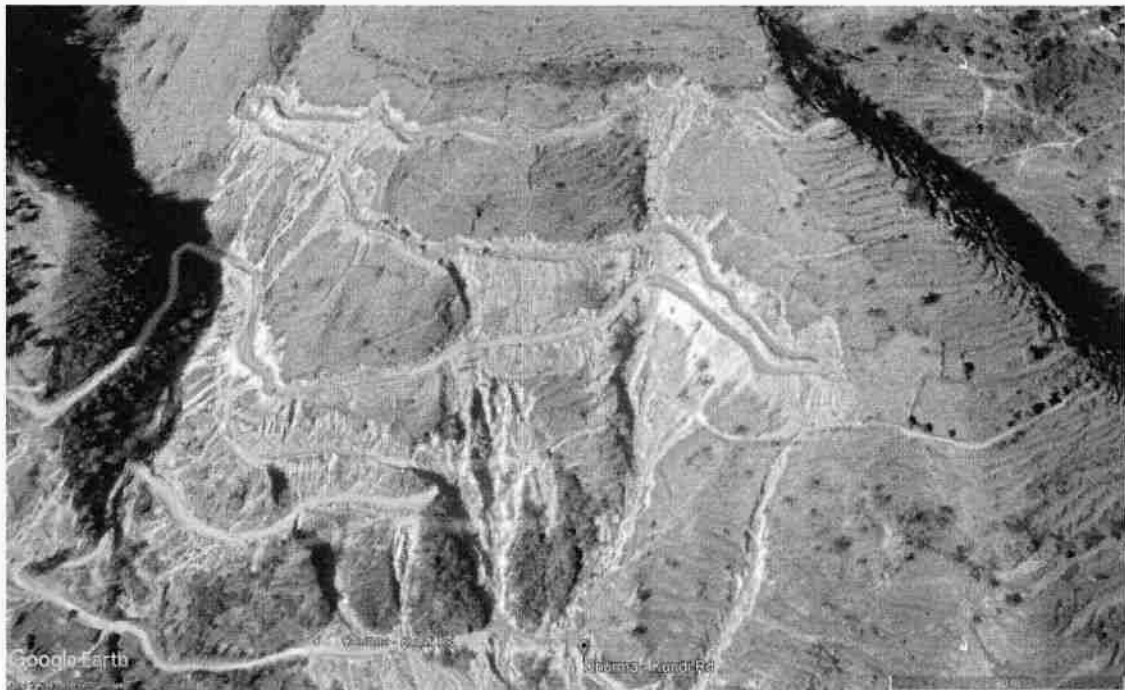
Following Satellite images (during Year 2018 to 2024) may illustrate the Morphology and chronology of slope degradation in terms of gradual erosion, gully formation and slope failure. It seems there is un-scientific road cutting on a steep and highly fragile (fractured rock) slope with multiple HP bends.

Figure 3-(b): Status of slope as on December 2021

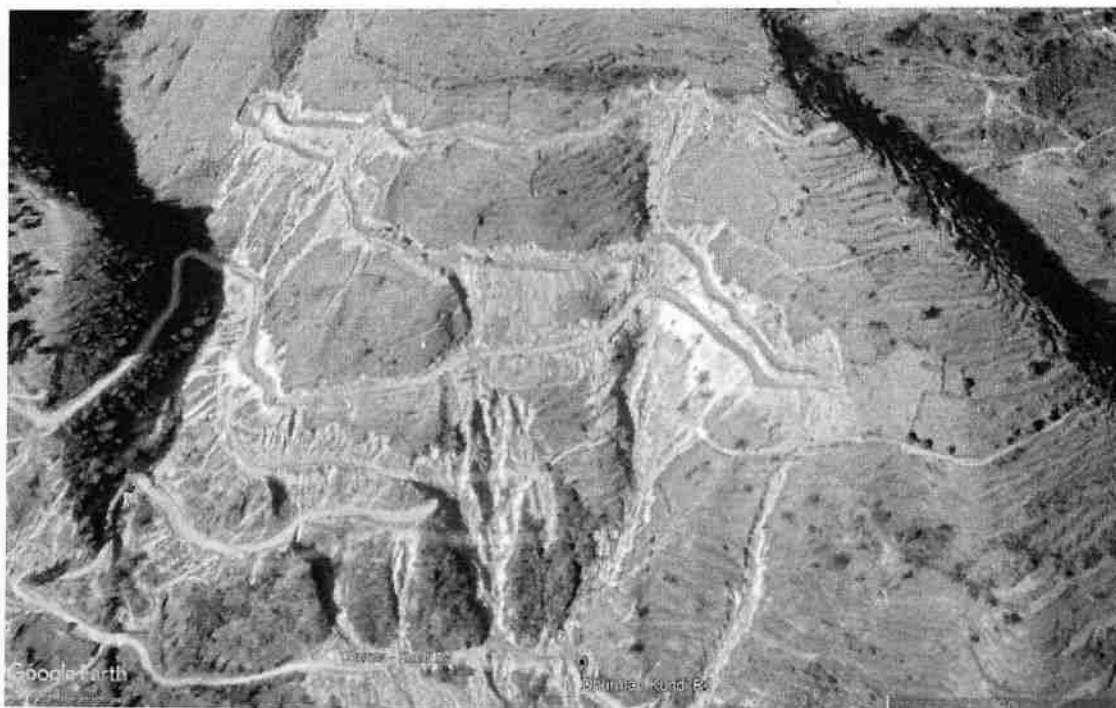
Figure 3-(c): Status of slope as on November 2023

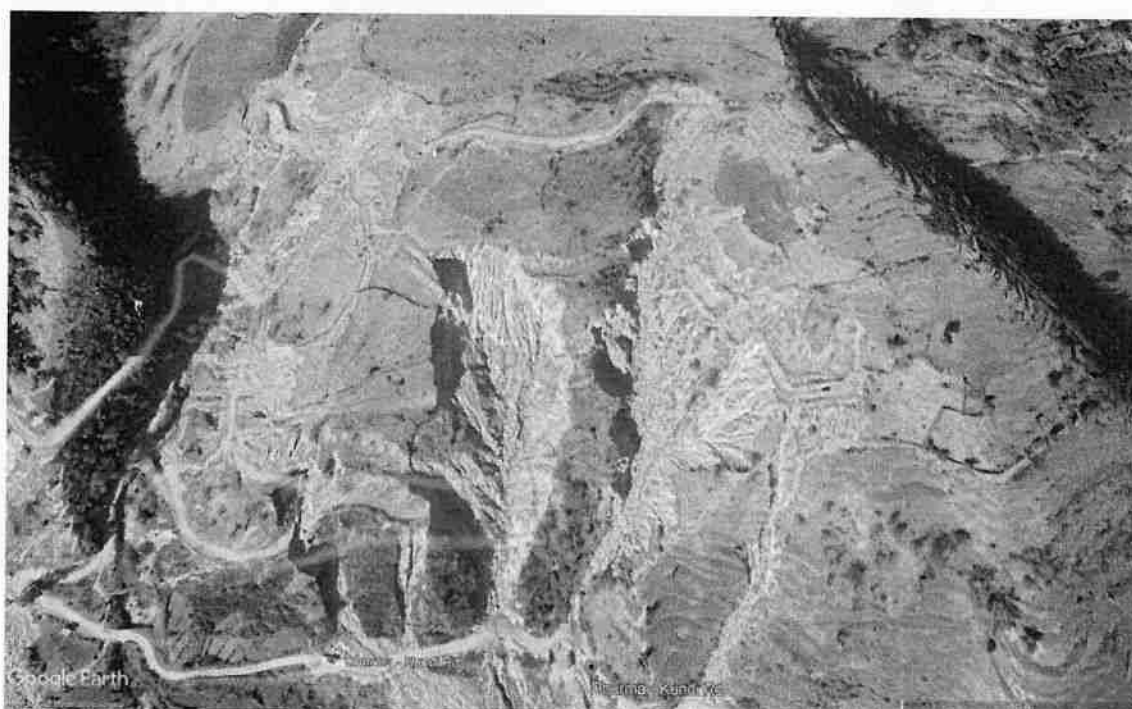
Figure 3-(d): Status of slope as on January 2024

- Approx 60 m road is completely washed out at KM 2 at Latitude 29.001148° & Longitude 79.675522°.
- Overburden and multiple road arcs on the upper slope. Constructing a road in such conditions may lead to the mobilization of the sliding zone, making the upper slope highly susceptible to failure, potentially resulting in a complete washout of the road network at the proposed location and its surroundings. (Figure- 3)

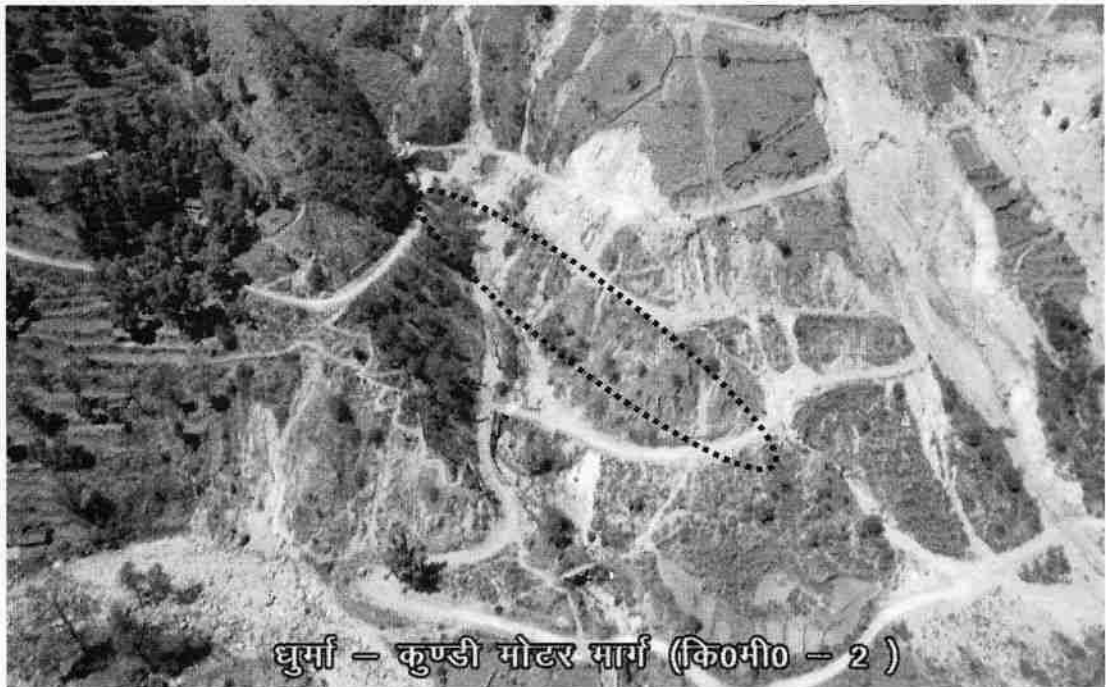
PWD has evolved a project proposal for road re-alignment to restore the road connectivity with an estimated cost of Rs 60.07lakh. Salient features of Proposed Plan as follows-

Figure 4: Proposed Road Re-alignment (Photo Courtesy to PDW Karnaprayag)

- Considering the current situation, lowering the road alignment at proposed location may further trigger the slope failure again and retaining wall for existing road would not be sustainable.

- It is recommended to re-align the road from another/ alternative location with due consultation of panchayat & local governance.
- Relevant IS Codes, Topographic survey and Specific Geo- investigations (including kinematic analysis, rock and slope mass rating, geological mapping, folds & faults of the strata at slope, relevant Geo-technical and if required Geophysical investigations) shall be considered as mandatory for new site selection.

- As per the proposal the gradient of new re-alignment is proposed as 1:20 however as per IRC 520:2019 for steep terrine for an elevation upto 3000 m it should be 1:16.7. Please review.

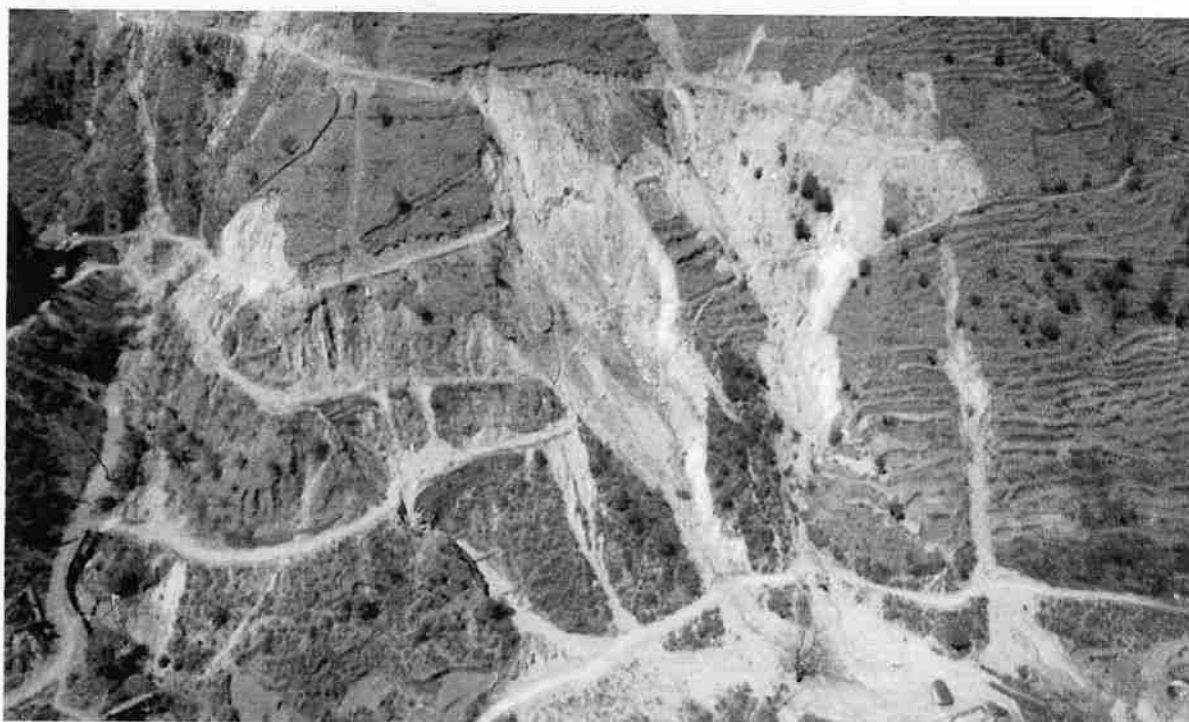
Figure 5: Over view of the Site

- Further, road passing through Point B to C, C to D and D to E is also on sliding zone which is highly susceptible to failure again. In such scenario, connectivity will again hinder.

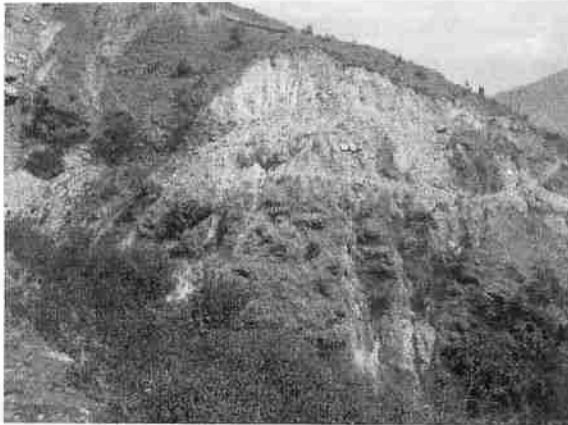
Sliding Zone

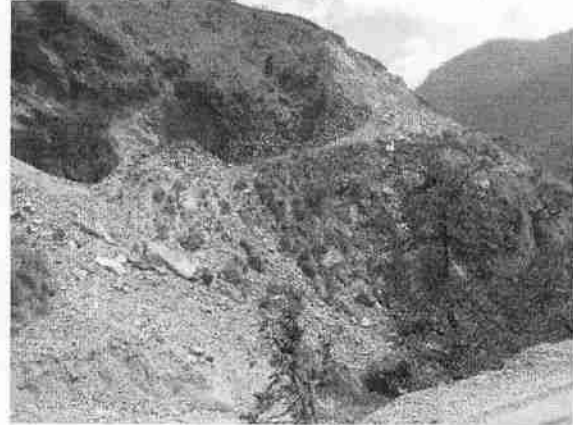
Road Block

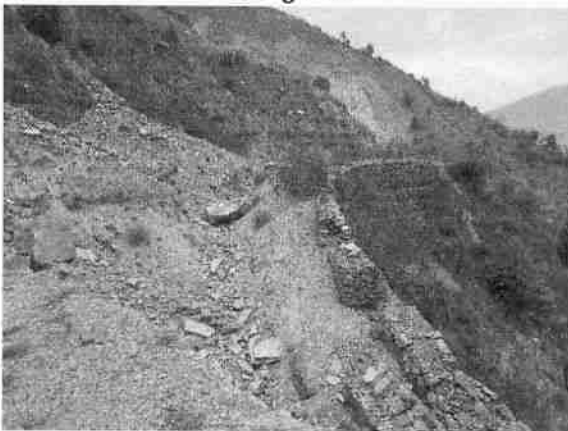
Road Block and Damaged Retaining Wall

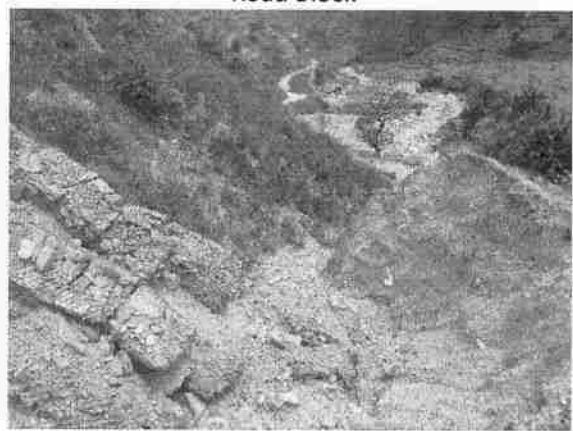
Road Wash out

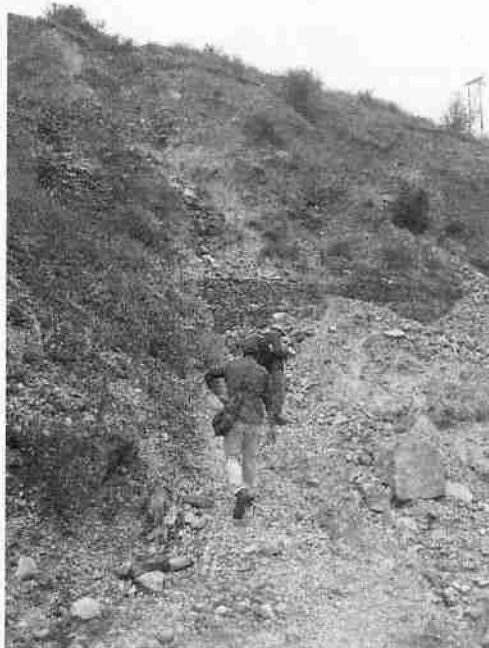
Road Block

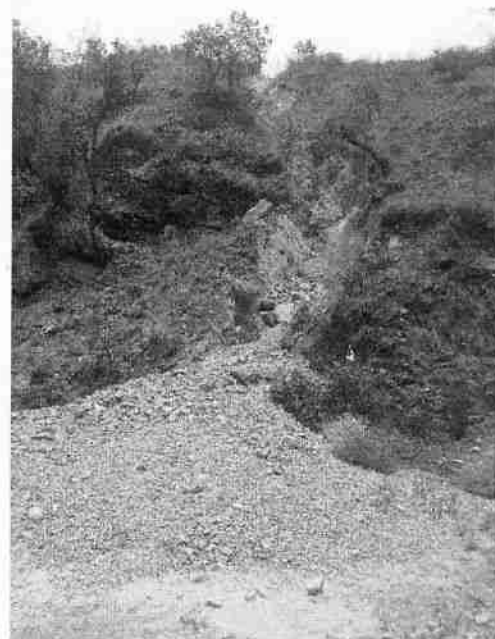
Gully Formation

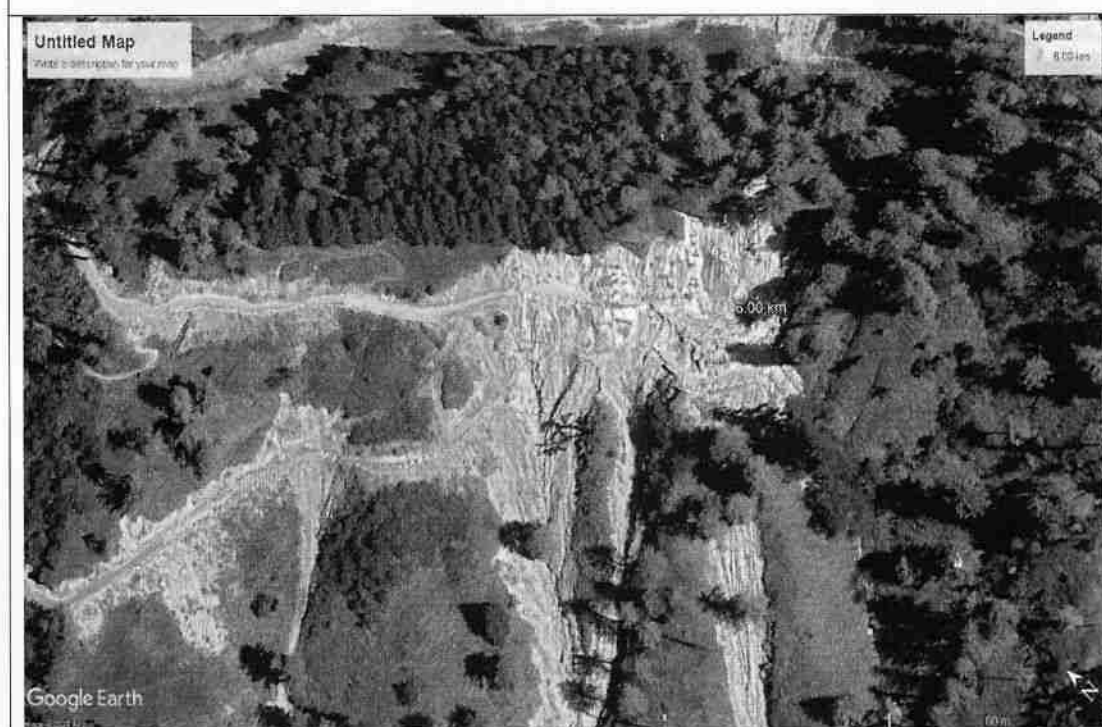
Following Satellite images (during Year 2018 to 2024) may illustrate the Morphology and chronology of slope. Widening of existing gullies and slope washout/ muck clearly can be observed. The road construction was carried out in year 2020-21 and corresponding image of 2021 & 2022 depicting the comparative degradation. It seems there is un-scientific road cutting on a steep and highly fragile slope with multiple HP bends.

Figure 2-(c): Status of slope as on Oct 2022

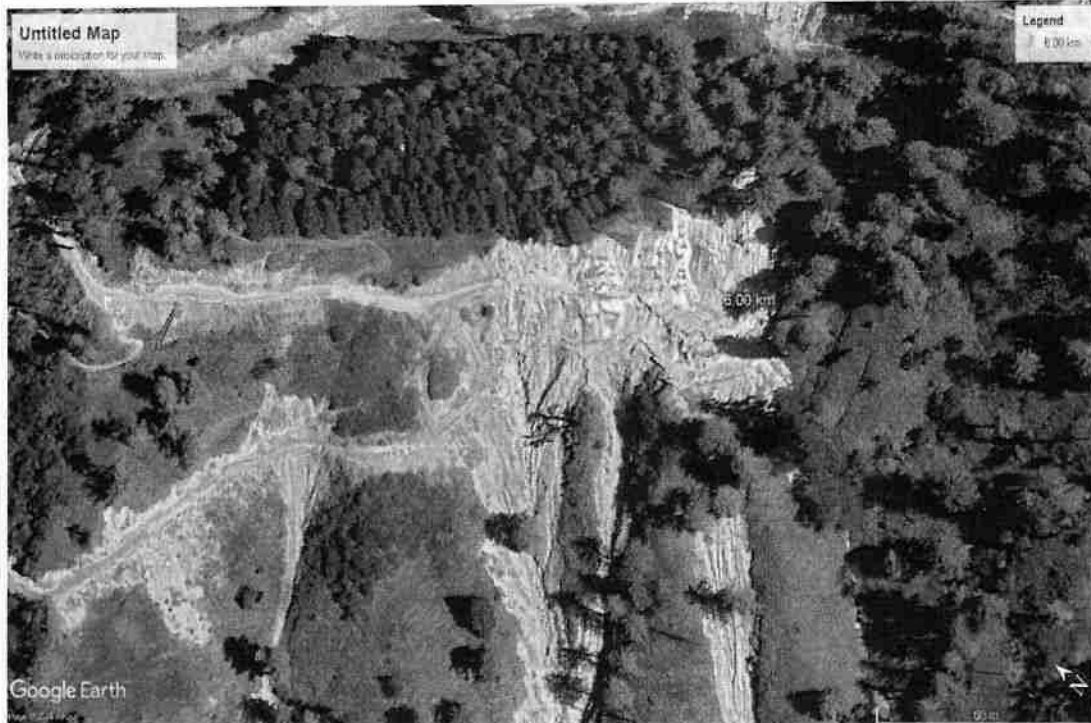
Figure 2-(d): Status of slope as on Nov 2023

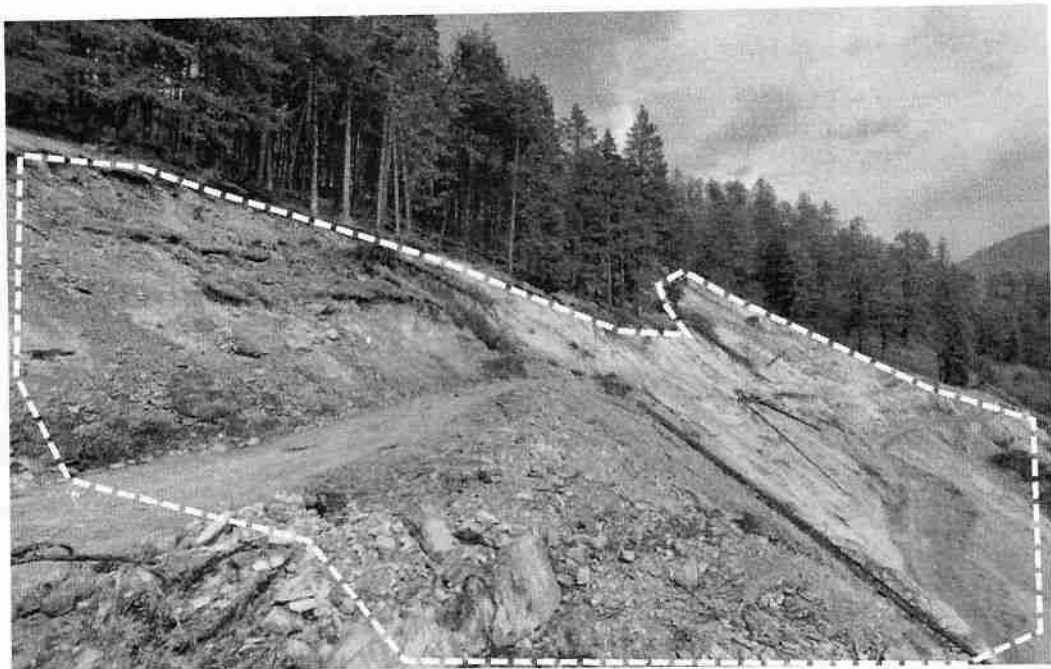
- The area possesses rugged topography and steep slopes, which predominantly exhibit circular failures (*Figure 3*).
- A substantial portion of the road traverses through slope wash material and pulverized rocks, which contributes to the instability and potential for slope failure.
- The area is experiencing creep, as evidenced by the tilted trees (*Figure 4*). The figure shows the tilting of trees between KM 6-8, illustrating the ongoing geomorphic processes ground movement.
- Muck dumping is not found in accordance to EC/Muck Management plan.
- Compensatory afforestation could not be located.

Figure 3: Slope failure (Circular failure) along the Sutol - Kanol road between KM 06 and KM 07.

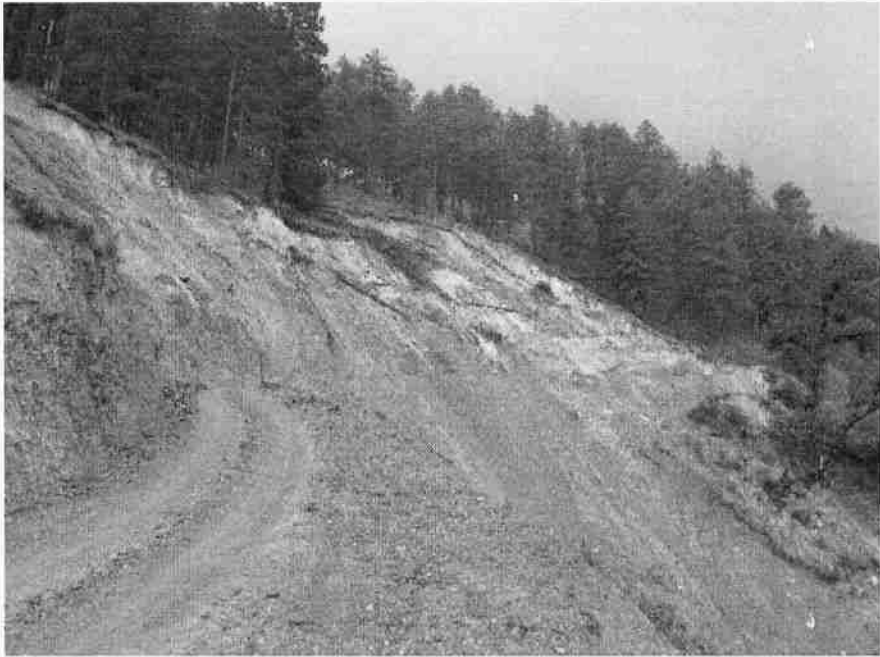
S. No.	Description
1

<p>Status: Road widening required through Retaining Wall. Suggestion: Slope is covered with Slope wash material and in a deep valley. Specific geo technical investigations eg- SBC, DST & grain size would be helpful to find out best suited solutions.</p>

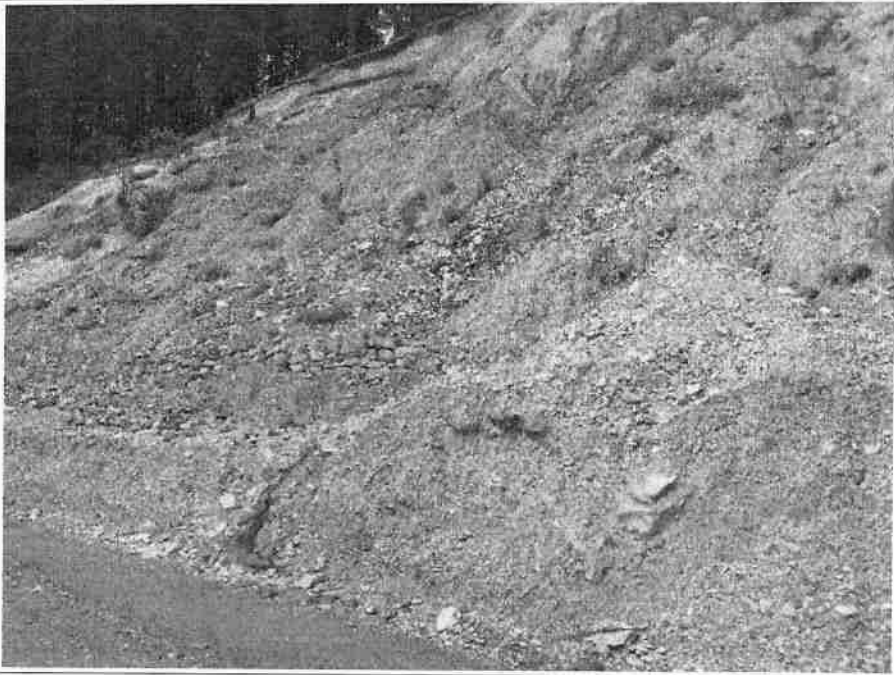
2

<p>Status: Hill side slope protection required. Suggestion: RR masonry/ banded Breast wall may be used with weep holes. Above said structures grasses, ringal and other NTFP may be used.</p>
3

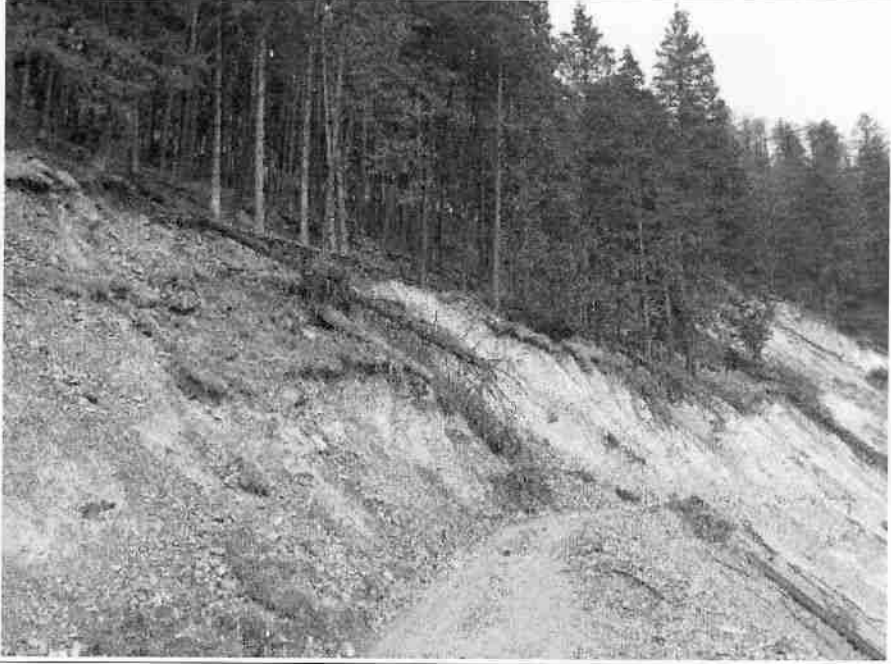
<p>Status: Hill side valley side (between 2 arms of the road) slope protection required. Suggestion: Hill side: Gabion (2 layers in step) above gabions NTFP Plantation. Drain construction to ensure safe disposal of road run-off. The run off may be disposed at the HP bend through a flexi vertical drain at minimum 150 m downwards at stable strata. Valley side (between 2 arms of the road): HP Stone filling between road and protection structures placed at lower arm.</p>

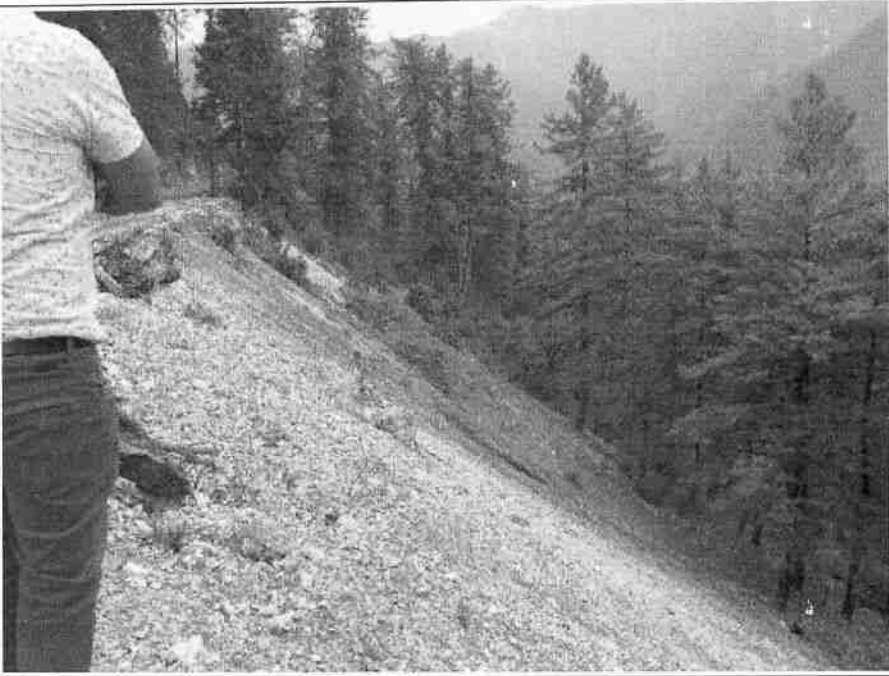
4

<p>Chainage: KM 8 Status: Slope protection on Valley Side required. Suggestion: Valley Side Vegetative fencing, Coir net with grasses till trees.</p>
5

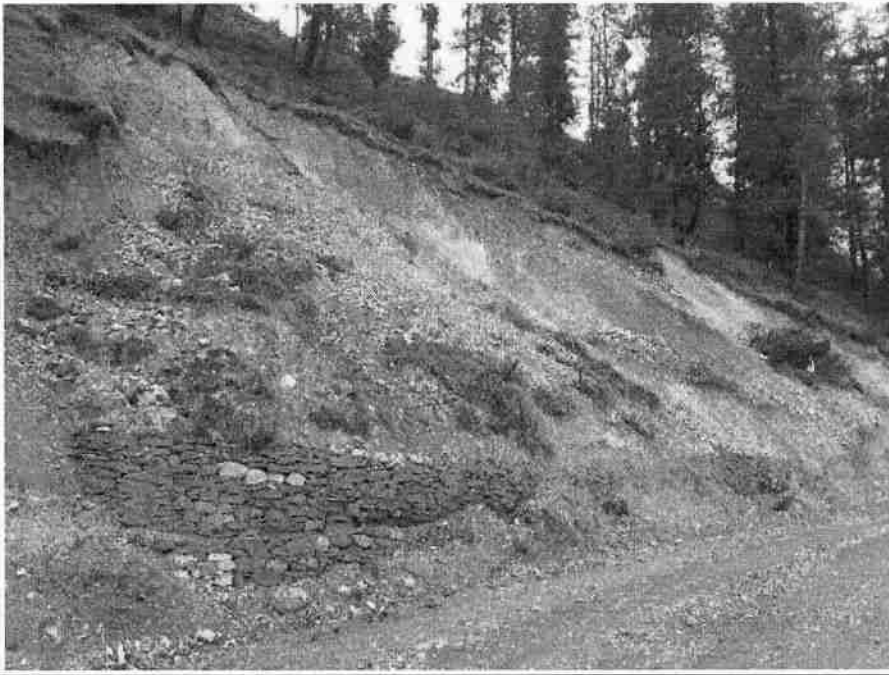
<p>Status: Hill side slope protection required. Suggestion: RR/ banded Breast wall may be used. Above said structures grasses, ringal and other NTFP may be used.</p>

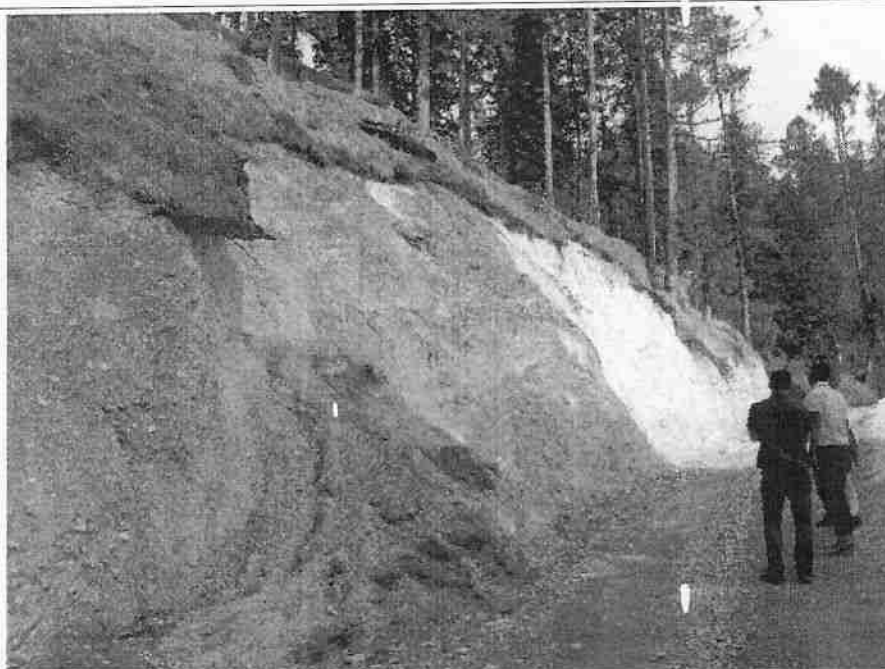
6

Status: Hill side protection required.
Suggestion: RR / banded Breast wall may be used.

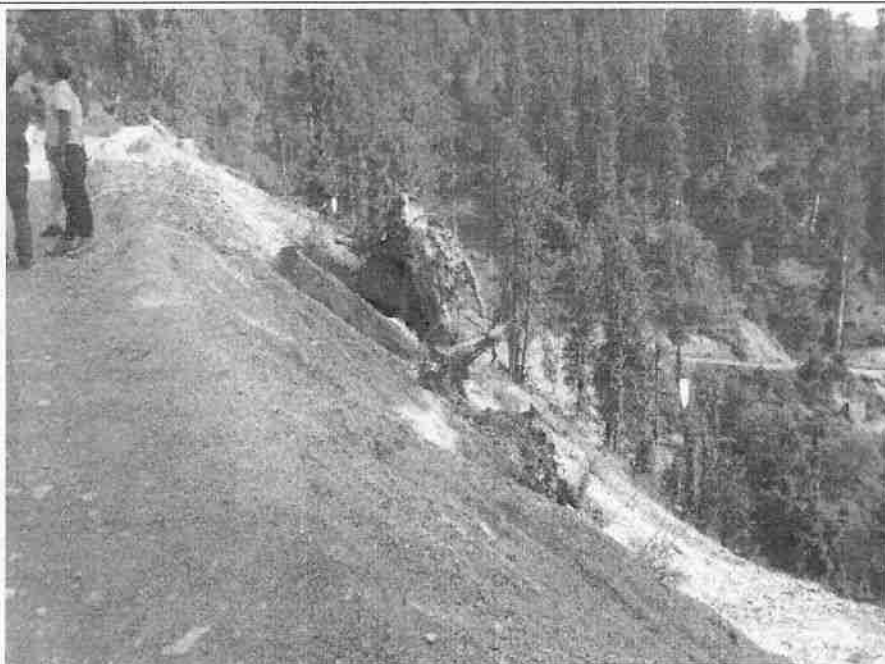
7

Status: Slope protection required.
Suggestion: Remove aggregate from the Slope.
Vegetative fencing along the road. Coir net with grasses + NTFP.

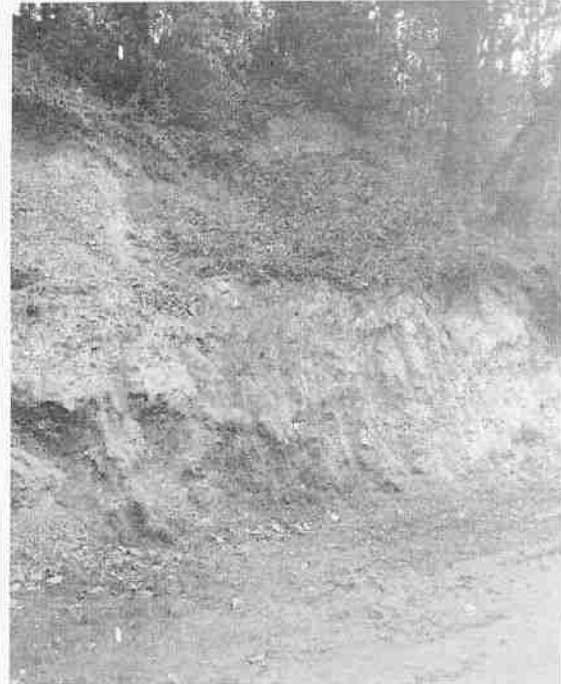
Status: Hill side slope protection required.
Suggestion: Remove loose material RR/ Banded Breast wall with weep holes may be used.

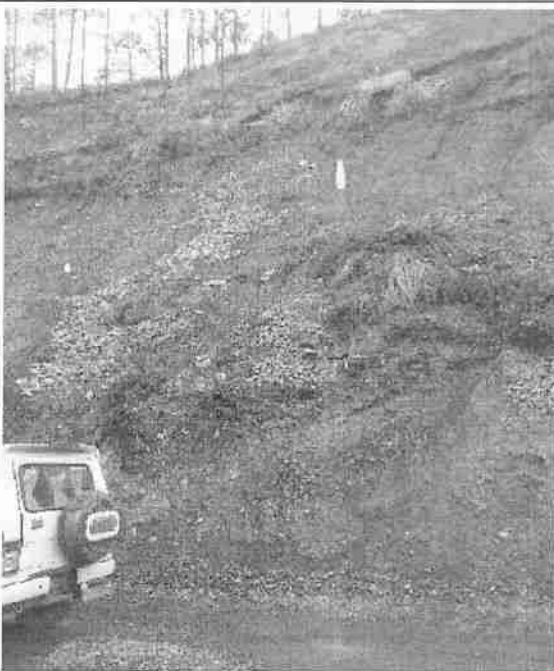
Status: Road widening at top required.
Suggestion: Vertical Drain must be connected to the culvert placed on upper & lower arm of the road, up to river at bottom (estimated vertical drain length 200 m).
Breast wall by using gabion (2 layers) +Coir net with grasses & NTFP.

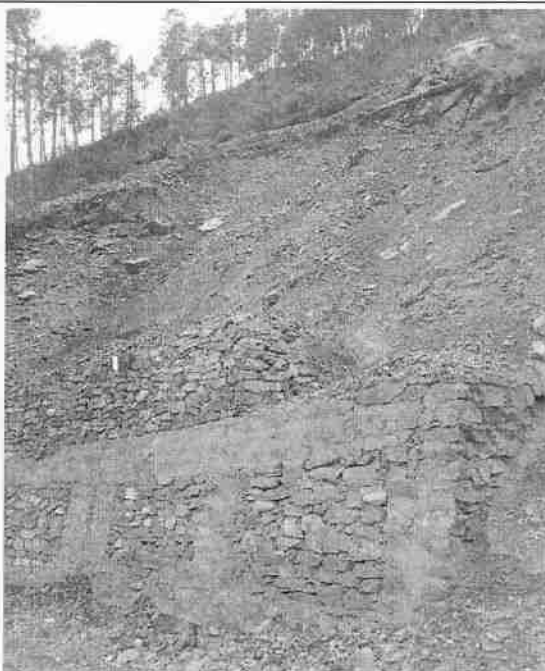
Status: Road widening at top required.
Suggestion: Shift crate wire/Gabions towards hill side and make upto the road in steps. HP stone filling must be used between road and Gabions.
Road run off should not be on this slope.
