**A REPORT  
ON  
TECHNICAL ASSESSMENT OF THE DHARALI DISASTER OF  
5th AUGUST 2025, UTTARKASHI DISTRICT, UTTARAKHAND**

*Submitted by*  
**ULMMC, CSIR-CBRI, GSI, WIHG and IITR**

*Submitted to*  
**Uttarakhand Disaster Management Authority  
Govt. of Uttarakhand  
1<sup>st</sup> September 2025**

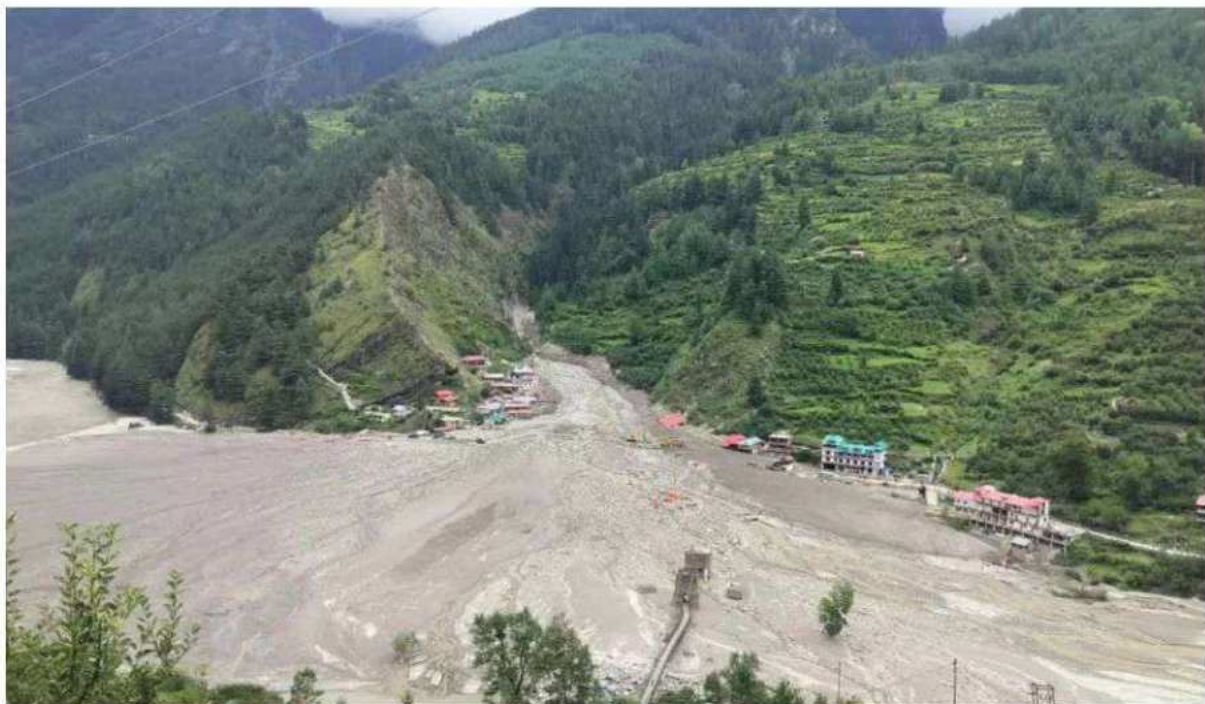
***Fig. 1: Panoramic view of debris flow at Dharali***

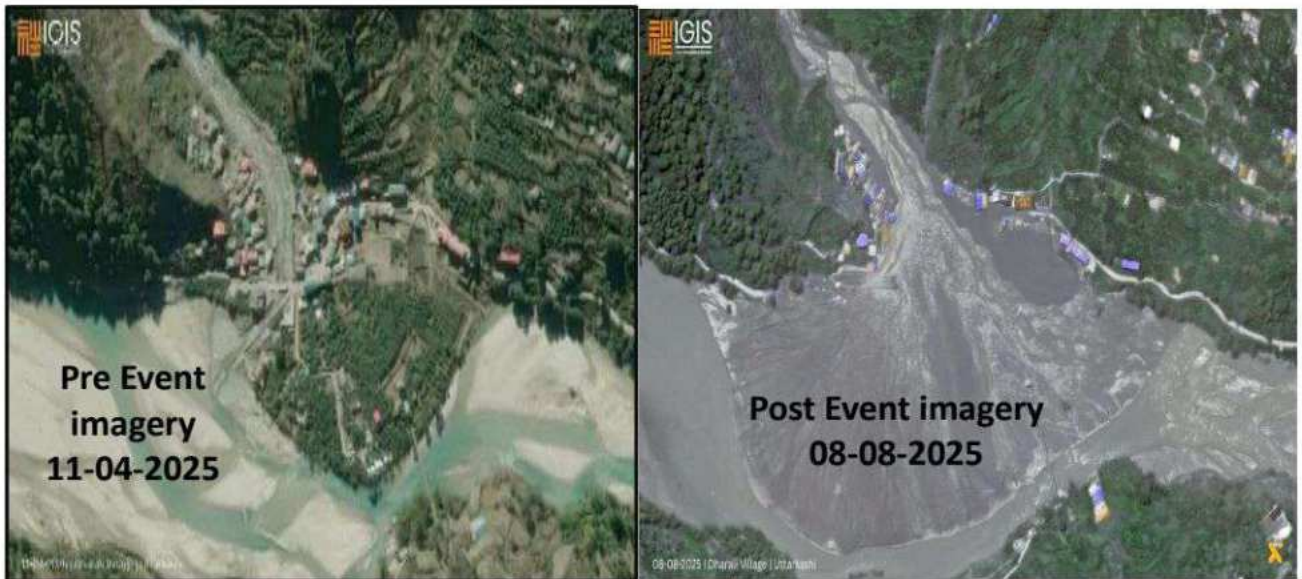
***Fig.2: High resolution satellite imagery showing pre and post Dharali Debris Flow event scenario***

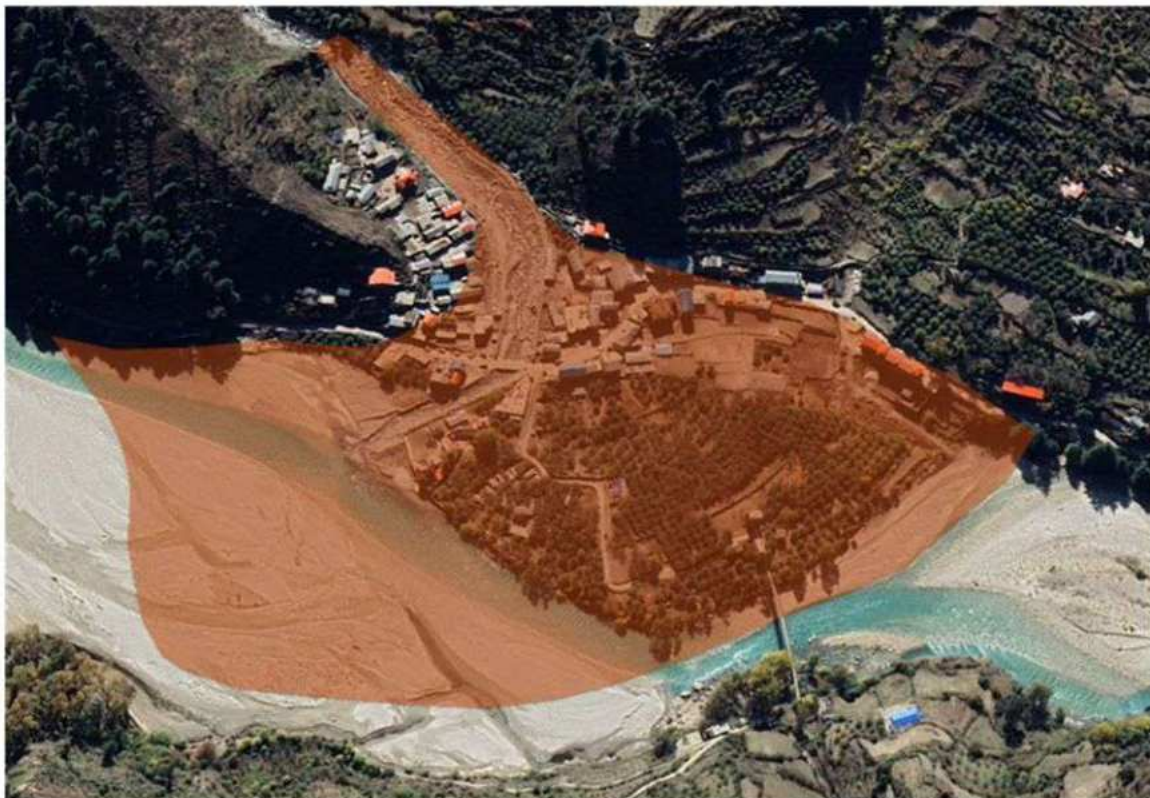
***Fig.3: The area encroached by the thick debris cover at Dharali shown in red colour***

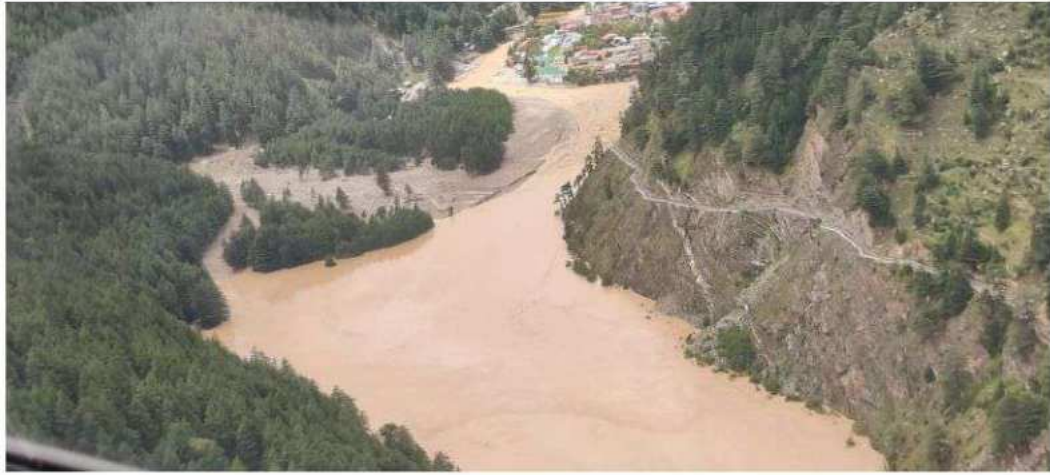
**Fig. 4: Formation of a temporary lake caused by the encroachment of the Bhagirathi River's flow due to the debris flow along Telgad at Harsil**

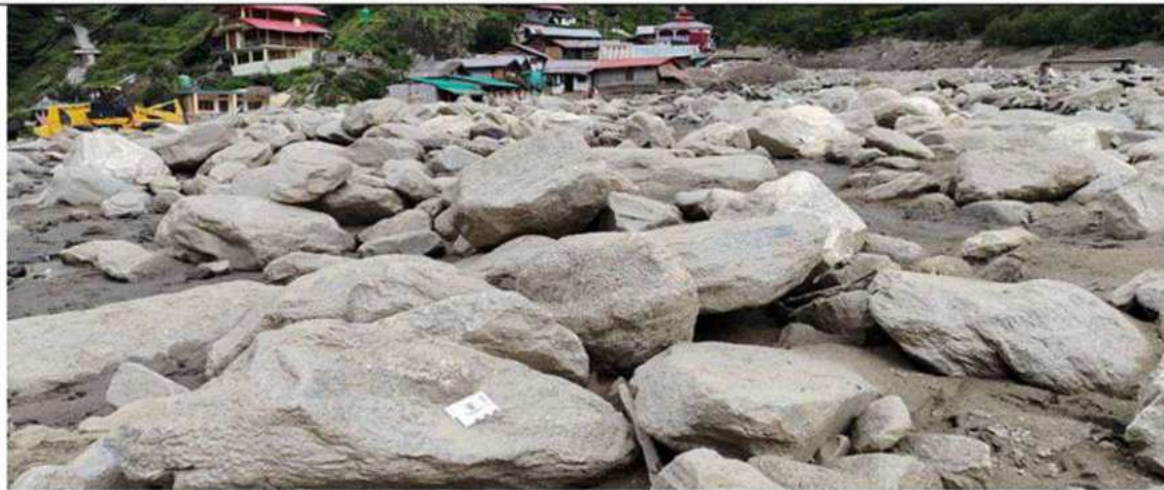
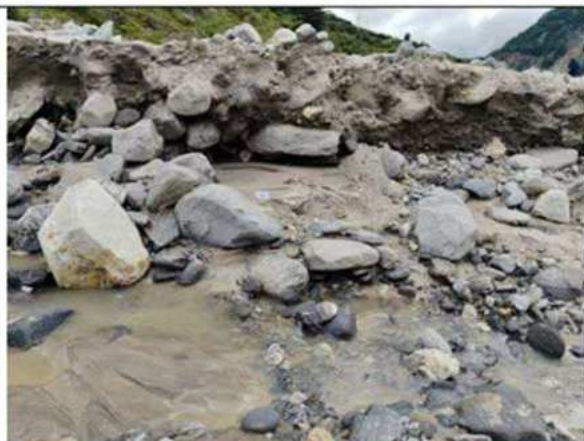
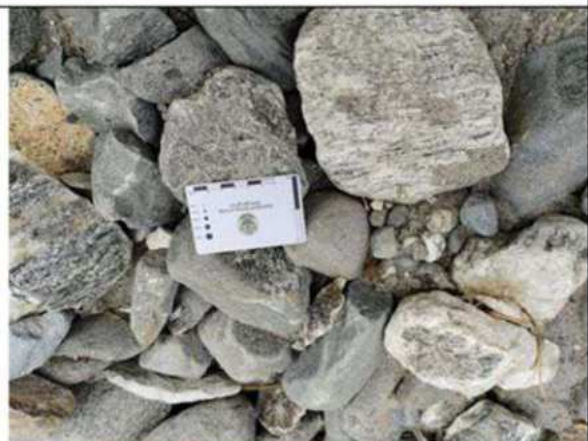
***Fig. 10: Field observation of transported material***

Field evidence (Fig. 10) shows a mix of large clasts embedded in sandy–silty matrix, representing different stages of debris transport, from high-magnitude boulder-rich surges to finer sediment-laden flows. The angular to sub-angular nature of the fragments, with minimal rounding, indicates their short-distance transport from nearby source slopes, highlighting the intensity and destructive power of the event.

Field evidence showing the enormous boulder-laden debris that devastated Dharali during the event, highlighting the sheer magnitude of transported material.

Field exposure showing stratified debris flow deposits, with coarse boulders embedded in a muddy–sandy matrix, indicative of high-energy transport and rapid deposition during the Dharali event.

Close-up view of debris material comprising angular to sub-angular gneissic fragments and metapelites embedded in a finer matrix, reflecting short-distance transport and high-energy deposition.

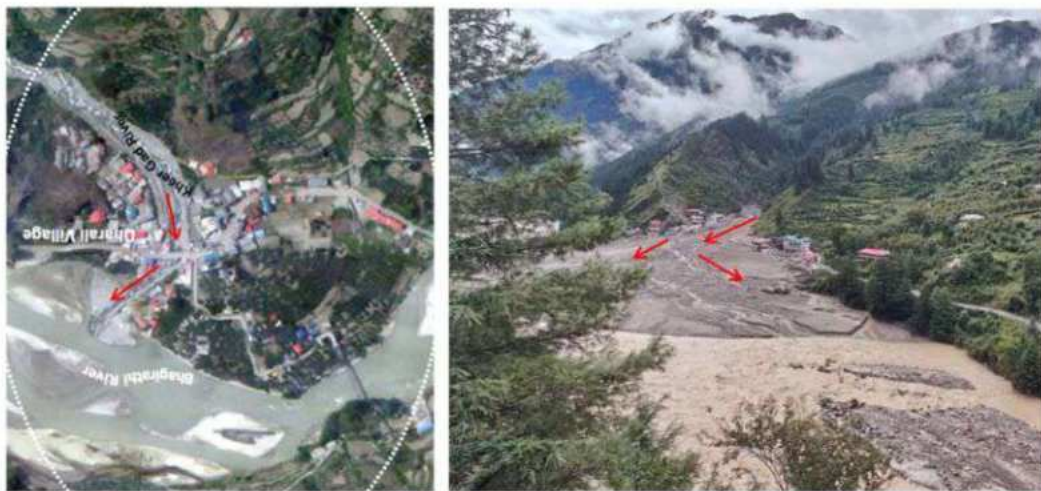
***Fig. 11: The pre and post event pictures showing the change of flow direction***

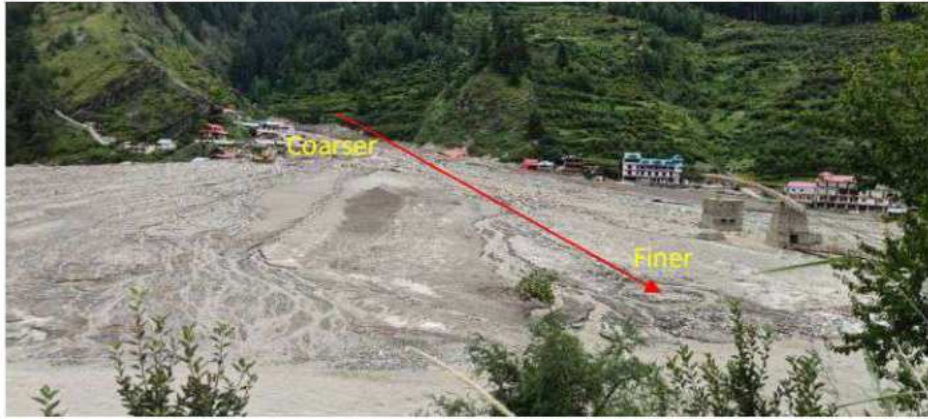
- c. Observations from the surface of the depositional fan indicate a gradational deposition pattern, with coarser material (boulders) near the National Highway location, progressively grading into finer material (sand/silt/clay) towards the periphery of the debris fan deposit.

***Fig. 12: Distribution of debris material***

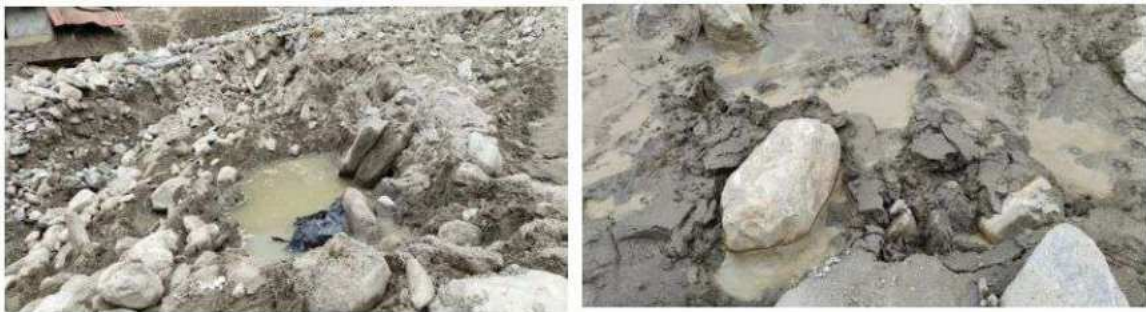
- d. During the search operations through manual excavation by the SDRF/NDRF team, it was observed that the subsurface showed a gradational deposition from finer to coarser material (i.e., sand/silt/clay to boulders) with increasing depth.
- e. At the peripheral areas of the fan deposit, the finer material exhibited high water retention, which hindered both manual and mechanical excavation efforts.

***Fig. 13: The water getting filled-up during the manual excavation showing the presence of underground water***

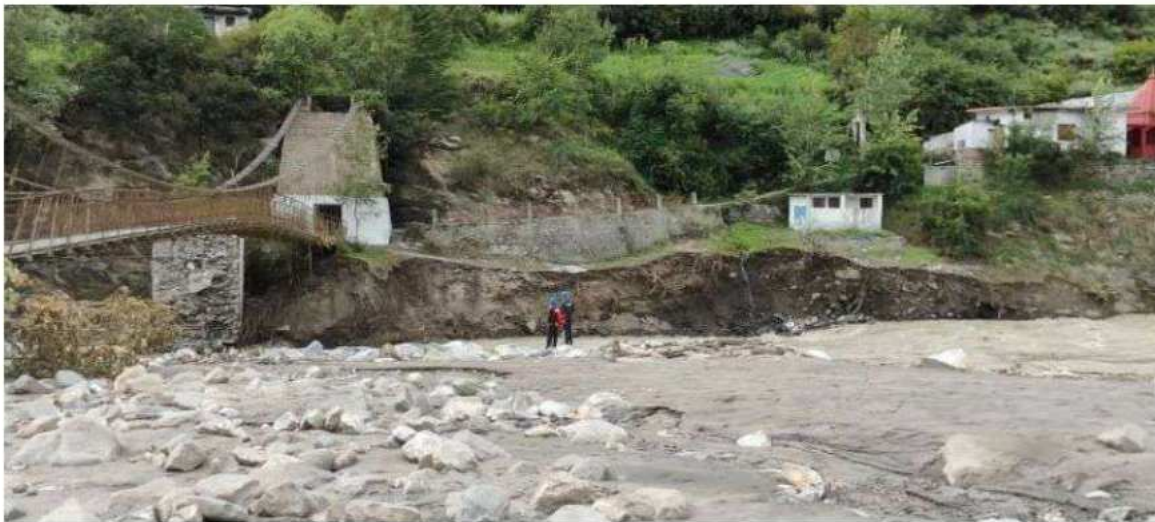
- h. The shifting of the Bhagirathi River towards the right bank, coupled with heavy water discharge during the peak monsoon season, is directly impacting the already weakened right-bank pier of the hanging bridge, thereby posing a critical threat to its long-term stability and functionality.

***Fig. 14: Impact of water on the right bank of the river damaging the foot bridge connecting Dharali to Mukhba***

- The debris deposits from the Dharali debris flow encroaching into the Bhagirathi River must be excavated in a planned manner to widen the river course and prevent damage along the right bank of the river.

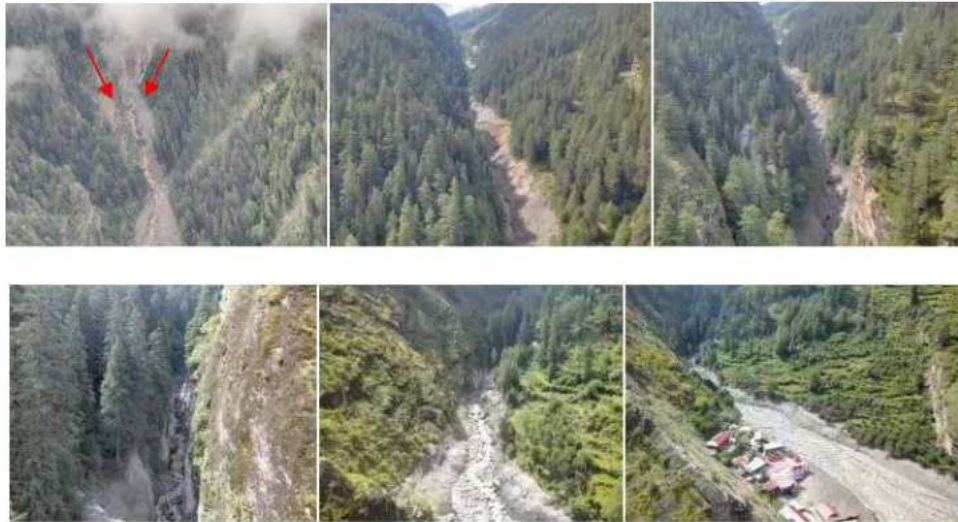
- j. Observations from the aerial survey indicate that the flow path is confined within a narrow, gorge-shaped valley with dense forest cover on both side slopes. No fresh landslides were observed along the side slopes of the valley, nor were there any signatures of a landslide dam formation. Therefore, the possibility of a landslide lake outburst flood (LLOF) is ruled out.

***Fig. 15: The Khir Gad stream at different heights from the confluence of two drains at upper level to the deposition site***

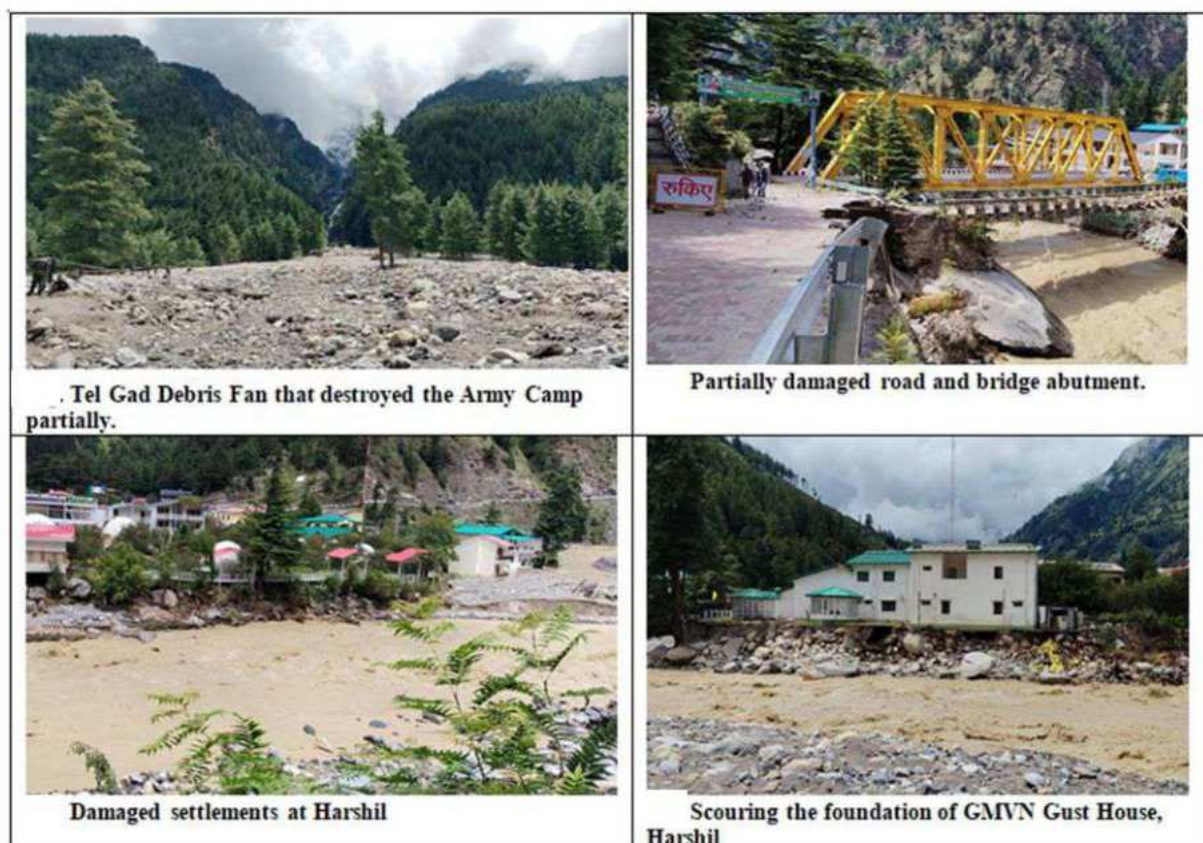
The debris transported along the bed of the Bhagirathi River from the Kheer Gad debris fan reached the Harshil–Tel Gad area under high discharge conditions. Its velocity was subsequently reduced by the additional debris material contributed by the Tel Gad. This interaction caused the deposition of assorted-sized boulders along the Bhagirathi main channel, just upstream of the Tel Gad debris fan. Intermittent high and low flows of the Bhagirathi river further sorted and channelled pebbles, cobbles, and finer gravel toward the left bank, immediately upstream of the Tel Gad fan. Additional obstruction caused by the increased bed load from the Dharali fan, combined with flow dampening near the Tel Gad confluence, generated a temporary impoundment, effectively creating a short-lived lake. The resulting

***Fig. 16: Debris flow at Harsil along Telgad***

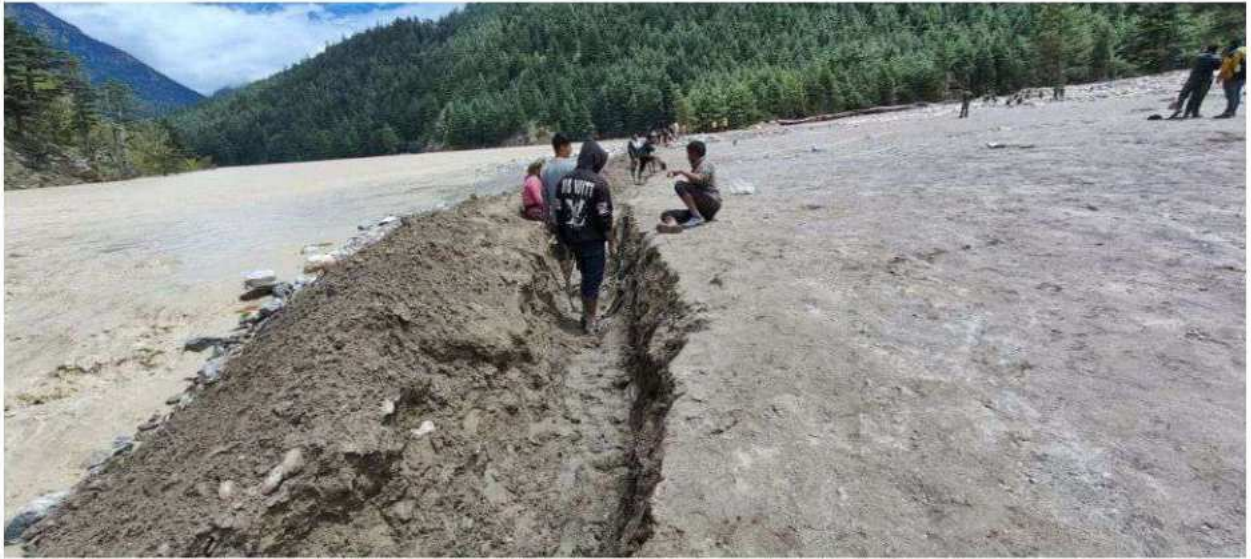
*Fig.17: Channelisation of water at Harsil lake*

The team surveyed the area and suggested the Irrigation Department to remove the debris by excavation at the outer periphery of the fan so as to channelise the water of the lake. It was observed that as soon as the debris removal began the river started widening and lake water also started flowing sluggishly. In the afternoon of 15<sup>th</sup> August, it was observed that there is a little decrease in water level in the lake at the Dharali side as measured by the NDRF.

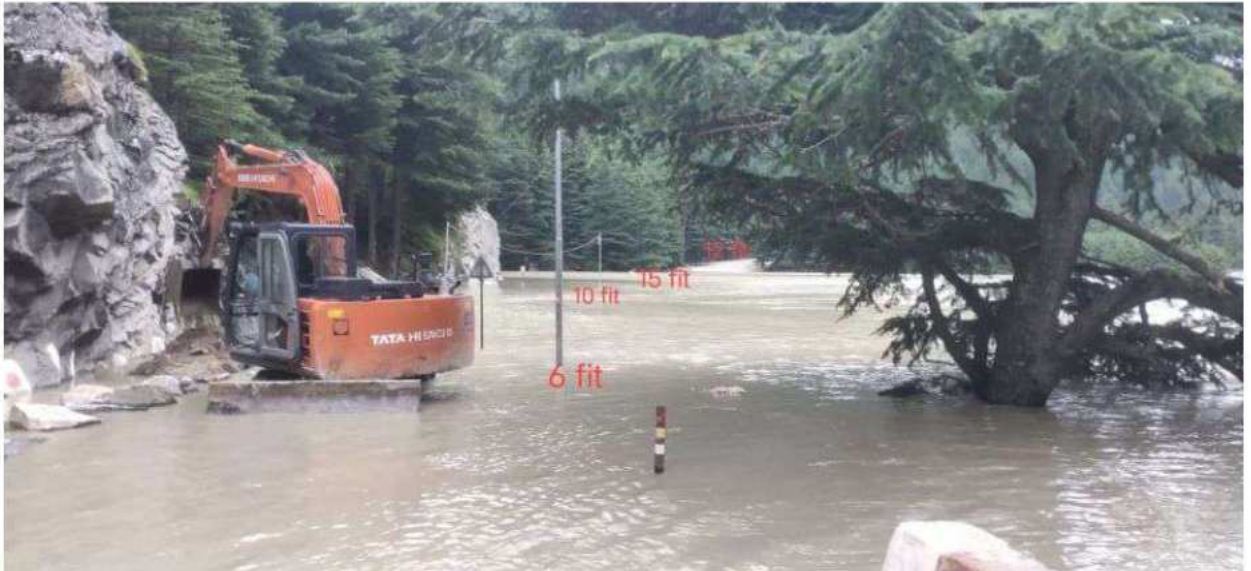
*Fig.18: Water level in the lake at Dharali side on 15<sup>th</sup> August*

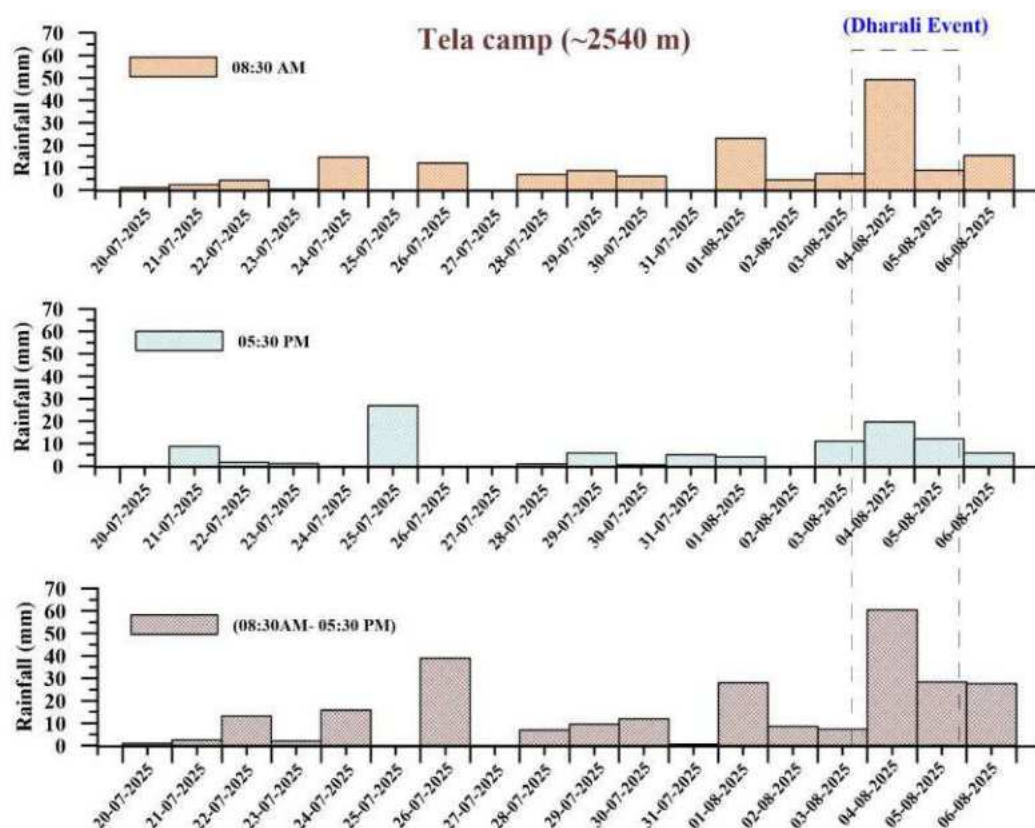
Between 3 and 5 August 2025, **Tela Camp** experienced a concentrated spell of heavy rainfall. On 3 August, moderate precipitation was recorded, with 7.4 mm in the morning and 11.2 mm in the evening, though the total value appears underreported in the Figure. This was followed by an extreme rainfall event on **4 August, when 49.2 mm** fell in the morning and **19.6 mm in the evening**, giving a total of **60.4 mm**, the single highest daily rainfall in the record (Fig.20).

**Fig.20: Daily rainfall distribution recorded at Tela Camp station established by Wadia Institute of Himalayan Geology, Dehradun in the Dingad catchment.**

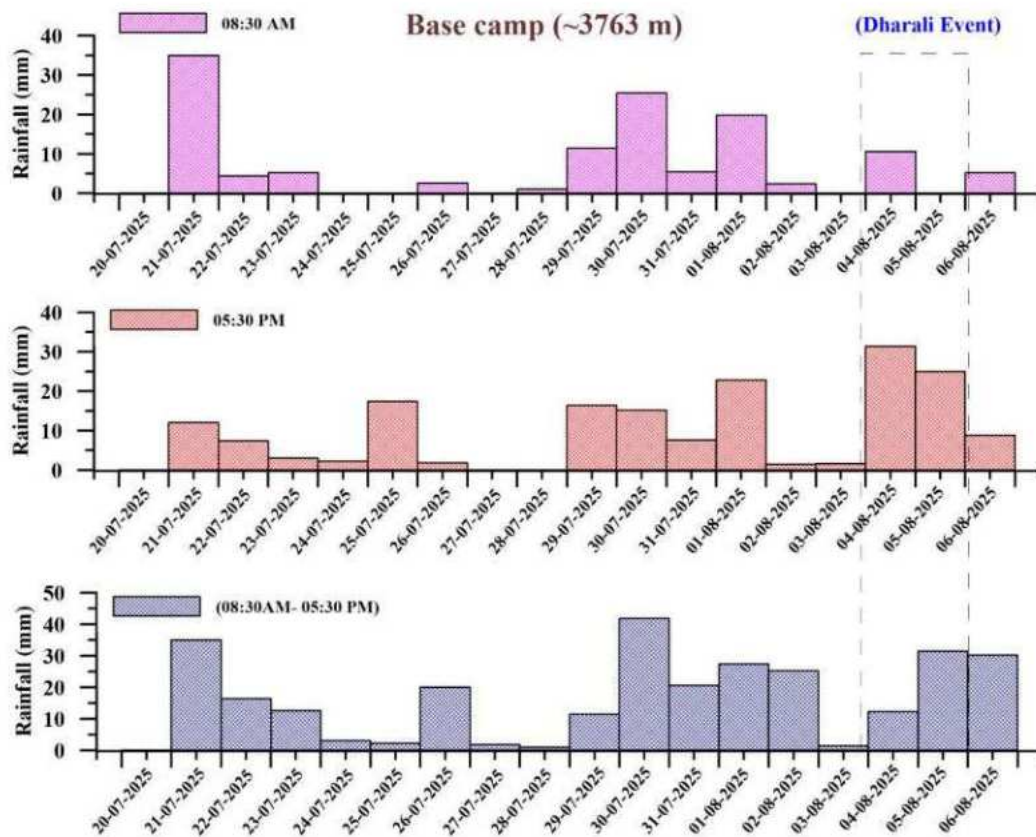
Between 3 and 5 August 2025, the Base Camp station also recorded a significant rainfall sequence, though with a different pattern compared to Tela Camp. On 3 August, only a trace amount was observed (1.6 mm in the evening, total 1.4 mm), indicating the beginning of unsettled conditions. **The situation intensified on 4<sup>th</sup> August, with 10.6 mm in the morning and 31.4 mm in the evening,** though the total is recorded as 12.2 mm, suggesting a possible reporting inconsistency. This still represents a day of notable rainfall activity, especially during the evening. The heavy spell continued on 5 August, when 25.0 mm fell in the evening, making up the full daily total of 31.4 mm (Fig.21). Thus, unlike Tela Camp, where the extreme burst came primarily in the morning of 4 August, the Base Camp experienced its heaviest rainfall later in the day on 4 and 5 August, with cumulative amounts exceeding 43 mm across the two days. This clustering of high evening rainfall events would have led to sustained catchment saturation, delayed runoff response, and potentially heightened downstream flood and slope instability risks.

**Fig.21: Daily rainfall distribution recorded at Base Camp established by Wadia Institute of Himalayan Geology, Dehradun in the Dingad catchment.**

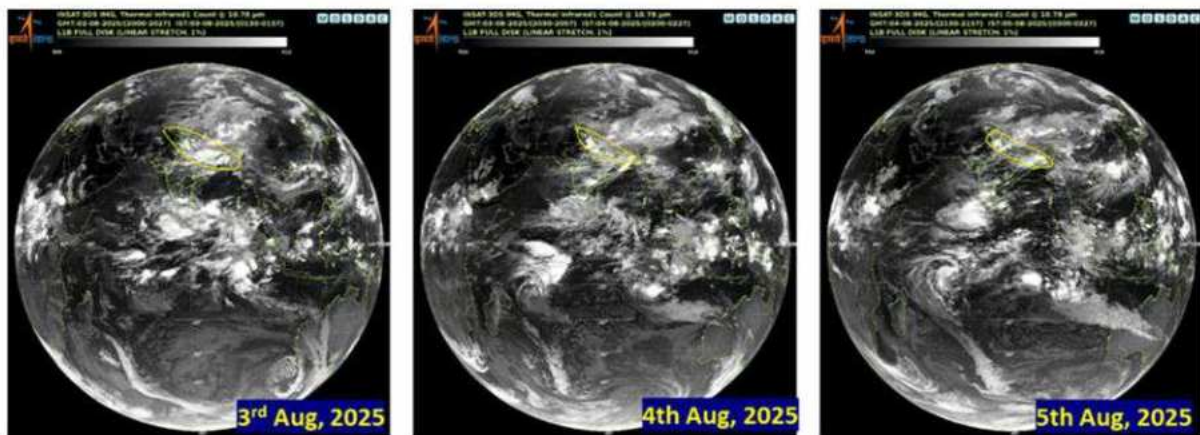
**Fig. 23: Observed position of monsoon trough from 3<sup>rd</sup> -5<sup>th</sup> Aug 2025 of INSAT-3DS Imagery (Source: ISRO-MOSDAC, downloaded on 6<sup>th</sup> August 2025)**

INSAT 3DS captures the evolution and positioning of the monsoon trough during 3<sup>rd</sup> –5<sup>th</sup> August 2025 (Fig.23). On 3<sup>rd</sup> Aug, the monsoon trough is situated at the foot of the Himalayas. By 4<sup>th</sup> August, it has migrated north-westward, while on 5<sup>th</sup> August, the trough has become stationary over the central Himalayan region. This progression illustrates a clear north-westward shift and stabilization of the trough in the days leading up to the Dharali event. This observed shift has aligned well with simultaneous IMD reports.

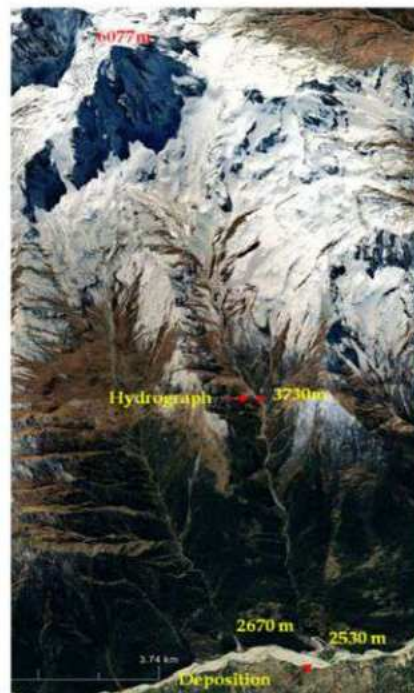
*Fig.24: Google Earth Image (29.10.2022) showing different elevations.*

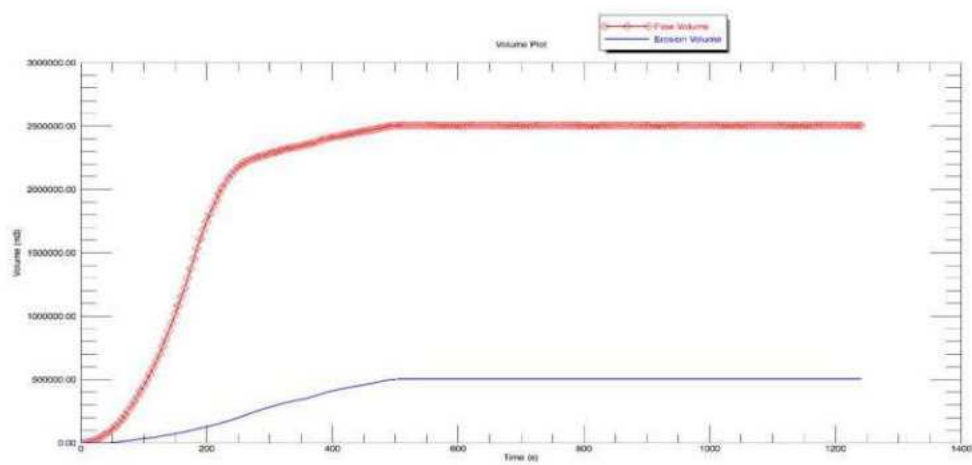
**Fig.27: Flow volume vs erosion volume over time**
