# **Geological Mapping along left bank of the River Alaknanda between Marwadi Bridge and Vishnuprayag**

**Uttarakhand Landslide Mitigation and Management Centre  
(ULMMC)**

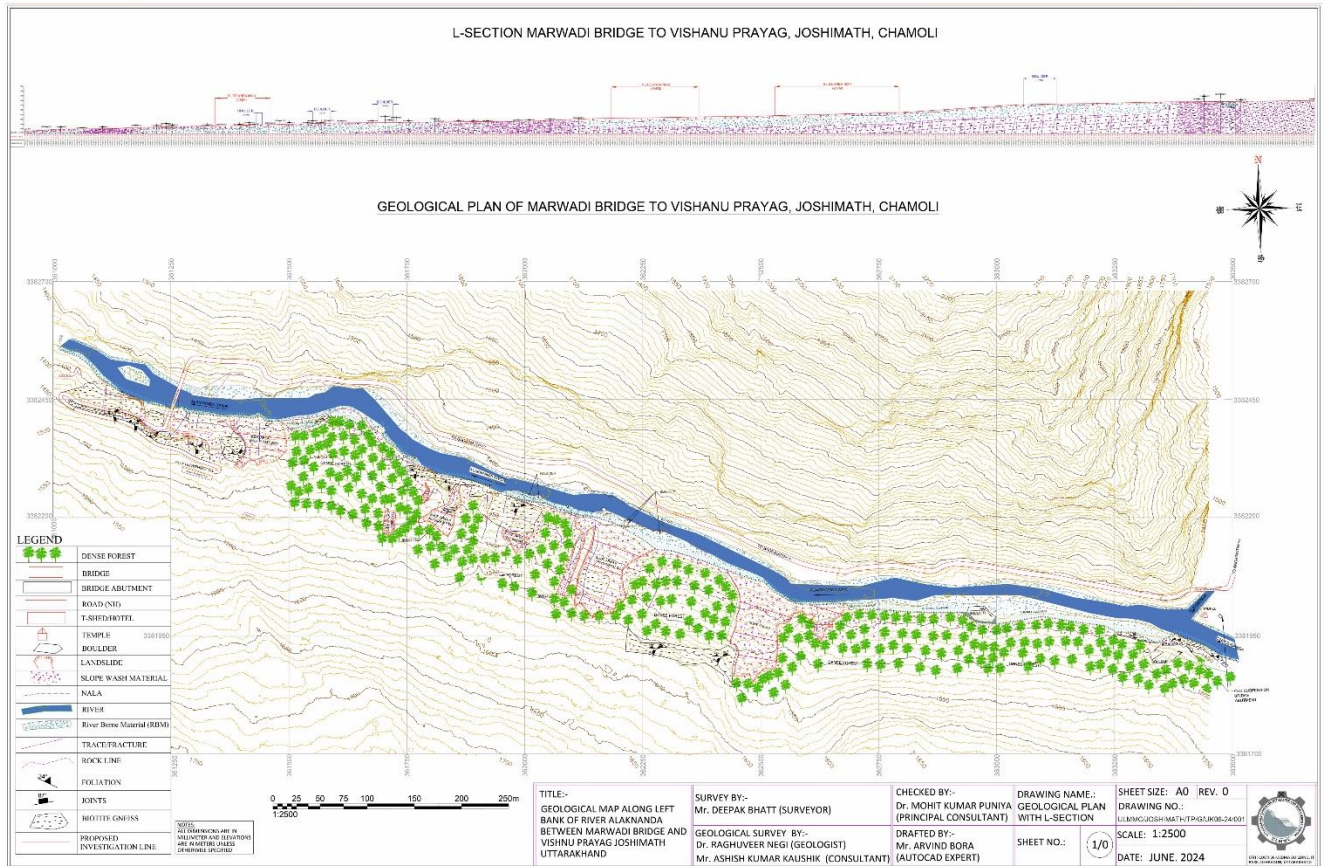
**Figure 4:** Geological Plan and L-section of Left Bank of the River Alaknanda between Marwadi Bridge and Vishnuprayag.

The boundary of different surface features and lithology was demarcated with the help of Total Station (TS) and Differential Geographical positioning System (DGPS) (**Figure 3**). The geological field data were collected along the left bank of the River Alaknanda between Marwadi bridge and Vishnuprayag at different elevations in according to IS codes (IS 11315 part 1). The geological plan and L-sections (**Figure 4**) of the area have been prepared from the data collected in the field on scale of 1:2500 and 1:500. The L-sections have been prepared which are given in the annexures 2. The Geological map (Figure 4) also shows the major landslides along the left bank of the river.

Another debris slide is observed near Vishnuprayag on the left bank of the River Alaknanda, between chainage 1583 to 1853 meters (**Figure 4; Figure 14**). The slide area covers 23,103 square meters (**Table 1**), with a chainage length of 263 meters and a maximum length of 209 meters. The slide material primarily consists of boulders, rock debris, and soil. Toe erosion is identified as one of the primary factors accelerating slope instability.

It is also imperative to conduct comprehensive geotechnical and geophysical investigations, including drilling, before designing toe protections and mitigation measures for the landslide zones. This approach ensures long-term stability. The following geotechnical analysis and geophysical investigations should be conducted before implementing any mitigation measures for slope failures and toe protection: Electrical Resistivity Tomography (ERT), Seismic Reflection Tomography (SRT), and Multi-Channel Analysis of Surface Waves (MASW). These investigations should cover a length of 1,040 meters, as per the proposed investigation lines in Figure 4, and reach a depth of 50 meters at the landslide sites.

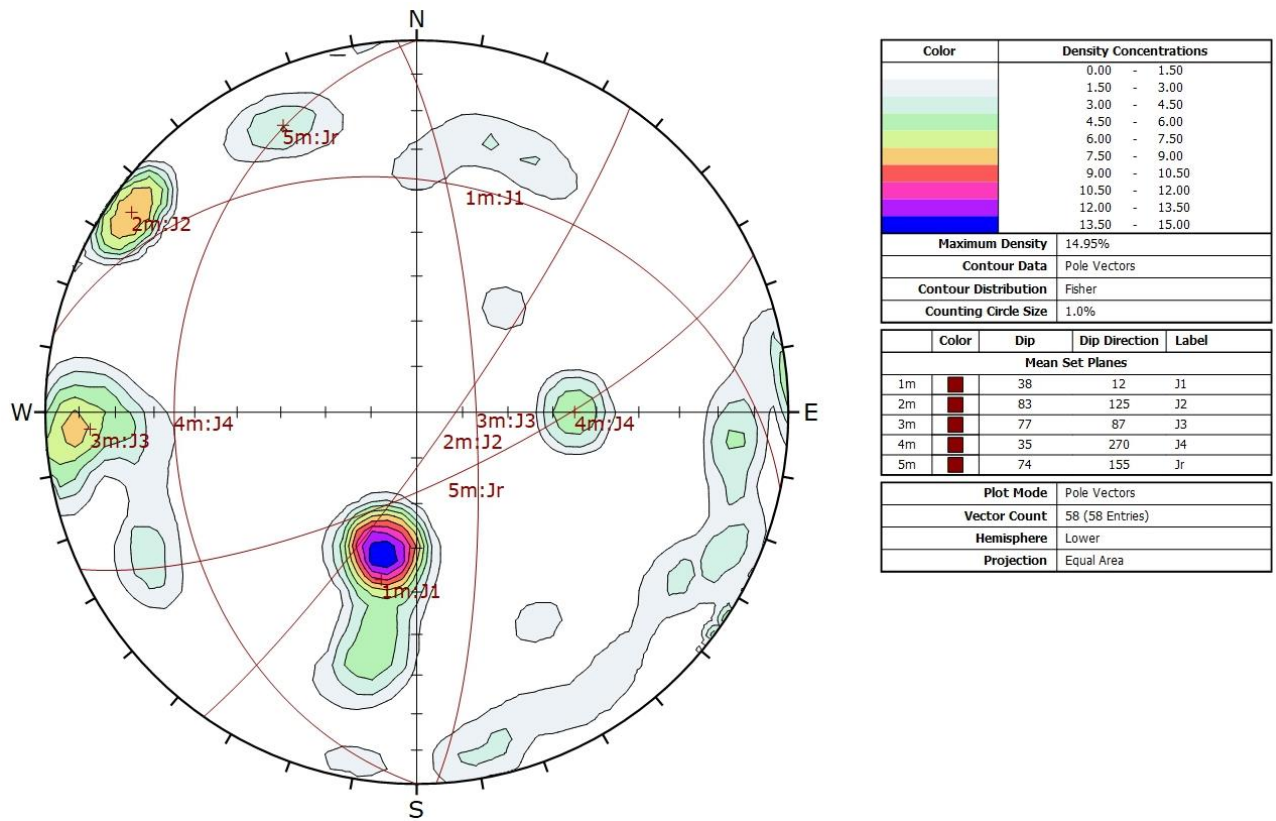
**Figure 7:** Stereographic projections major discontinuity of left bank of River Alaknanda between Marwadi Bridge and Vishnuprayag.

The biotite-gneiss in the Joshimath area is slightly weathered (**Figure 5**) and exhibits minor jointing and fracturing. Consequently, the biotite-gneiss in this area is classified as having fair to good rock mass quality (**Figure 6**). The dip of foliation ranges between  $17^{\circ}$  and  $61^{\circ}$  with a dip direction between  $N032^{\circ}$  and  $N358^{\circ}$ . Joint set J2 dips between  $72^{\circ}$  and  $89^{\circ}$  with a dip direction

between N117° and N135°. Joint set J3 dips between 58° and 89° with a dip direction between N074° and N099°. Joint set J4 dips between 23° and 44° with a dip direction between N256° and N284°. There is also a random joint set dipping between 63° and 85° with a dip direction between N143° and N165° (**Figure 7**, Annexure 1).

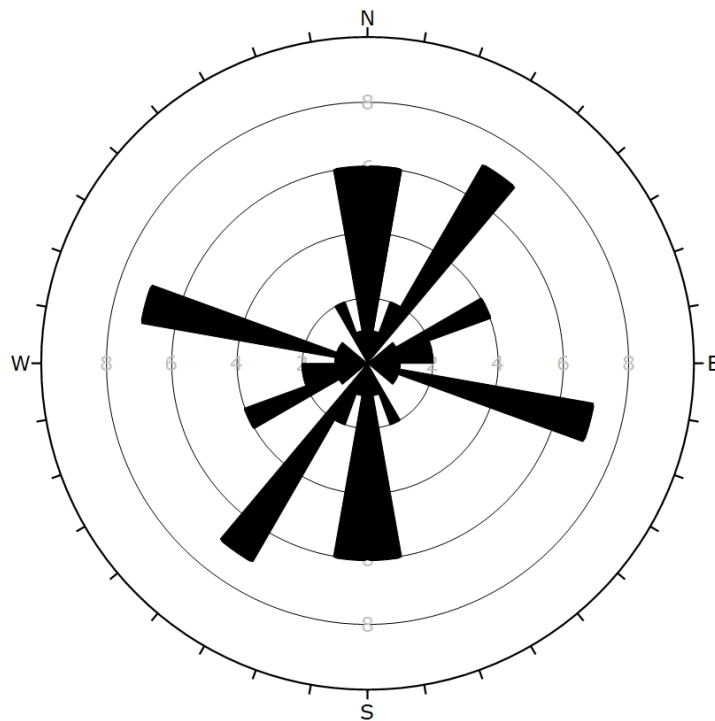
**Figure 8:** Rose diagram showing trends of major discontinuity along left bank of River Alaknanda between Marwadi Bridge and Vishnuprayag

The Biotite-Gneiss dips northerly, and the majority of the joint sets show trends along N-S, WNW-ESE, and NE-SW directions (**Figure 8**).
