**Preliminary Site Investigation of Landslides and Associated  
Distress along the Hill Bypass Road around Mansa Devi,  
Haridwar**

**Uttarakhand Landslide Mitigation and Management Centre  
Government of Uttarakhand  
August 2023**

### **PROLOGUE**

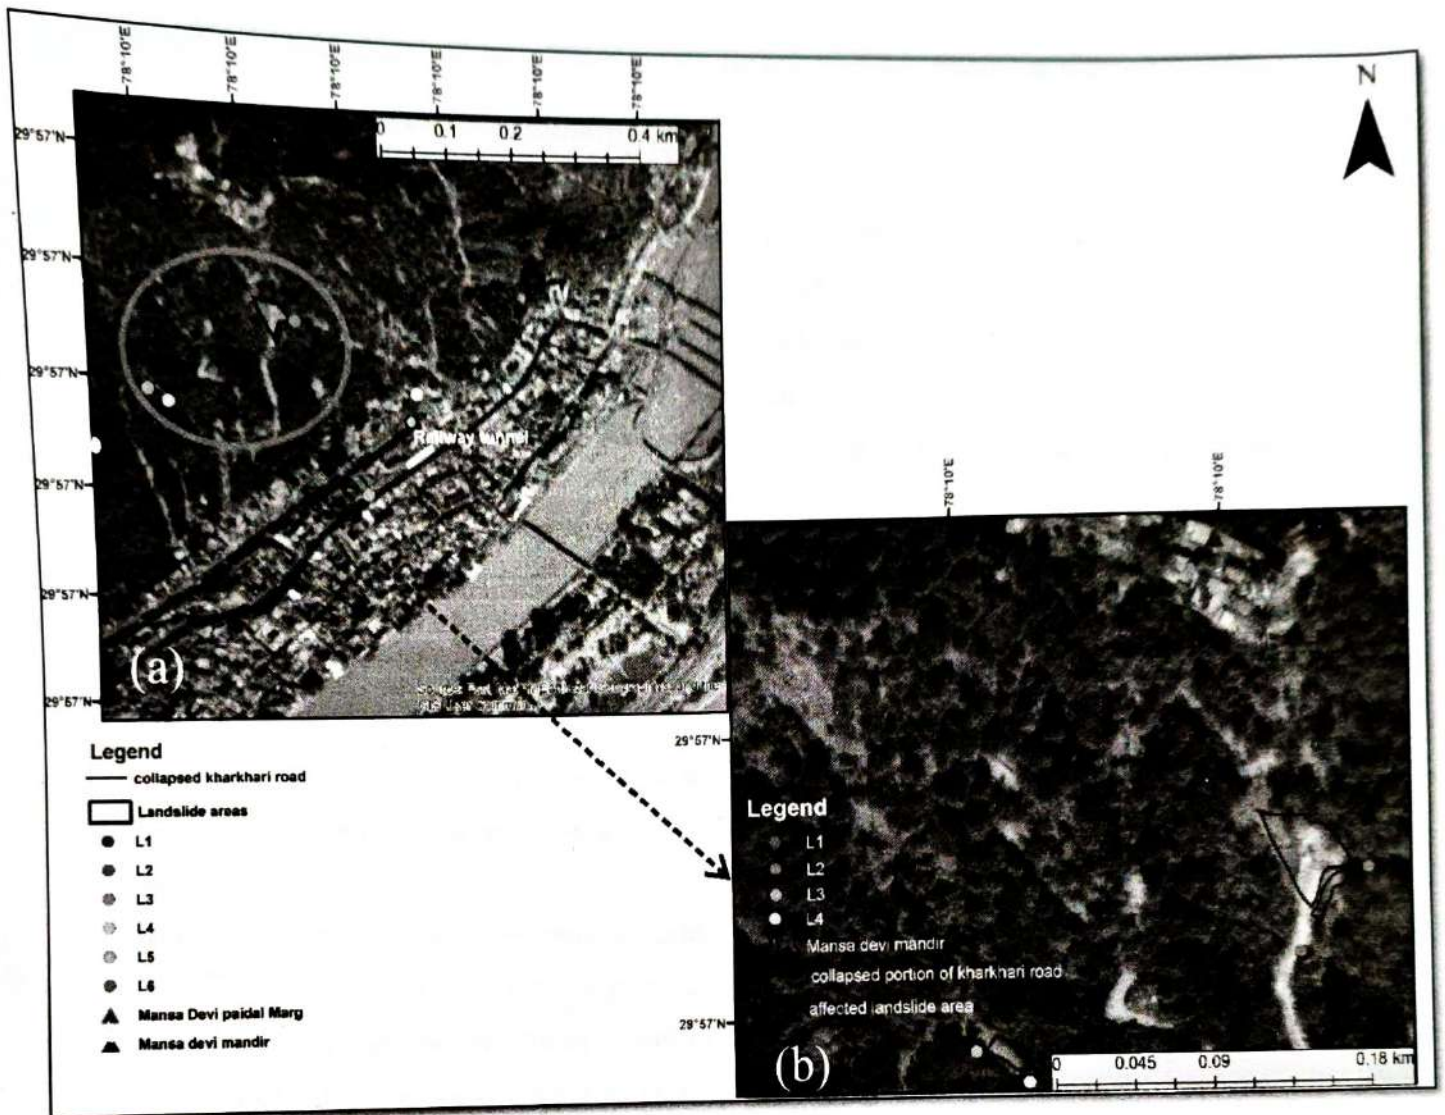
**Fig. 2:** (a) Location map showing the points where preliminary survey is carried out (b) The pink circle marked in (a) is extended further which highlights two major landslide areas along the Hill Bypass road

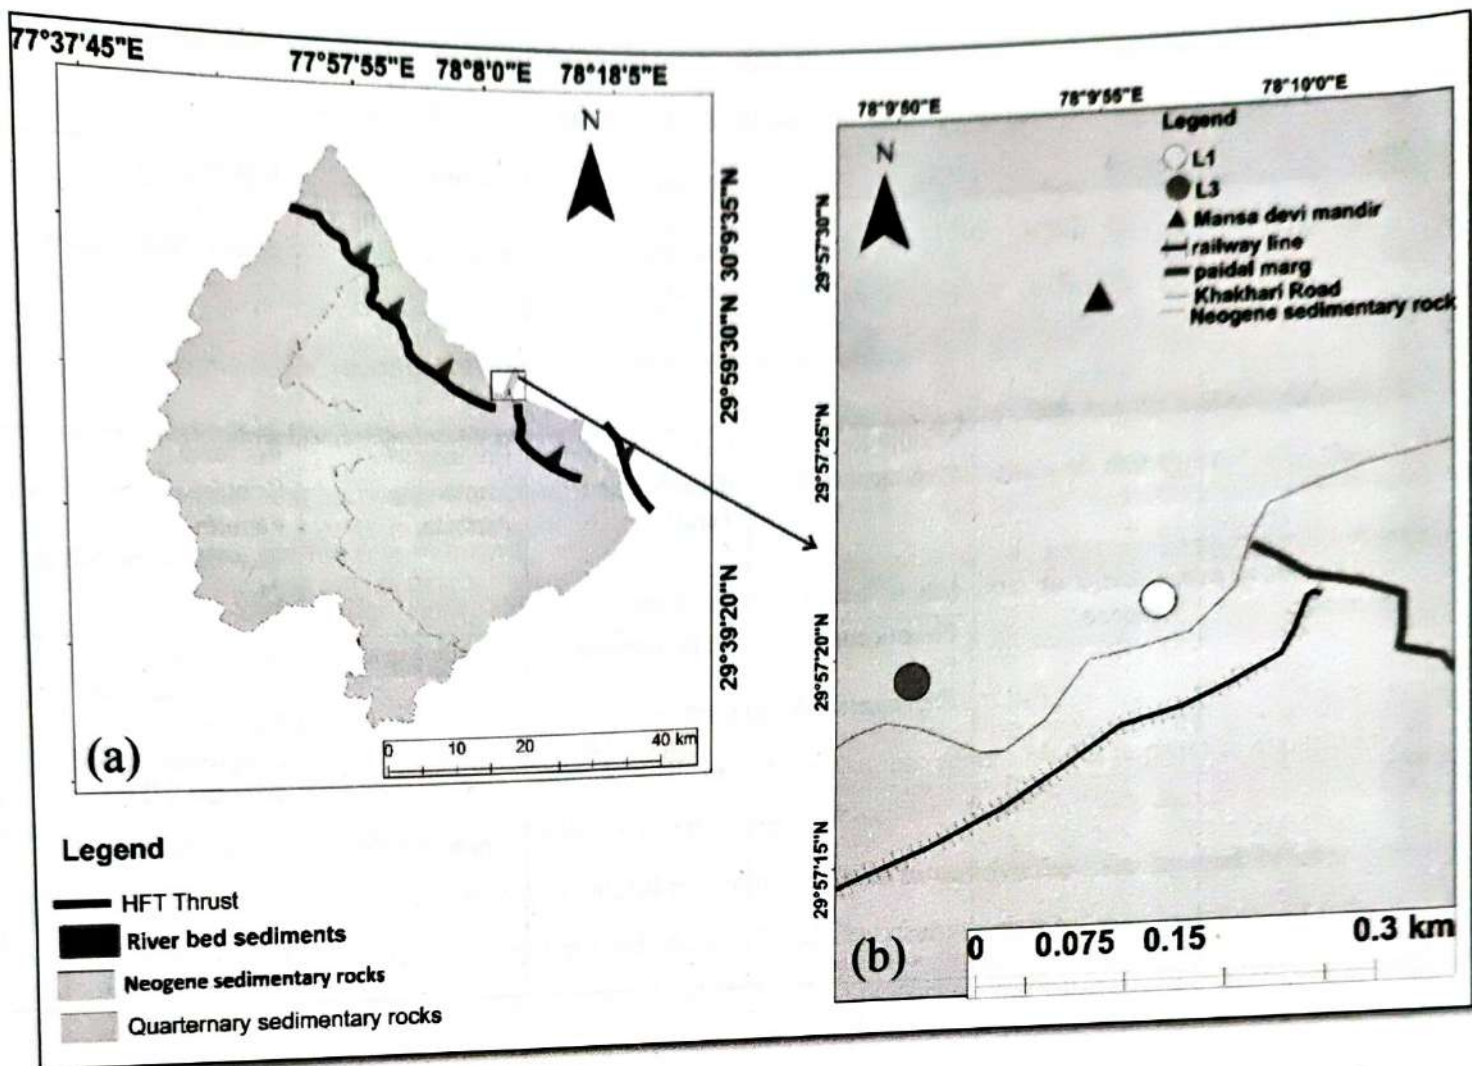
**Fig 4:** (a) Geology map of Haridwar, composed of Neogene and Quaternary sedimentary rocks. The brown colour line demarcates the HFT or Himalayan Frontal thrust (b) The black square in (a) is extended further, which shows the lithology of the preliminary survey area and important location points.
