विषय:- टिफिन टॉप व चार्टन लॉज, नैनीताल में हो रहे भू-स्खलन के स्थलीय निरीक्षण के संबंध में आख्या।

टिफिन टॉप, नैनीताल में हो रहे भूस्खलन की निरीक्षण आख्या

चार्टन लॉज, नैनीताल में हो रहे भूस्खलन की निरीक्षण आख्या

Field Report on Tiffin Top

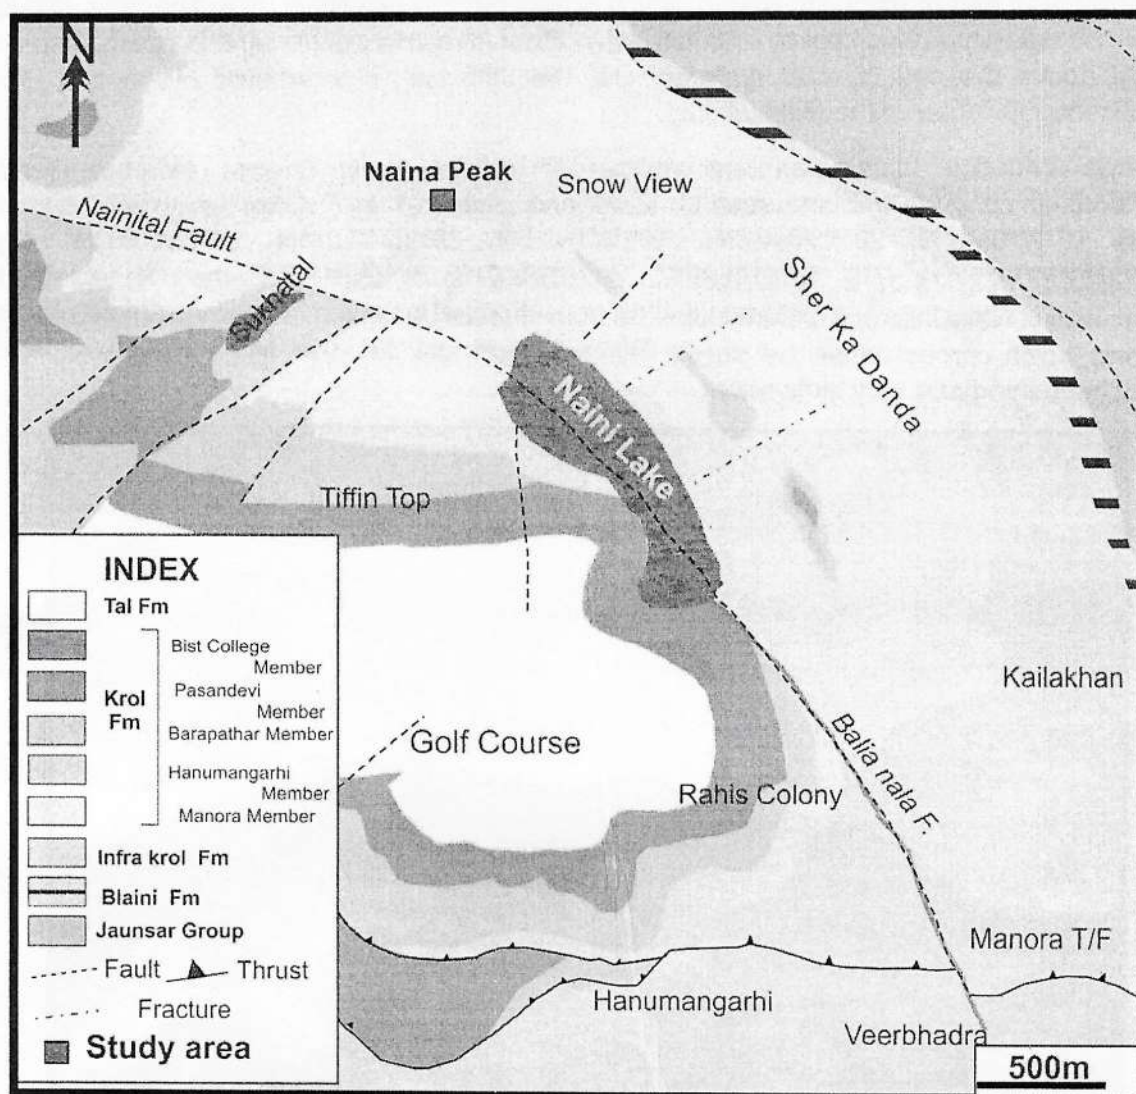
Figure.3 represents the geological map of the area

The area of the study is a part of Nainital hills that represents the outer sequence of the lesser Himalayan sequence (LHS) which is bounded by the Main Boundary Thrust (MBT) in the south and Main Central Thrust (MCT) in the north. In the Nainital area, the MBT has been observed near Jeolikot where it separates the Nagthar and Krol formations from the Siwaliks. The other main faults in this area are Nainital lake fault, **Lake/Deopatha fault**, **Lariakanta Fault** and Manora fault along with splay of these faults.
